1 CLAYTON ELEMENTARY

CLAYTON ELEMENTARY: BUILDING EVOLUTION

CLAYTON ELEMENTARY: EXISTING SITE PLAN

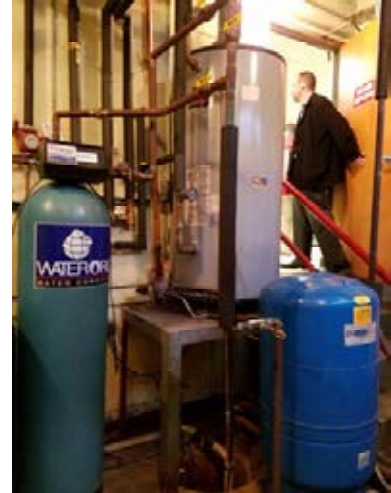
- A. Water is well supplied to the building by what appears to be 2" water service with well tank. The water service is at its limit and could not support any future additions.
- B. The majority of the water distribution piping in the building appears to be galvanized pipe and copper. The water distribution piping appears to be in fair condition.
- C. The building has no fire suppression system.

- A. The water distribution piping in the original building is at the end of its life expectancy. We would recommend replacing the existing pipe and fittings with new type "L" copper tube and fittings.
- B. If there are any new additions or major remodeling planned, a new larger water service will need to be provided.
- C. If a complete fire sprinkler system is preferred for the building, a new 6" water service will need to be provided.

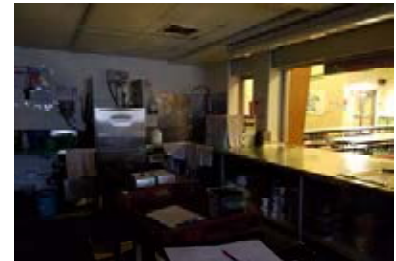
Sanitary and Storm Piping

- A. The sanitary waste from the building flows by gravity out the building to a field system.
- B. The sanitary waste piping in the original is underground and could not be identified.
- C. The building has a prep kitchen with a two single compartment sinks, a dishwasher, and no disposal.
- D. The classroom sinks do not have solids traps installed on the waste piping.
- E. The existing roof water is collected by gutter and downspout flow by gravity out the building to drainage field.
- F. There is a clearwater sump pump located in the Boiler Room for removing groundwater. The sump systems appear to be in fair to good condition.

- G. The sanitary sewer system in the original building is nearing the end of their life expectancy. We would recommend the existing

sewer located below the floor be inspected with a camera and may need to be replaced, pending outcome of scope.

- H. The storm sewer system in the original building is nearing the end of their life expectancy. We would recommend the existing sewer located below the floor be inspected with a camera and may need to be replaced, pending outcome of scope.
- I. The existing clearwater sump pump should be monitored and repaired or replaced as necessary.

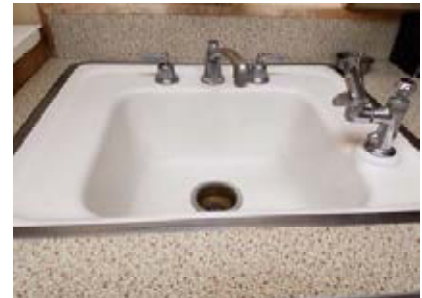
- A. The existing plumbing fixtures in the building are a combination of various styles and ages. Most of the fixtures are original to the building age they were installed. Some of the fixtures have been replaced with newer water efficient and ADA compliant fixtures.

- B. The water closets are floor set, tank type fixtures. They do not appear to be water conserving or ADA compliant. The fixtures are old and in fair condition.

- C. The urinals in the building are floor set varying types of flushing. The fixtures are not water conserving. The fixtures are old and are in fair condition.

- D. The lavatories in the building are wall hung with multiple styles of faucets. They do not appear to be water conserving or ADA compliant and are in fair condition.

- E. The drinking fountains in the building are vitreous china drinking fountains or wall hung electric water coolers. They are not ADA compliant and are in fair condition. The fixtures are in good condition.

- F. The classroom sinks are single bowl, vitreous china drop-in sinks with gooseneck faucet and separate drinking fountain. The fixtures are not ADA compliant and are in fair condition.

- A. The water closets should be replaced with new water conserving and ADA compliant fixtures.

- B. The urinals should be replaced with new water conserving and ADA compliant fixtures.
- C. The lavatories should be replaced with new water conserving and ADA compliant fixtures.
- D. The older drinking fountains should be replaced with new ADA compliant fixtures with a bottle filler.
- E. The faucets on the classroom sinks should be replaced with new ADA compliant faucets.
