2 COOLIDGE ELEMENTARY

COOLIDGE ELEMENTARY: BUILDING EVOLUTION

COOLIDGE ELEMENTARY: BUILDING SYSTEMS SUMMARY

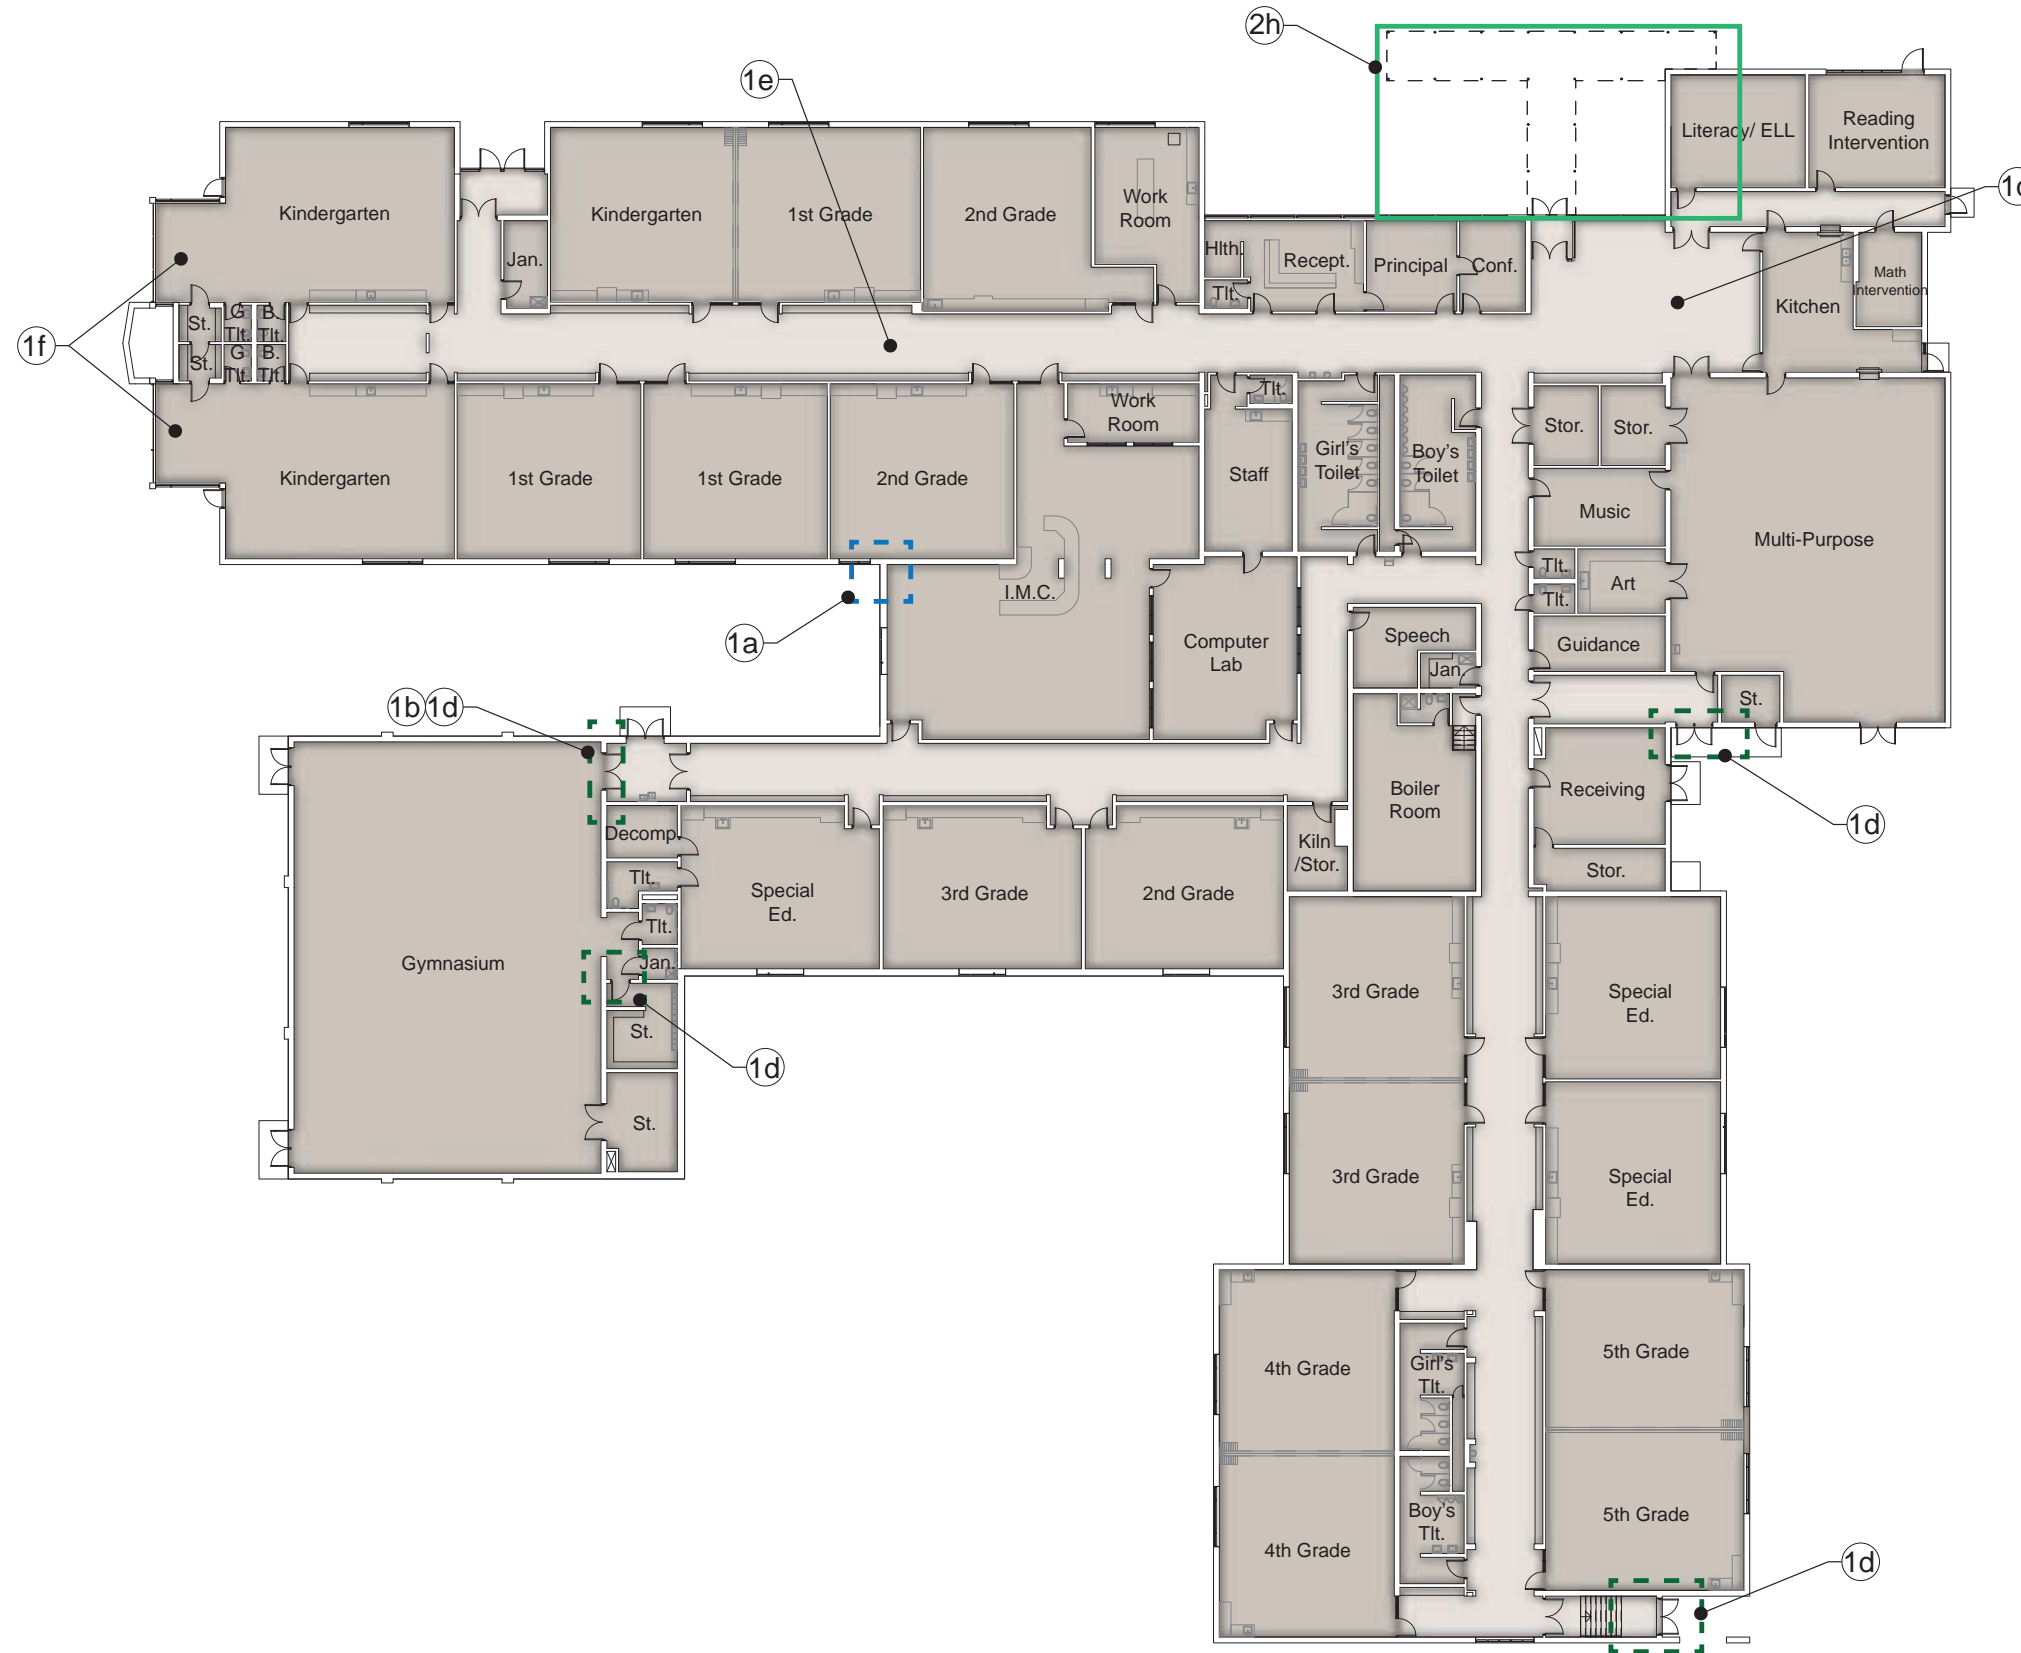
FIRST FLOOR PLAN
not to scale

- a. Some concrete masonry block walls and walls covered in tile are cracking

- b. Interior double doors at the corridor leading into the Gymnasium are rotting and rusting, possibly due to water damage

- c. Ceiling tiles are dated, with some tiles stained/showing signs of water damage and many bowing, bending and separating from the ceiling grid; there are a mix of tile types throughout the building
- d. Staff reported areas where water is leaking through the ceiling and into the building, especially at areas near the Gymnasium

- e. Much of the hard-surface flooring is stained, worn, cracking/heaving and in need of repair; there are multiple types of flooring throughout the building
- f. Wood parquet floors have instances of separation, rotting and wear
- g. Staff indicated areas of potential asbestos tile throughout the building; some tiles in these areas are chipped and/or missing

- a. Exterior brick is crumbling/cracking, especially at building corner conditions and near the foundation wall and at flowerbed locations
- b. Exterior walls are stained, especially at the foundation wall; there are rust spots throughout the concrete masonry block walls
- c. Many of the unit vents are damaged, dented and rusting

- d. Windows are dated/worn and appear to allow draftiness; some windows have panels that are worn and have paint peeling off on the exterior

- e. Many exterior doors are dated/worn and rusting; wood doors are peeling

- f. Roof overhangs have metal fascia that is damaged and peeling off
- g. Structural beams supporting the roof are worn and have paint peeling off on the exterior
- h. The canopy at the main entrance has dented/damaged metal fascia, and the wood support beams are chipping/splitting at some locations; water pools/collects underneath the canopy
- i. Gutters are dented, especially at the bottom of the downspouts

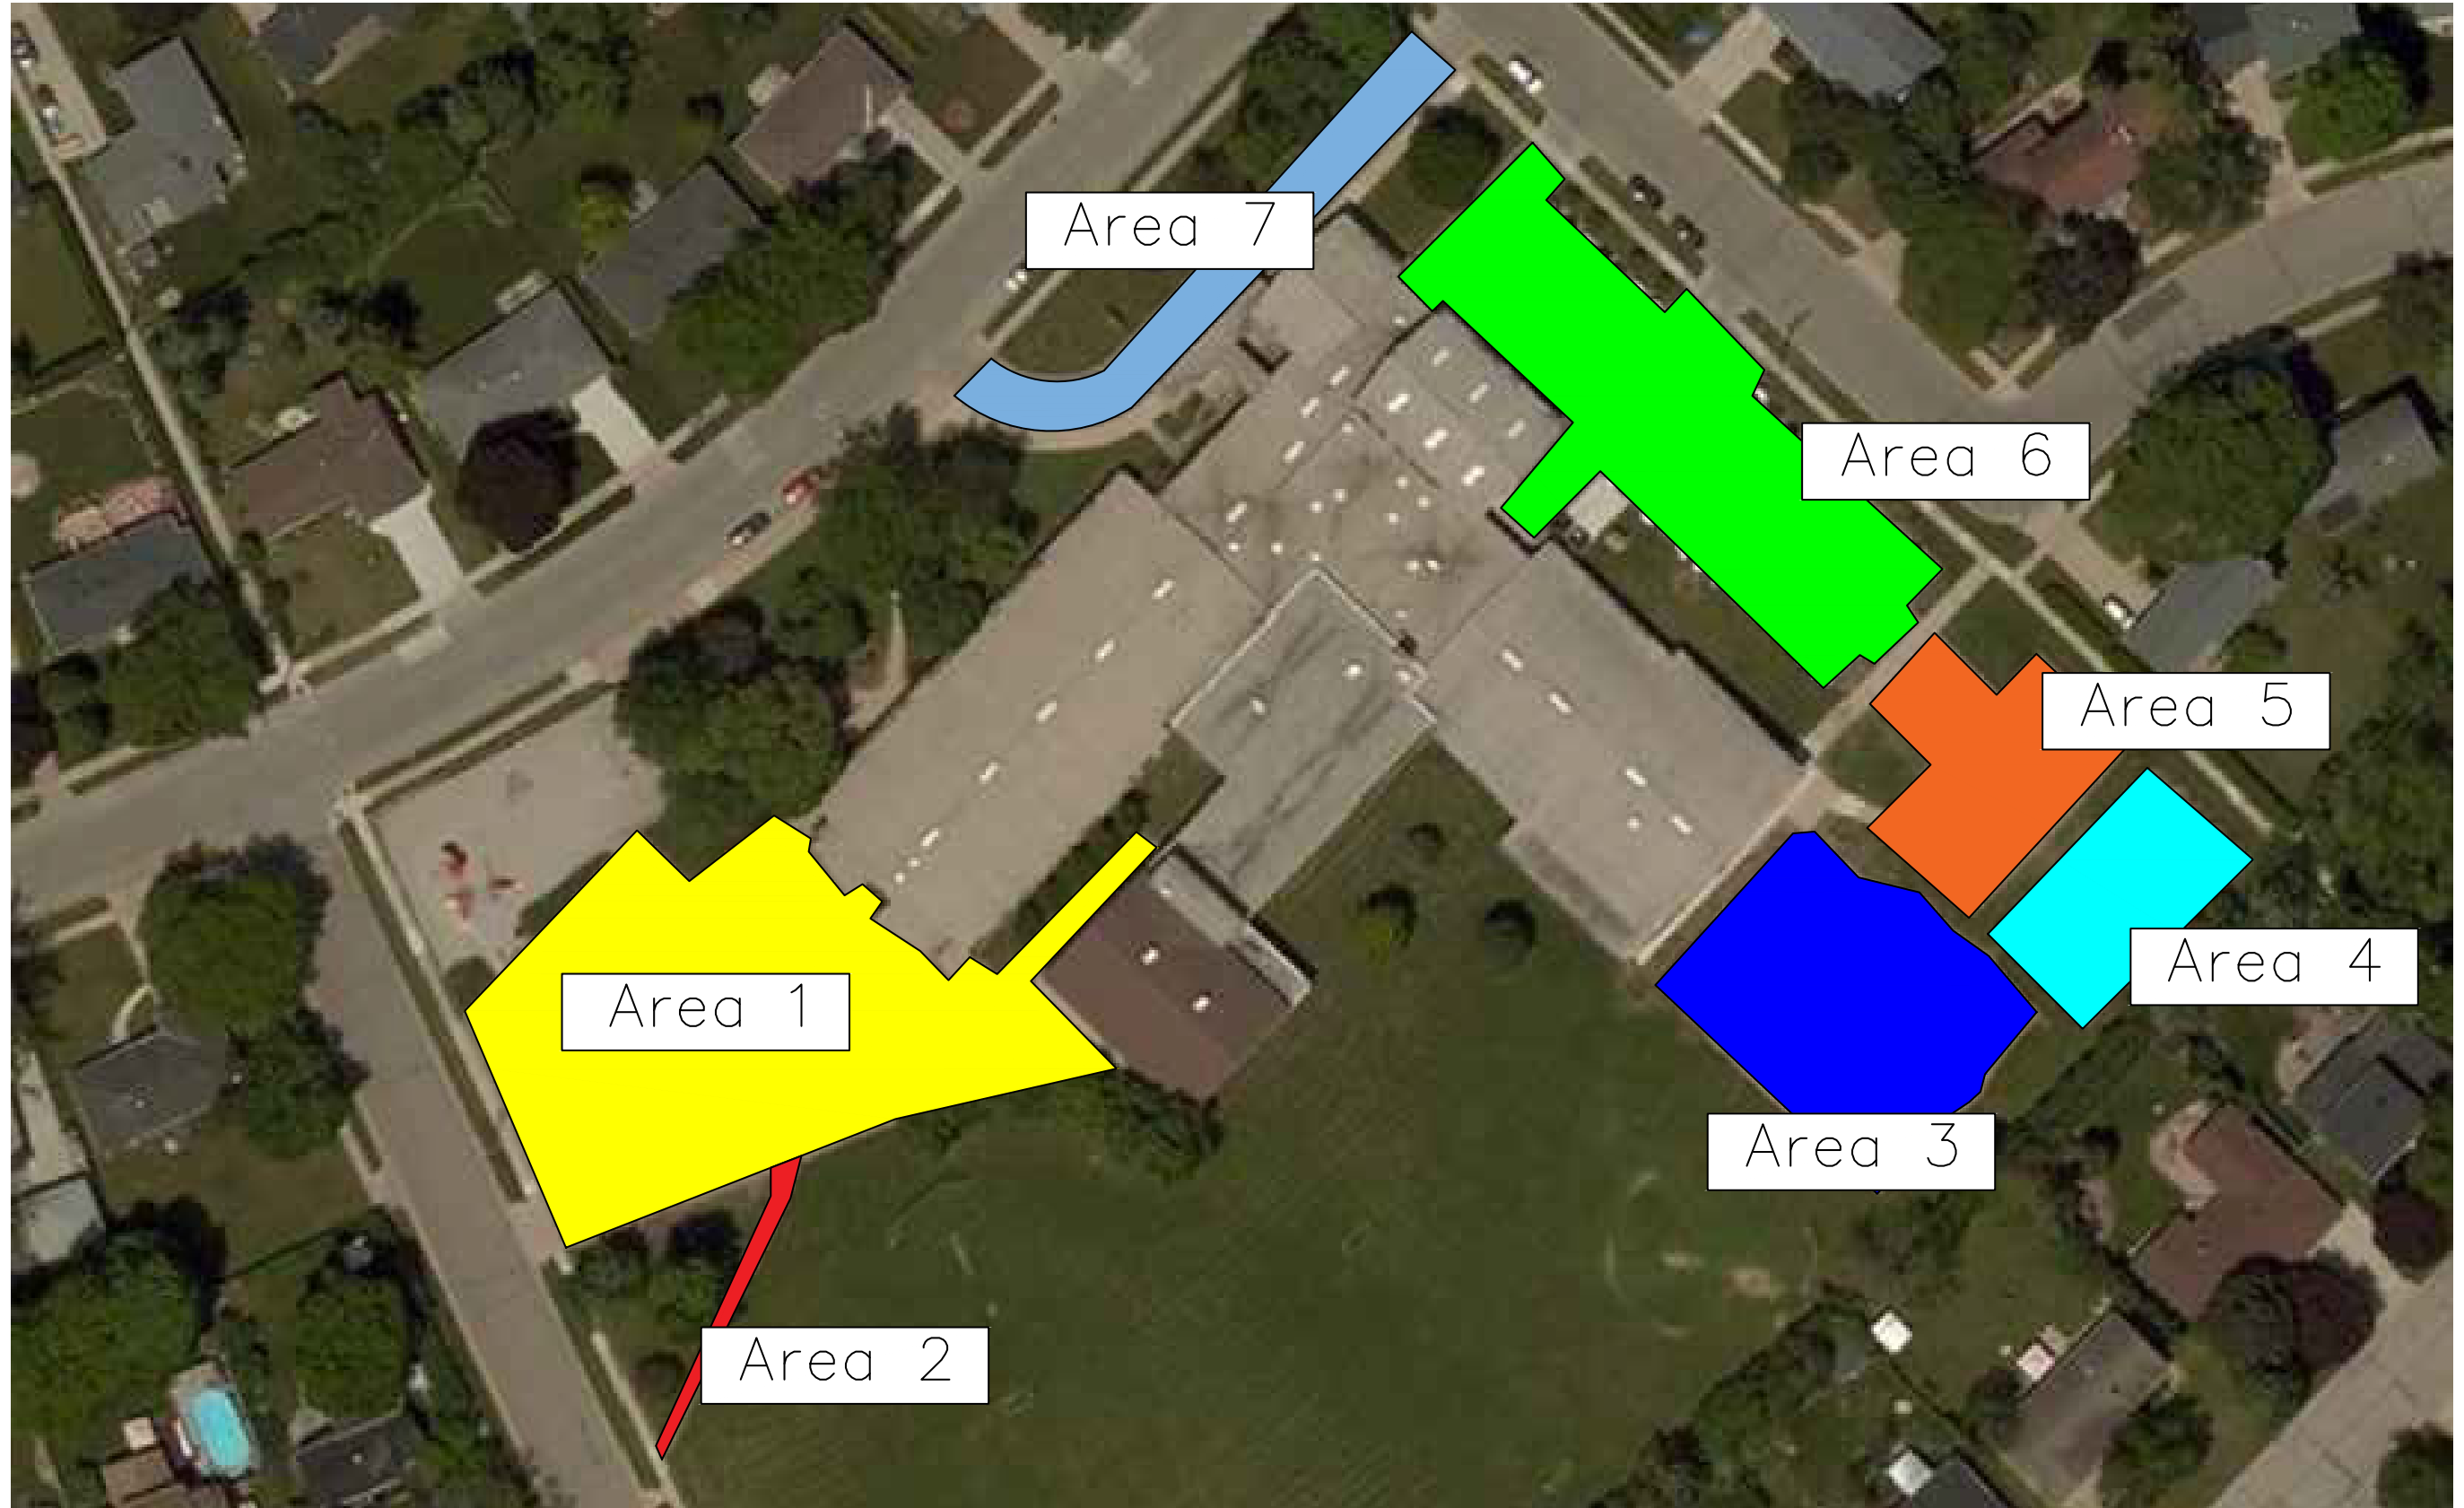
SITE PLAN
not to scale

- Distresses Present:
 - Thermal cracking
 - Depressions due to the base settling
 - Fatigue cracking due to the base failure (throughout area)
 - Raveling
 - Surface weathering
- Recommended Repair:
 - Remove the existing pavement and 12 inches of base and/or subgrade
 - Pave 12 inches of base aggregate dense
 - Pave 3.5 inches of asphaltic pavement
 - Paint all pavement markings for a playground

- Distresses Present:
 - Thermal cracking
 - Fatigue cracking due to base failure
 - Raveling
 - Surface weathering
 - Drainage/grading issues
- Recommended Repair:
 - Remove the existing pavement and 12 inches of base and/or subgrade
 - Place 12 inches of base aggregate dense
 - Pave 3 inches of asphaltic pavement

- Concerns:
 - Timbers are not at uniform height and pose a tripping hazard
- Recommended Repair:
 - Remove the existing timbers
 - Pour a 6 inch, concrete border

- Distresses Present:
 - Thermal cracking
 - Depressions due to the base settling
 - Raveling
 - Surface weathering
- Recommended Repair:
 - Pavement removal
 - 12 inches of base and/or subgrade removal
 - 12 inches of base aggregate dense
 - Pave 3 inches of asphaltic pavement
 - Pavement markings for a basketball court

- These areas have had a recent crack fill and seal coat; they should be re-evaluated in two years

- Distresses Present:
 - Cracked sections of sidewalk pose a tripping hazard
 - Spalling at some joints
- Recommended Repair:
 - Remove and replace the areas of sidewalk that are cracked

- Playground equipment appears newer; swing-set appears dated
- No dumpster enclosure exists

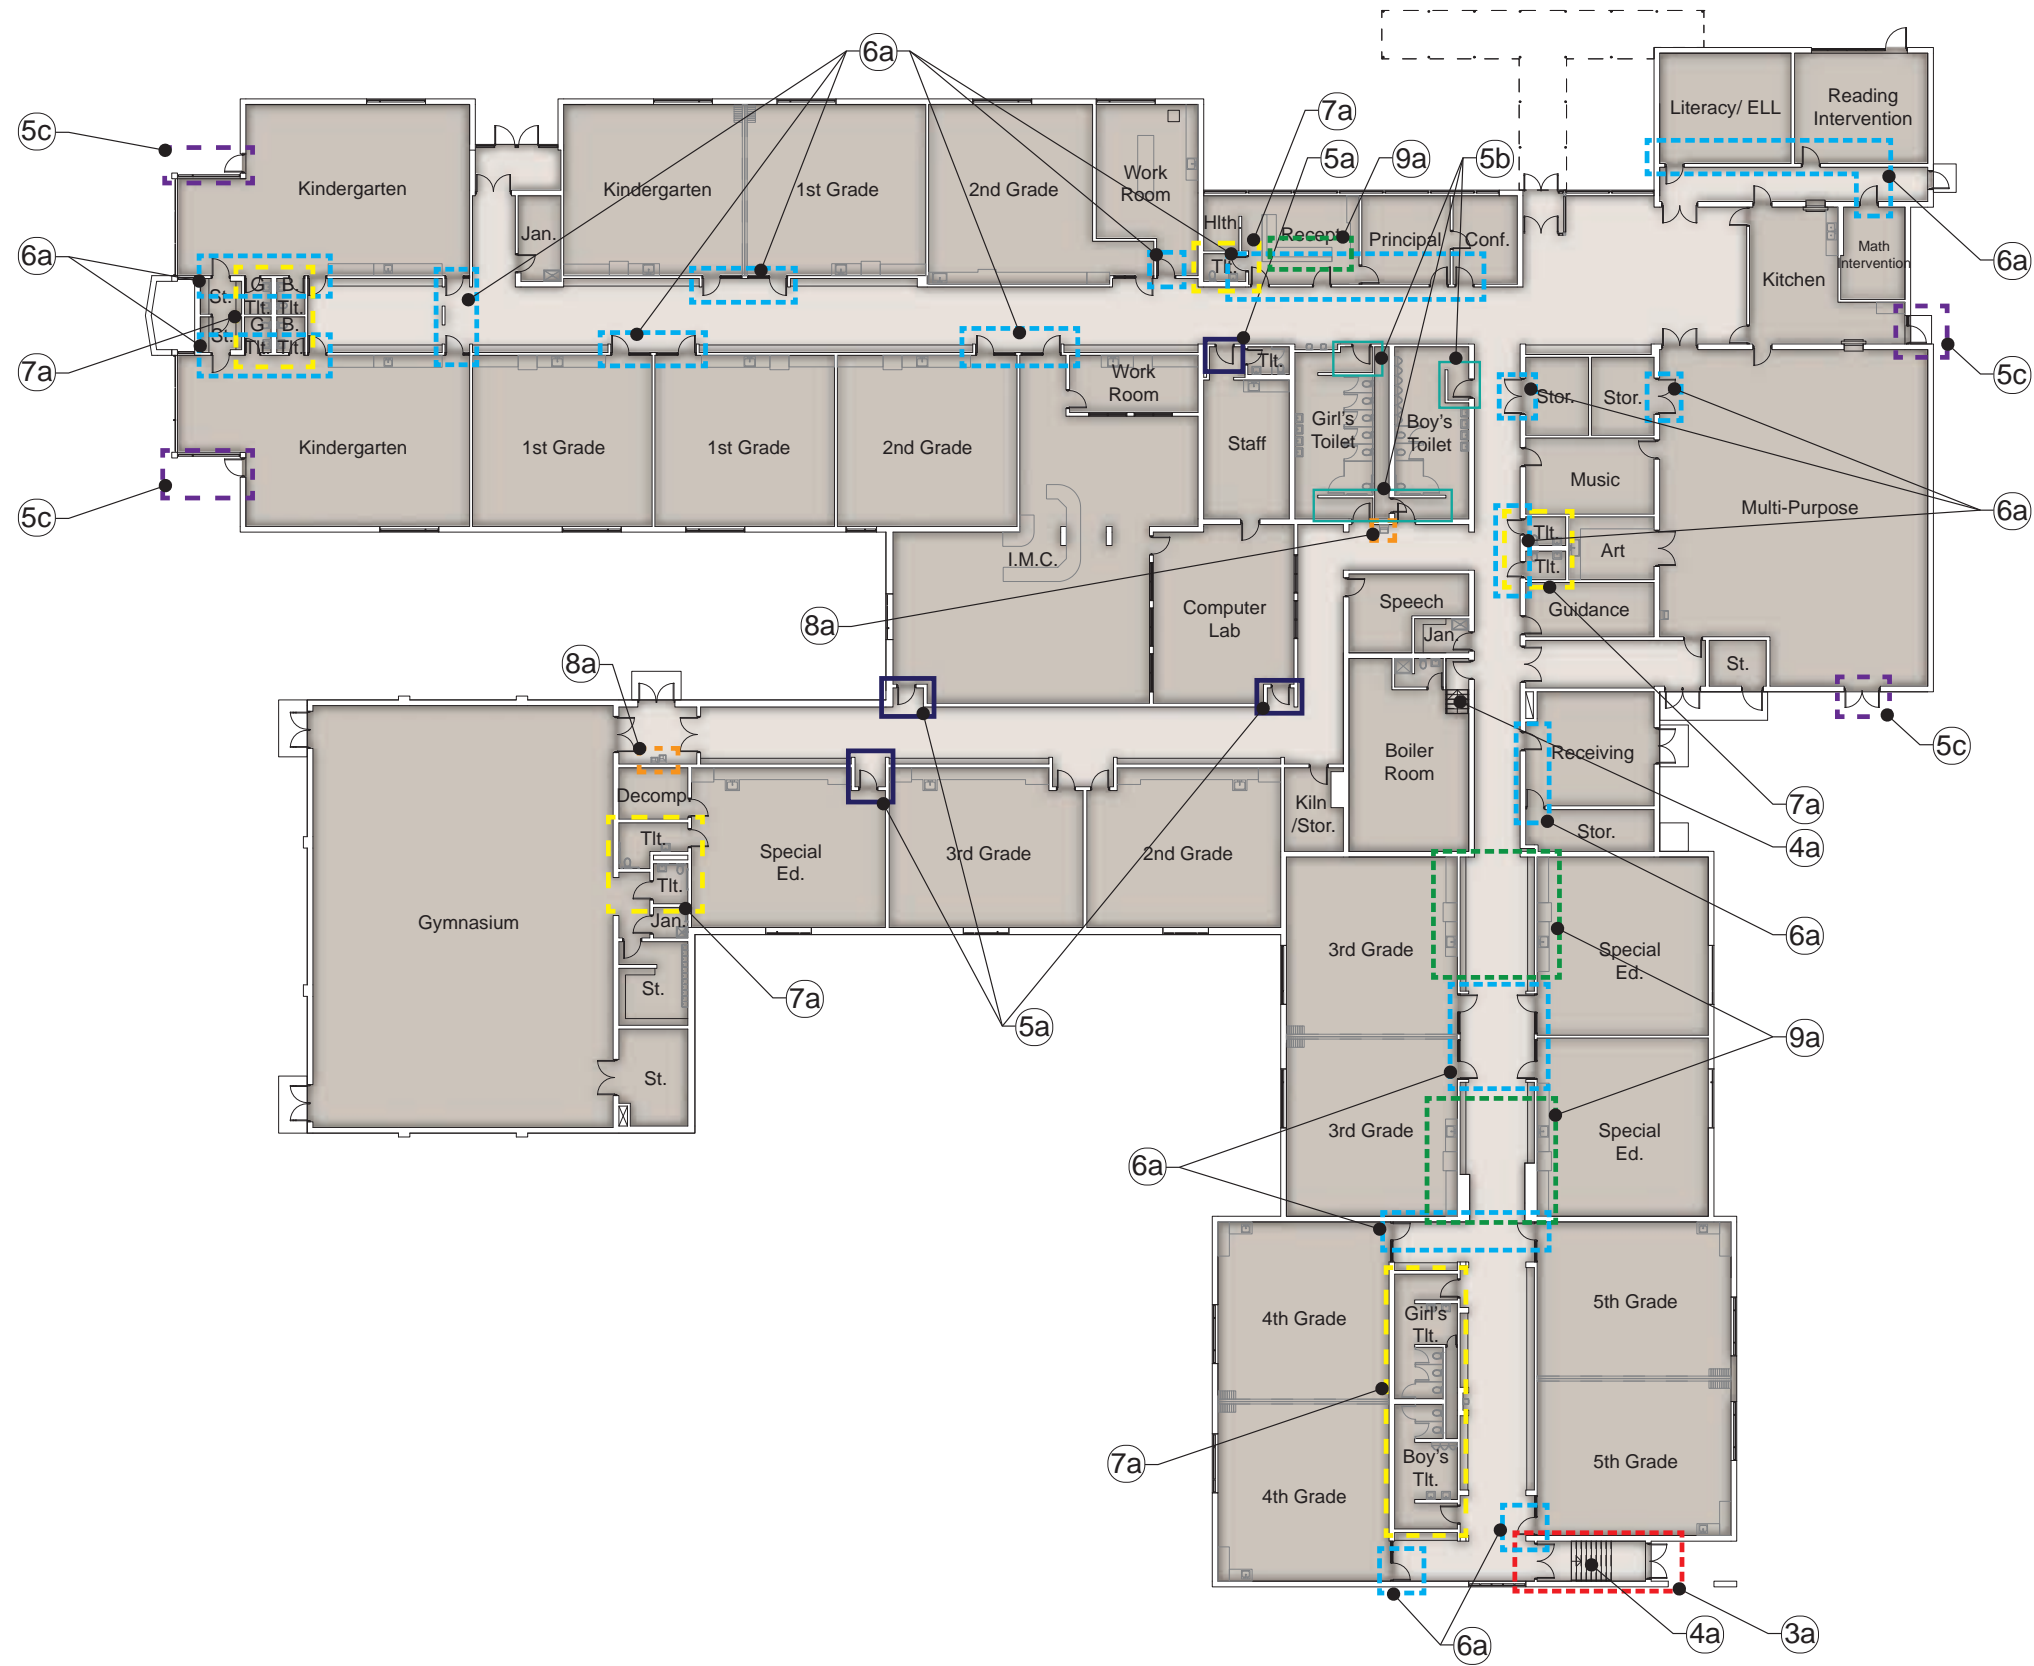
FIRST FLOOR PLAN
not to scale

9a. There are counter-tops that do not meet the above criteria for meeting accessibility standards.
