13 NEENAH HIGH SCHOOL

NEENAH HIGH SCHOOL: BUILDING EVOLUTION

NEENAH HIGH SCHOOL: BUILDING SYSTEMS SUMMARY

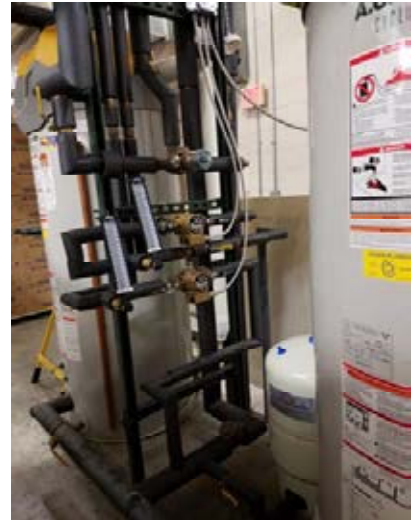
- A. The building has multiple domestic water heaters.
 - 1. A single gas fired water heater serves the north portion of the building as was recently installed. It is in good condition.
 - 2. A central water heating system with two gas fired water heaters and storage tank is in the Receiving Room Mezzanine serves the central portion of the building including the Cafeteria.
 - 3. A water heater serving the pool area. This heater is in good condition.
- B. The domestic water is not softened.

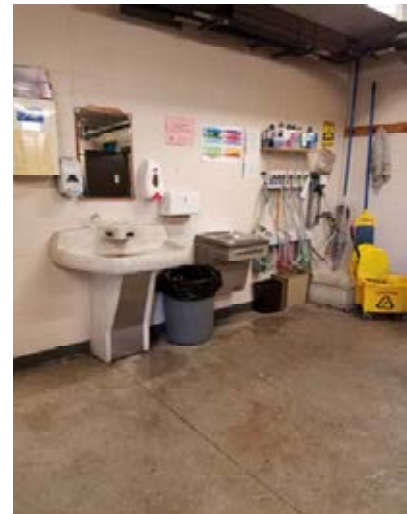
- C. The urinals in the building are floor set flush valves. Some are water conserving. The fixtures are in fair condition.
- D. The lavatories in the building are wall hung with multiple styles of faucets. They do not appear to be water conserving. Some area ADA compliant. Most are in fair condition.

- E. The showers in the have mixing valves and are in good condition.
- F. The drinking fountains in the building are wall hung electric water coolers with bottle fillers. Some are ADA compliant. The fixtures are in generally in good condition however units in the Fieldhouse and locker rooms are in poor condition.

- A. The water closets should be replaced with new water conserving and ADA compliant fixtures.
- B. The urinals should be replaced with new water conserving and ADA compliant fixtures.
- C. The lavatories should be replaced with new water conserving and ADA compliant fixtures.
