# 3 HOOVER ELEMENTARY

# HOOVER ELEMENTARY: BUILDING EVOLUTION

# HOOVER ELEMENTARY: SUMMARY OF STAFF SURVEY FEEDBACK

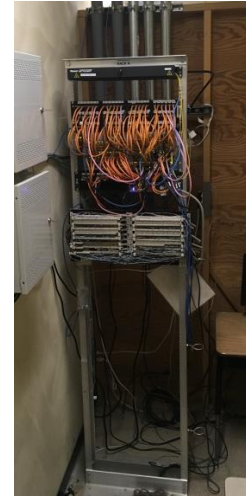
Data Rack

- A. Data service is provided via fiber optic utility service. The system seems to be in good working condition.
- B. Fiber optic wiring interconnects all of the schools to the main district network.
- C. General data cabling consists of a variety of Cat5e and Cat6 cabling, both in plenum and riser rated varieties.
- D. The school has (1) data rack, which has spare rack capacity for future needs. Data cabling management at the rack is run in a disorganized fashion with no labeling. There are also no provisions for backup power.

- A. It was unknown at the time of the site visit if the facility has ceiling plenums, but if there are plenums in the ceiling spaces, the riser rated data cabling should be replaced with plenum rated cabling.
- B. Data cabling at the data rack should be reinstalled in a clean workmanlike manner. Proper labeling of data cabling should also be considered to facilitate cable management and traceability.
- C. A possible recommendation is to provide a UPS battery backup system to provide backup power to the data rack in the event of power loss.
