11 HORACE MANN MIDDLE SCHOOL

HORACE MANN
MIDDLE SCHOOL

HORACE MANN MIDDLE SCHOOL: BUILDING SYSTEMS SUMMARY

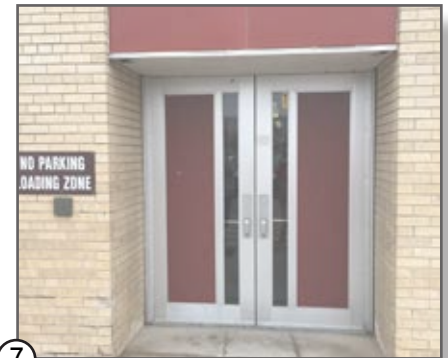
⑦ ALUMINUM DOORS & ALUMINUM FRAME, STAFF INDICATED SCHEDULED FOR REPLACEMENT

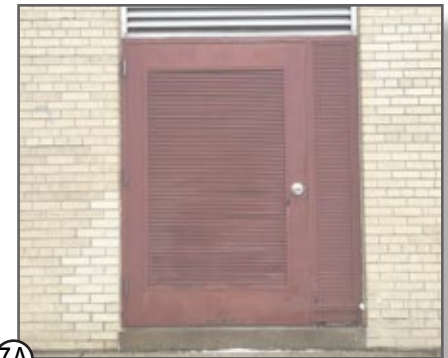
⑦A HOLLOW METAL DOOR & HOLLOW METAL FRAME; STAFF INDICATED SCHEDULED FOR REPLACEMENT

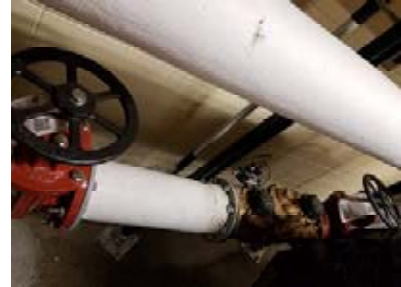
- A. Water is supplied to the building by what appears to be 6" water service which connects to the Municipal water system. There is a water meter located in the building. The water service is at its limit and could not support any future additions.
- B. The majority of the water distribution piping in the building appears to be copper tube and fittings with some galvanized pipe and fittings in the original building. The water distribution piping appears to be in fair condition.
- C. There is no fire sprinkler system in the building.

- A. If there are any new additions or major remodeling planned, a new larger water service will need to be provided.
- B. If a complete fire sprinkler system is preferred for the building, a new water service may be need to be provided.

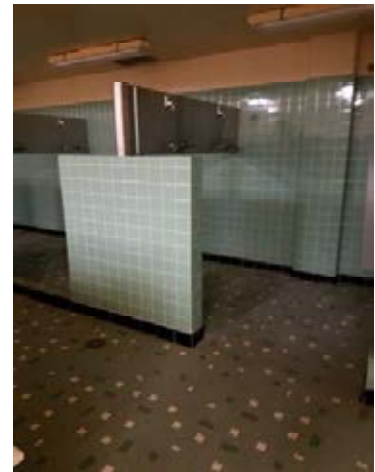
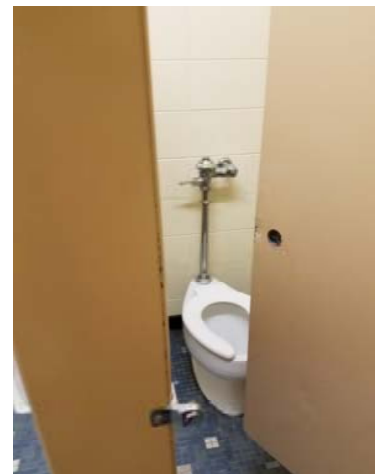
- A. The existing plumbing fixtures in the building are a combination of various styles and ages. Most of the fixtures are original to the building age they were installed. Some of the fixtures have been replaced with newer water efficient and ADA compliant fixtures.

- B. The water closets are floor set with flush valves. They do not appear to be water conserving or ADA compliant. The fixtures are old and in fair condition.

- C. The urinals in the building are floor set with mostly sensor operated flush valves. The fixtures are old and are in fair condition.
- D. The lavatories in the building are wall hung with multiple styles of faucets. They do not appear to be water conserving or ADA compliant and are in fair condition.

- E. The showers in the building are in good condition but are reported to be rarely used.
- F. The drinking fountains in the building are mix of vitreous china drinking fountains and wall hung electric water coolers. Some EWCs have bottle fillers. Some water coolers are ADA compliant and are in fair condition. The fixtures are in good condition.

- G. The classroom sinks are single bowl, stainless steel drop-in sinks with gooseneck faucet. The fixtures are not ADA compliant and are in fair condition.

- A. The water closets should be replaced with new water conserving and ADA compliant fixtures.
- B. The urinals should be replaced with new water conserving and ADA compliant fixtures.
- C. The lavatories should be replaced with new water conserving and ADA compliant fixtures.
- D. The older electric water coolers should be replaced with new ADA compliant fixtures with a bottle filler.
- E. The faucets on the classroom sinks should be replaced with new ADA compliant faucets.

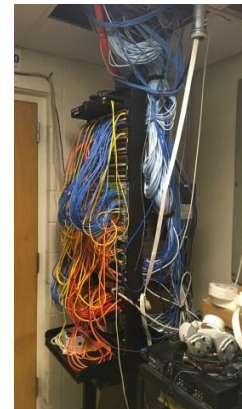
Data Racks

- A. Data service is provided via fiber optic utility service. The system seems to be in good working condition.
- B. Fiber optic wiring interconnects all of the schools to the main district network.
- C. General data cabling consists of a variety of Cat5e and Cat6 cabling, both in plenum and riser rated varieties.
- D. The school has (1) data rack, which has reached full capacity and has no space for future needs. Data cabling management at the rack is run in a disorganized fashion with no labeling. There are also no provisions for backup power.
