4 LAKEVIEW ELEMENTARY

LAKEVIEW ELEMENTARY: BUILDING EVOLUTION

LAKEVIEW ELEMENTARY: BUILDING SYSTEMS SUMMARY

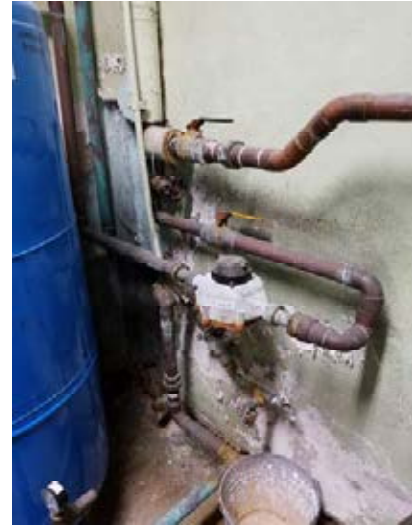
Sanitary and Storm Piping

- A. The sanitary waste from the building flows by gravity out the building and connects to the Municipal sanitary sewer system.
- B. The sanitary waste piping is below the slab and material could not be verified.
- C. The building has a prep kitchen with a 2-compartment stainless steel sink. No disposer, grease interceptor, or dishwasher is installed.
- D. The existing roof water is collected by mix of internal roof drains and conductors and gutter and downspout which flow by gravity out the building and connect to the Municipal storm sewer system.
- E. There are multiple clearwater sump pumps located in the basement level for removing groundwater. Some of the pumps have been replaced with new pumps. The sump systems appear to be in fair to good condition.

- A. The sanitary sewer system is nearing the end of their life expectancy. We would recommend the existing sewer located

below the floor be inspected with a camera and may need to be replaced pending outcome of the scope.

- B. The storm sewer system in the original building, 1954 addition, and 1957 addition are nearing the end of their life expectancy. We would recommend the existing sewer located below the floor be inspected with a camera and may need to be replaced pending outcome of the scope.
- C. The existing clearwater sump pumps should be monitored and repaired or replaced as necessary.
