# 5 ROOSEVELT ELEMENTARY (ALLIANCE CHARTER ELEMENTARY)

Roosevelt Elementary and Alliance Charter Elementary share a building, and both schools provide a comprehensive program for Kindergarten and 1st through 5th grade students.

# ROOSEVELT ELEMENTARY: BUILDING SYSTEMS SUMMARY

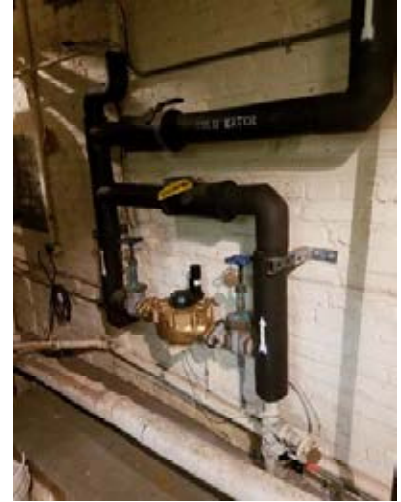
- A. Water is supplied to the building by what appears to be 2" water service which connects to the Municipal water system. There is a water meter located in the boiler room. The water service is at its limit and could not support any future additions.
- B. The water distribution piping in the building appears to be black iron, copper tube and galvanized steel. The water distribution piping appears to be in fair condition.
- C. The building has no fire sprinkler system.

- A. The water distribution piping in the original building, 1924 addition, and 1957 addition are at the end of their life expectancy. We would recommend replacing the existing pipe and fittings with new type "L" copper tube and fittings.
- B. If there are any new additions or major remodeling planned, a new larger water service will need to be provided.
- C. If a complete fire sprinkler system is preferred for the building, a new 6" water service will need to be provided.

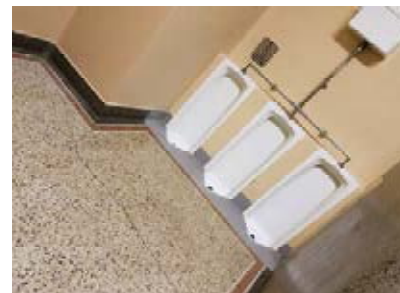
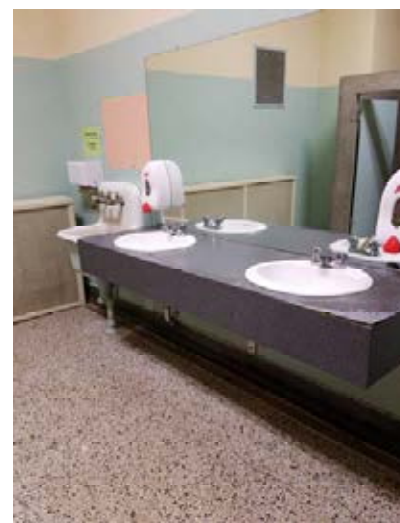
- A. The existing plumbing fixtures in the building are a combination of various styles and ages. Most of the fixtures are original to the building age they were installed. Some of the fixtures have been replaced with newer water efficient and ADA compliant fixtures.

- B. The water closets are floor set, flush valve type fixtures. They do not appear to be water conserving or ADA compliant. The fixtures are old and in fair condition.

- C. The urinals in the building are floor set with flush tanks. The fixtures with the flush tank are not water conserving. The fixtures are old and are in fair condition.

- D. The lavatories in the building are a variety of wall hung and drop in fixtures with multiple styles of faucets. They do not appear to be water conserving or ADA compliant and are in fair condition.

- E. The fixtures in the lower level locker rooms in the building have been abandoned.
- F. The drinking fountains in the building are variety of vitreous china drinking fountains and wall hung electric water coolers. Most are not ADA compliant and are in fair condition. The fixtures are in good condition.

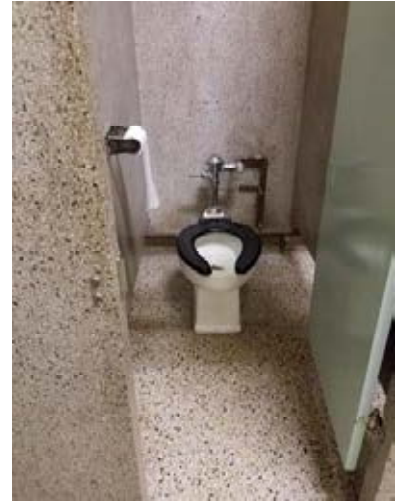
- G. The a few classrooms have sinks that are single bowl and either stainless steel or vitreous china. Some have separate drinking fountain. The fixtures are not ADA compliant and are in fair condition.

- A. The water closets should be replaced with new water conserving and ADA compliant fixtures.
- B. The urinals should be replaced with new water conserving and ADA compliant fixtures.
- C. The lavatories should be replaced with new water conserving and ADA compliant fixtures.
- D. The older electric water coolers should be replaced with new ADA compliant fixtures with a bottle filler.
- E. older classroom sinks should be replaced. All classroom sinks should have new ADA compliant faucets.
- F. Remove all locker room fixtures, floor drains, and associated piping serving these fixtures.
