12 SHATTUCK MIDDLE SCHOOL

S.F. SHATTUCK
MIDDLE
SCHOOL

SHATTUCK MIDDLE SCHOOL: BUILDING EVOLUTION

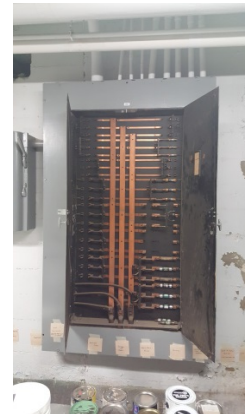
Old Fusible Panelboard

- Main electric service is nearing the end of its useful lifespan, has no capacity for future loads, and should be scheduled to be replaced within the next 10 years. Provide surge suppression, as none exists.
- Panelboards vary in age, with some nearing the end of their useful lifespan, and some having been replaced or added and are in good condition; vintage circuit breaker panelboards should be scheduled for replacement within the next 5 years.
- Utility service consists of a pad mounted transformer adjacent to the building with an underground electrical service.
