## 6 SPRING ROAD ELEMENTARY

## SPRING ROAD ELEMENTARY: BUILDING EVOLUTION

**SPRING ROAD ELEMENTARY: NEEDS ASSESSMENT**

# SPRING ROAD ELEMENTARY: BUILDING SYSTEMS SUMMARY

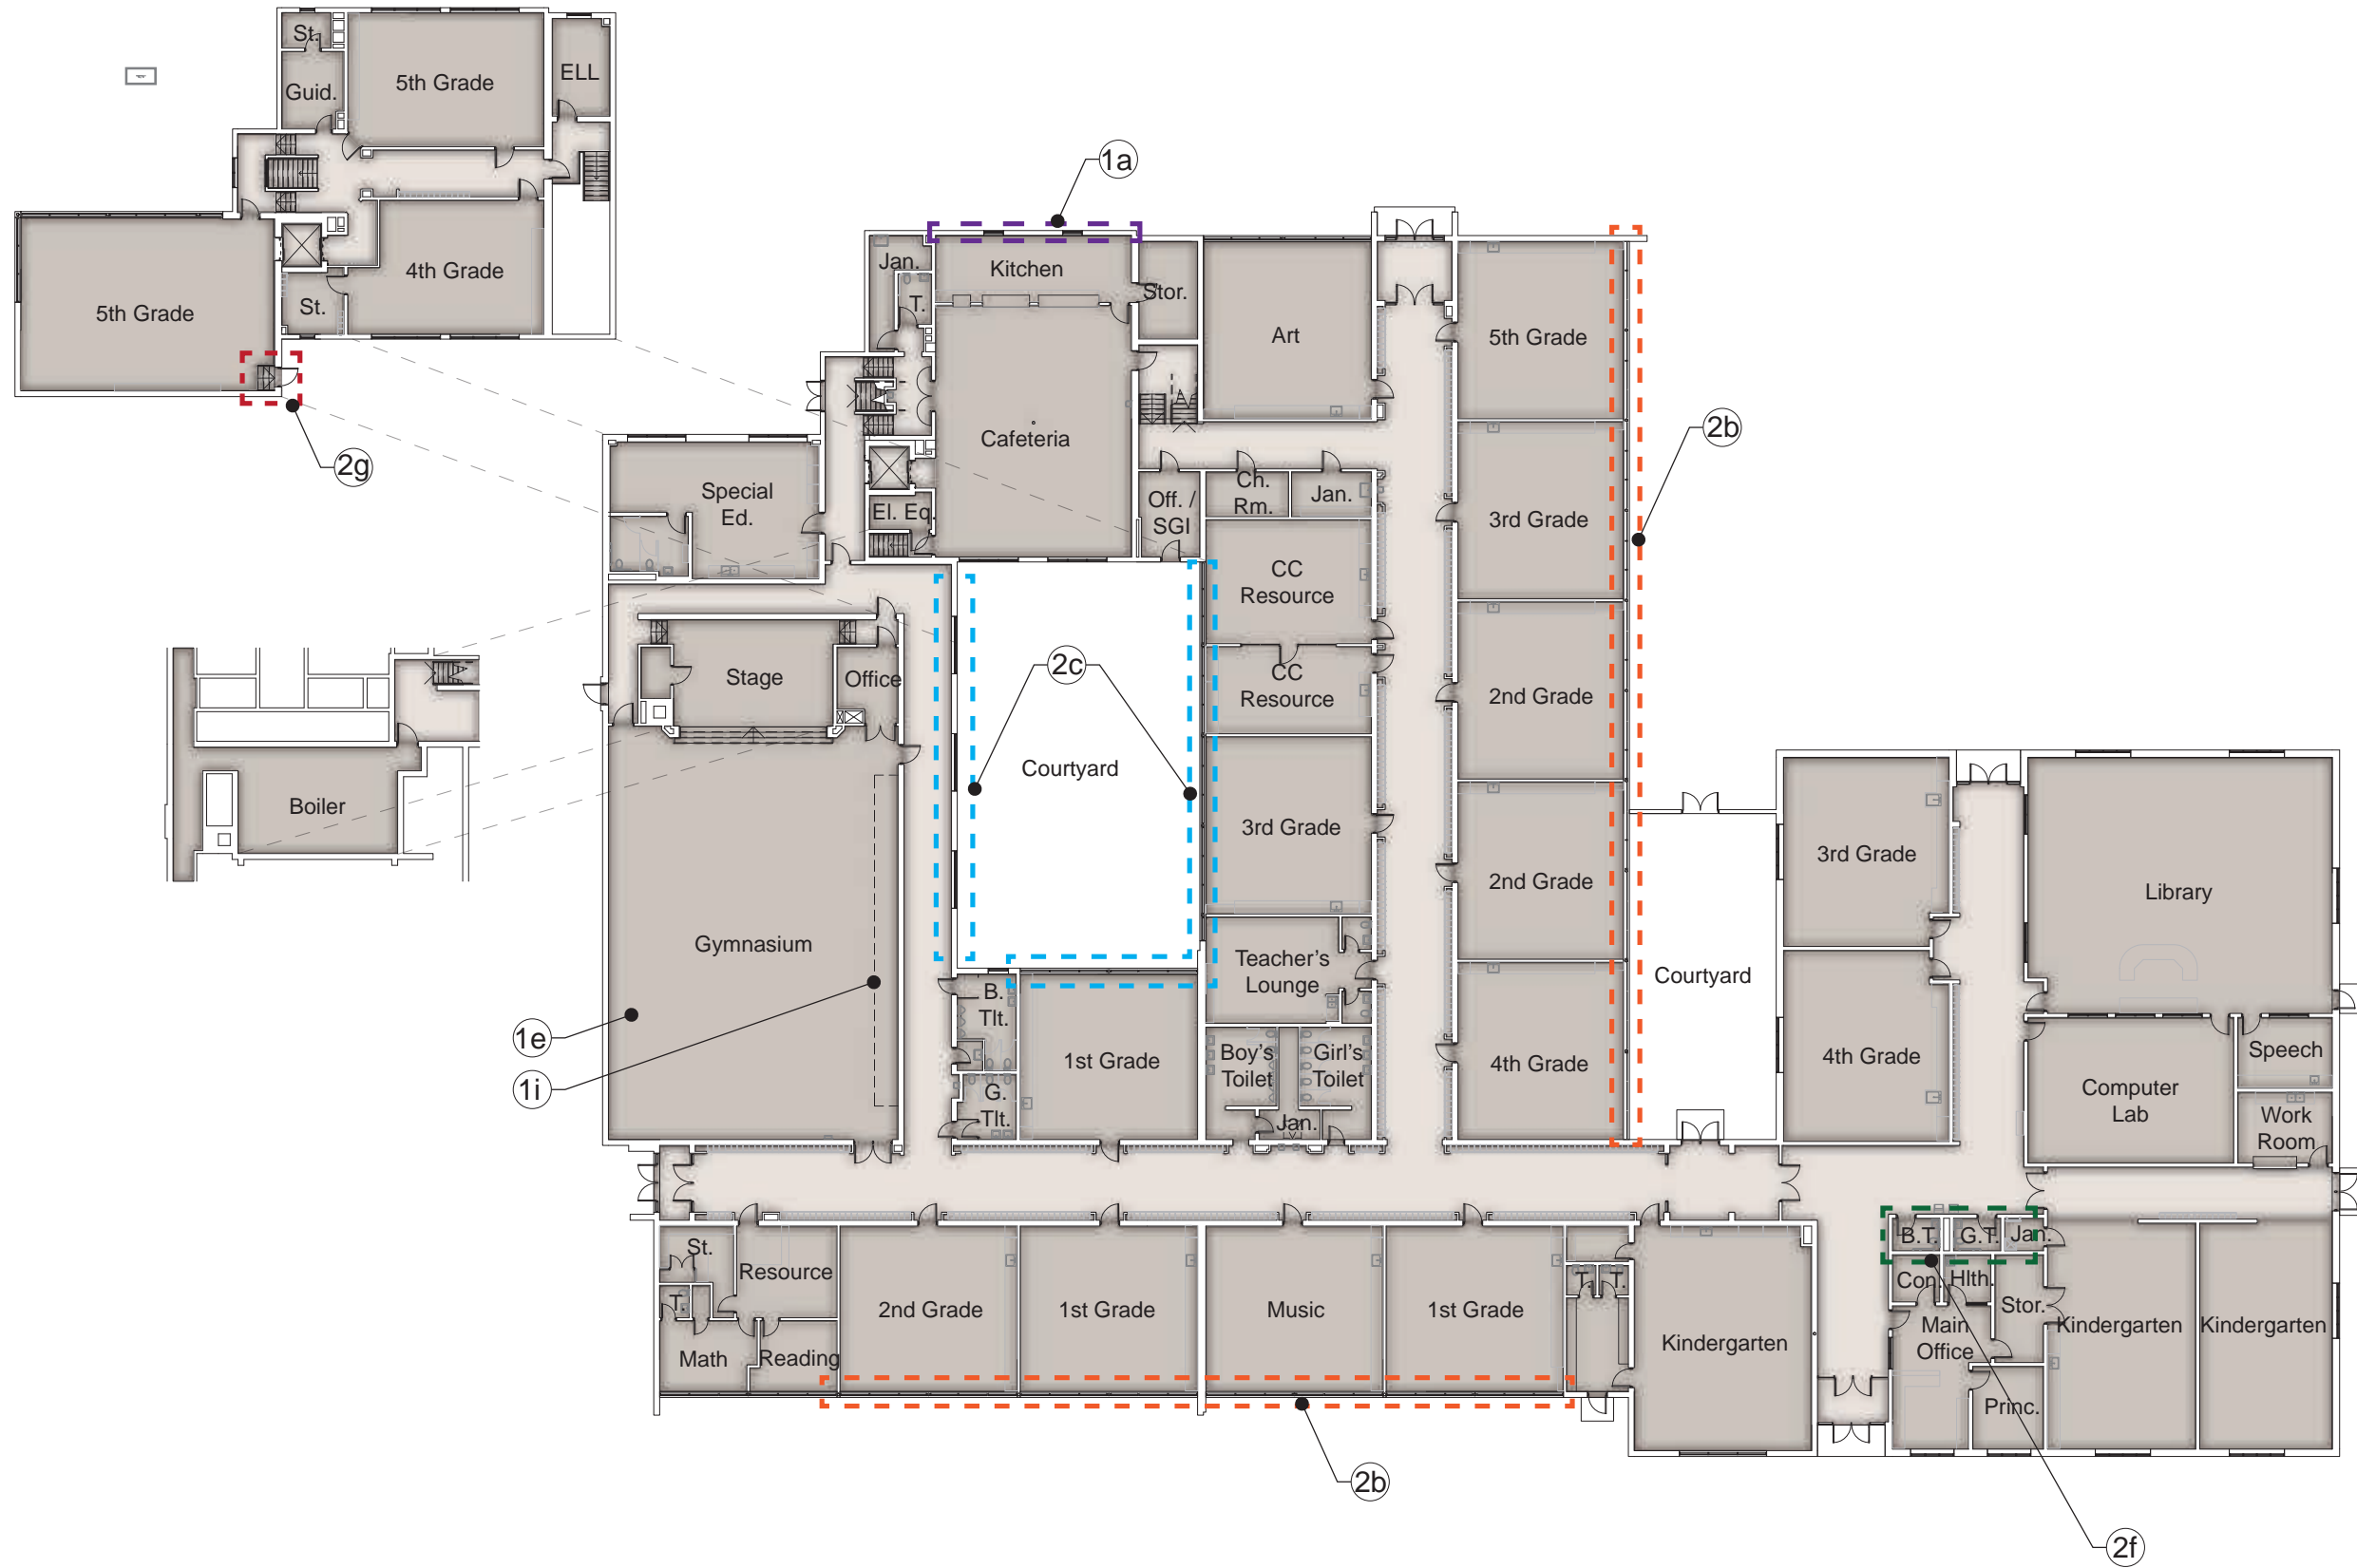
**FIRST FLOOR PLAN**  
not to scale

- c. Ceiling tiles are dated, with some tiles stained/showing signs of water damage and many bowing, bending and separating from the ceiling grid; there are a mix of tile types throughout the building

- d. No known large concerns with flooring, although some flooring is dated and/or cracked, especially in the older sections of the building
- e. Rubber flooring in the Gymnasium is dated and worn
- f. There is an area of flooring below the drinking fountain at the Cafeteria where the floor seems to be caving in where it meets the wall, and the vinyl floor tile appears to be rotting/disintegrating
- g. Terrazzo floors in the older part of the building are cracking, not level, and are a tripping hazard

- h. Lockers are dated, dented, rusting, and have paint chipping off; this is especially prevalent at the base of the lockers, as the lockers lack adequate ventilation or drainage and water gathers here from wet boots/clothing being stored within the locker
- i. Gymnasium bleachers are dated

- a. Exterior brick is crumbling/cracking, especially at building corner conditions, and there are some areas where tuckpointing is present

- b. Windows in the older section of the building are single-pane, drafty, and have issues with water leaking and paint peeling at the frame; some condensation/frost build up on window panes has been reported by staff
- c. Glass block windows are cracked, drafty, and many have adjacent single-pane windows that are also drafty and leak water
- d. Windows at the Cafeteria are relatively new and were installed as part of the recent summer renovation project

- e. Door #9 was reported by staff to have issues with water leaking into the building

- f. Staff reported that water comes into the building near the Mechanical Room on the roof and leaks into the mechanical space and adjacent Men's Bathroom
- g. The old Library space in the older section of the building contains a door directly off the space that allows for roof access; the door does not require a key to be opened, and the roof lacks a parapet nor any railing/means of preventing someone from falling off the roof
- h. Paint is peeling at the underside of the roof canopy

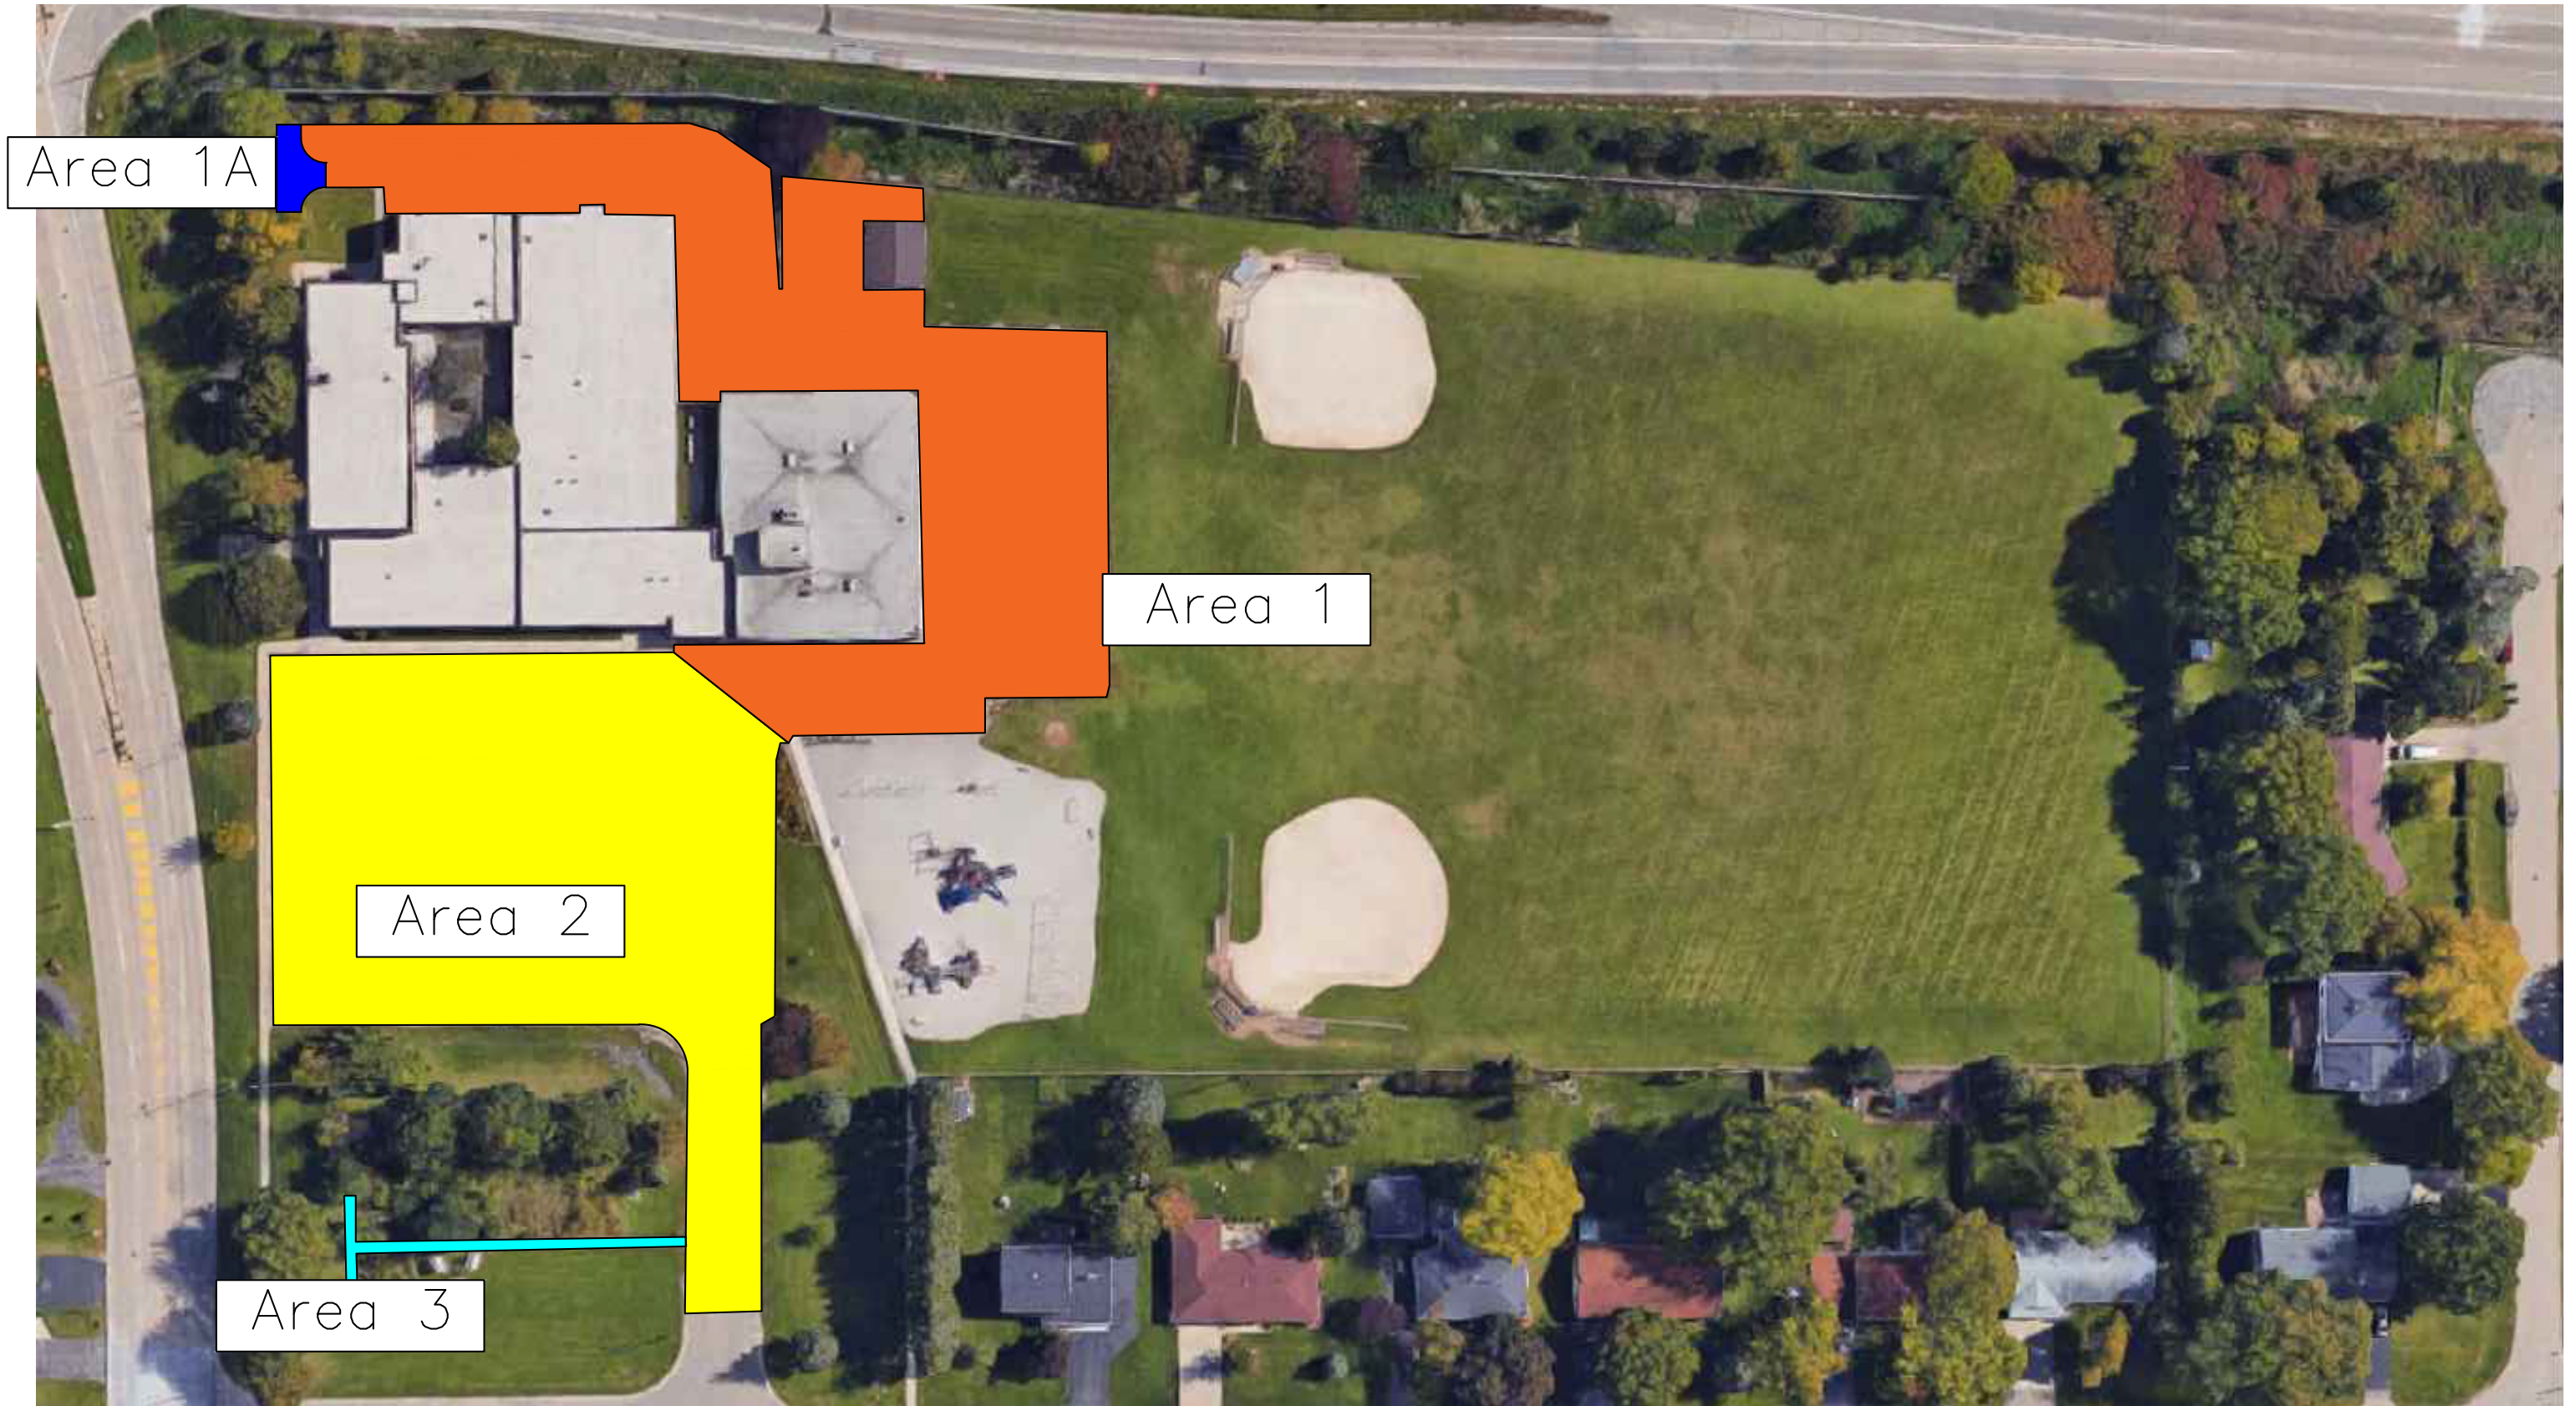
SITE PLAN  
not to scale

- Distresses Present:
  - Thermal cracking
  - Surface weathering
  - Fatigue cracking due to base failure
  - Poor Drainage
- Recommended Repair:
  - Remove existing pavement and 12 inches of base and/or subgrade
  - Place 12 inches of base aggregate dense
  - Pave 4 inches of asphaltic pavement
  - Place storm sewer for the downspouts to tie-in
  - Grade the area to better flow towards the ditch
  - Pavement marking for parking lot

- Distresses Present:
  - Fatigue cracking due to base failure
  - Thermal cracking
  - Surface weathering
  - Potholes
- Recommended Repair:
  - Remove existing pavement and 12 inches of base and/or subgrade
  - Place 12 inches of base aggregate dense
  - Pave 4 inches of asphaltic pavement
  - Grade the area for better drainage
  - Pavement marking for parking lot

- Distresses Present:
  - Spalling at edges of sidewalk in areas
  - Large cracks in sidewalk that poses a tripping hazard
  - Section of curb damaged by plowing operations
- Recommended Repair:
  - Remove and replace the areas of sidewalk that have spalling or cracked
  - Remove and replace damaged section of curb
  - Add thickened edge walk to north side of staff/visitor parking lot

- Distresses Present:
  - Rusted
  - Bent in some locations
- Recommended Repair:
  - Replace fence

- Some playground equipment is dated, especially the swings; basketball hoops are dated and rusted
- No dumpster enclosure exists

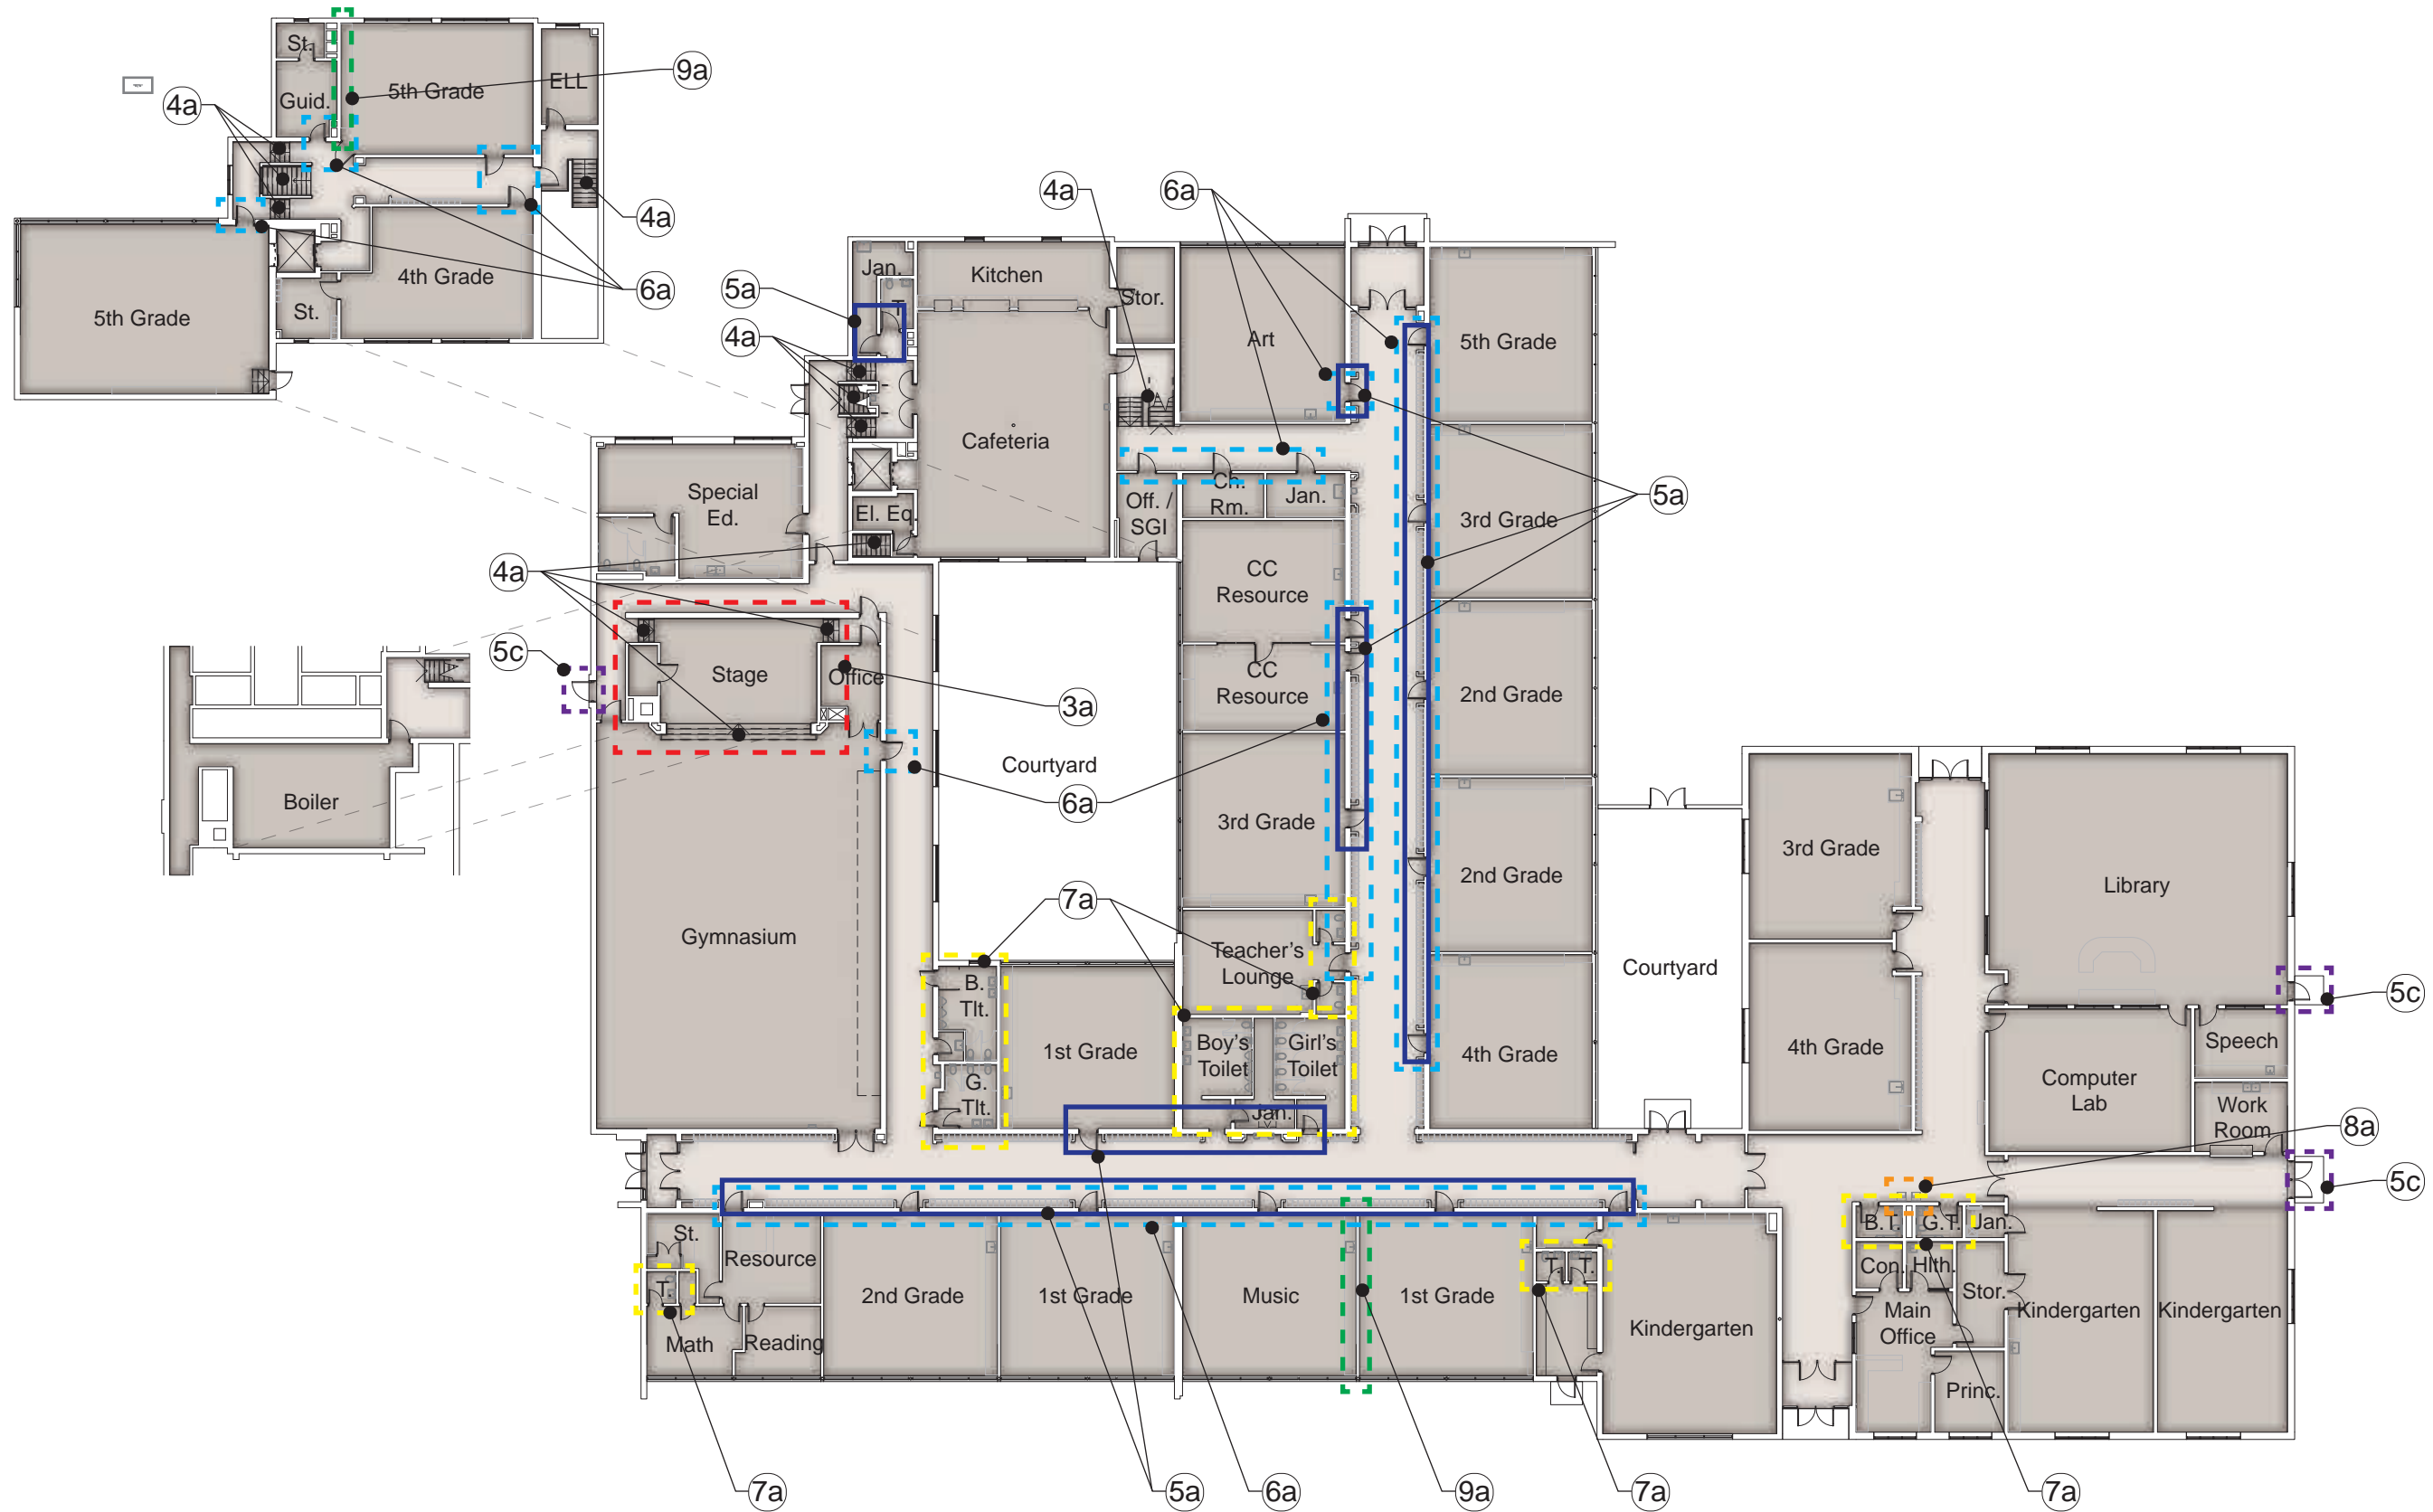
**FIRST FLOOR PLAN**  
not to scale

9a. There are counter-tops that do not meet the above criteria for meeting accessibility standards.

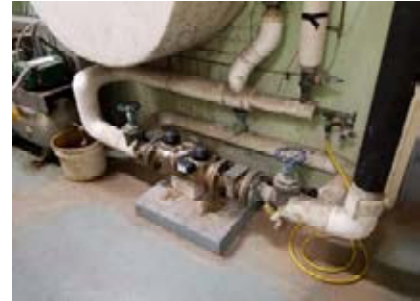
- A. Water is supplied to the building by what appears to be 4" water service which connects to the Municipal water system. There is a water meter located in the building. The water service is at its limit and could not support any future additions.
- B. The majority of the water distribution piping in the building appears to be copper tube and fittings with some galvanized pipe and fittings in the original building. The water distribution piping appears to be in fair condition.
- C. The building has no sprinkler system.

- A. The water distribution piping in the original building, 1954 and 1958 additions are at the end of their life expectancy. We would recommend replacing the existing pipe and fittings with new type "L" copper tube and fittings.
- B. If there are any new additions or major remodeling planned, a new larger water service will need to be provided.
- C. If a complete fire sprinkler system is preferred for the building, a new 6" water service will need to be provided.

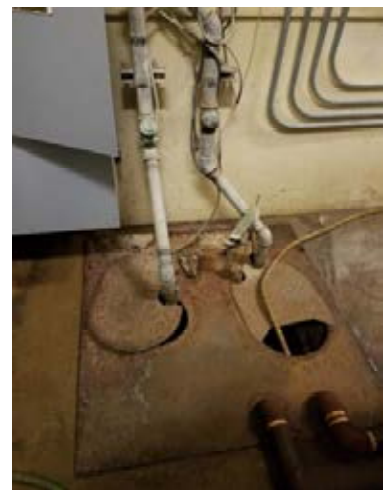
- A. The sanitary waste from the building flows by gravity out the building and connects to the Municipal sanitary sewer system.
- B. The sanitary waste is a mix of pvc and metal piping.
- C. The building has a service kitchen with a two sinks and commercial dishwasher. There is no interior grease interceptor.
- D. The building has a small group instruction kitchenette with double compartment sink with disposal.
- E. The classroom sinks do not have solids traps installed on the waste piping.
- F. The building has both internal roof drains and conductors which flow by gravity out the building and connect to the Municipal storm sewer system.
- G. There are clearwater sump pumps located in the basement level for removing groundwater. The sump systems appear to be in fair to good condition.

- A. The sanitary sewer system in the original building, 1954 and 1958 additions are nearing the end of their life expectancy. We would recommend the existing sewer located below the floor be inspected with a camera and may need to be replaced, pending outcome of scope.
- B. The storm sewer system in the original building, 1954 and 1958 additions are nearing the end of their life expectancy. We would recommend the existing sewer located below the floor be inspected with a camera and may need to be replaced, pending outcome of scope.
- C. The existing clearwater sump pumps should be monitored and repaired or replaced as necessary.

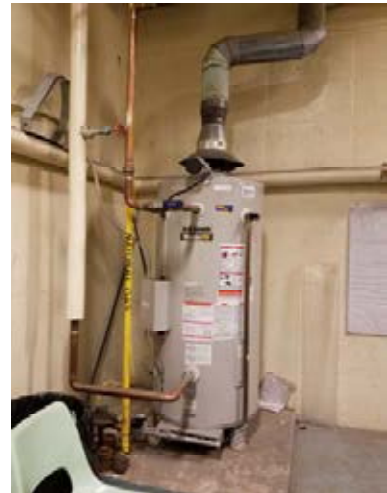
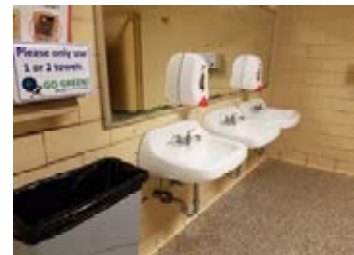
- A. The existing plumbing fixtures in the building are a combination of various styles and ages. Most of the fixtures are original to the building age they were installed. Some of the fixtures have been replaced with newer water efficient and ADA compliant fixtures.

- B. The water closets are floor set with flush valves. They do not appear to be water conserving or ADA compliant. The fixtures are old and in fair condition.

- C. The urinals in the building are floor set with flush tank mount. The fixtures with the flush tank are not water conserving. The fixtures are old and are in fair condition.

- D. The lavatories in the building are wall hung with multiple styles of faucets. Some lavatories have multiple styles of faucets. They do not appear to be water conserving or ADA compliant and are in fair condition.

- F. The classroom sinks are vitreous china or stainless steel single bowl drop-in sinks with gooseneck faucet and separate drinking fountain. The fixtures are not ADA compliant and are in fair condition.

- G. The utility sinks are wall mount and original to the building. They are in fair condition.

- A. The water closets should be replaced with new water conserving and ADA compliant fixtures.
- B. The urinals should be replaced with new water conserving and ADA compliant fixtures.
- C. The lavatories should be replaced with new water conserving and ADA compliant fixtures.
- D. The older electric water coolers should be replaced with new ADA compliant fixtures with a bottle filler.
- E. The faucets on the classroom sinks should be replaced with new ADA compliant faucets.
- F. Replace wall mount utility sinks with floor mount mop basins.
