7 TAFT ELEMENTARY

TAFT ELEMENTARY: BUILDING EVOLUTION

TAFT ELEMENTARY: BUILDING SYSTEMS SUMMARY

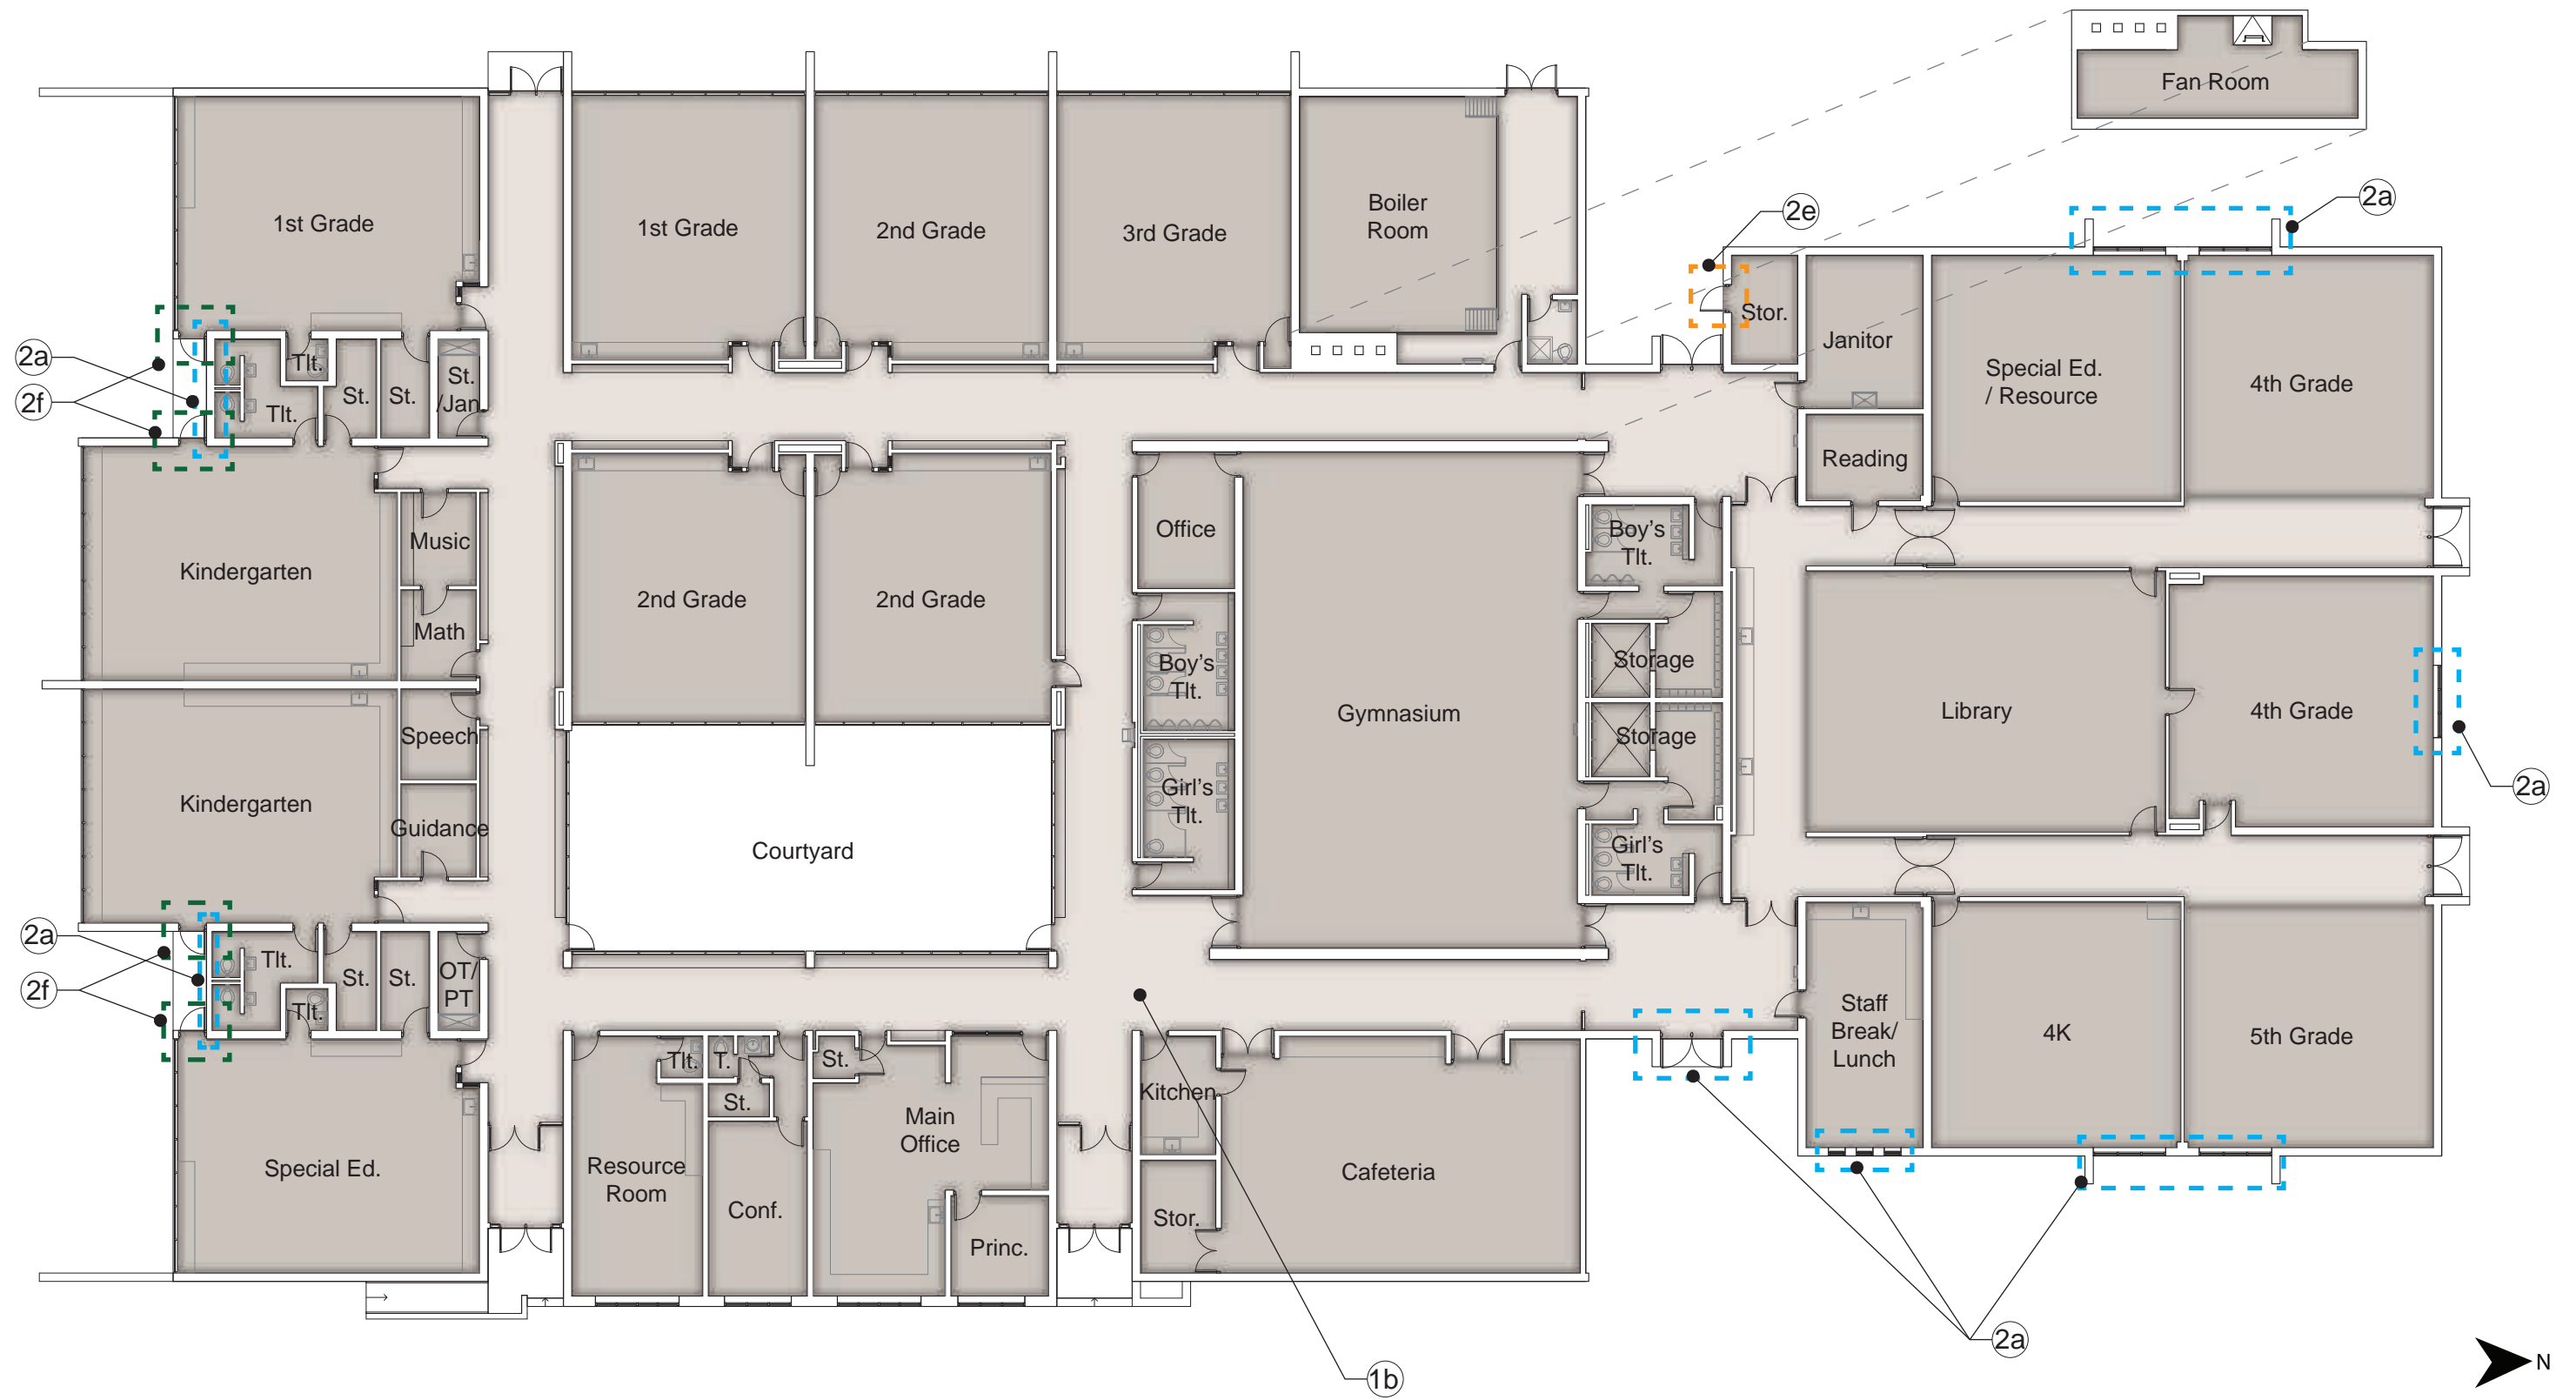
FIRST FLOOR PLAN
not to scale

- a. Ceiling tiles are dated, with some tiles stained/showing signs of water damage and many bowing, bending and separating from the ceiling grid; there are a mix of tile types throughout the building
- b. There are multiple areas of ceiling tile which appear to have been patched/filled in at one point in time; staff indicated these might be areas where skylights were removed/enclosed

- c. Much of flooring is stained, worn, cracking and in need of repair
- d. Staff indicated areas of potential asbestos tile throughout the building

- e. The underside of overhangs are stained, cracking and have paint peeling

- a. There are multiple areas of discoloration and staining present on the exterior of the building, possibly due to water damage; this is especially present above windows and doors
- b. Some areas of the exterior wall show cracking/crumbling, especially at the foundation wall
- c. Many of the unit vents are damaged and rusting

- e. Many of the exterior doors are original to the building, aged, rusting, and are worn and damaged by dents and salt exposure; some of these doors have large gaps in the frame that allow for drafts
- f. Wood exterior doors are peeling and missing hardware

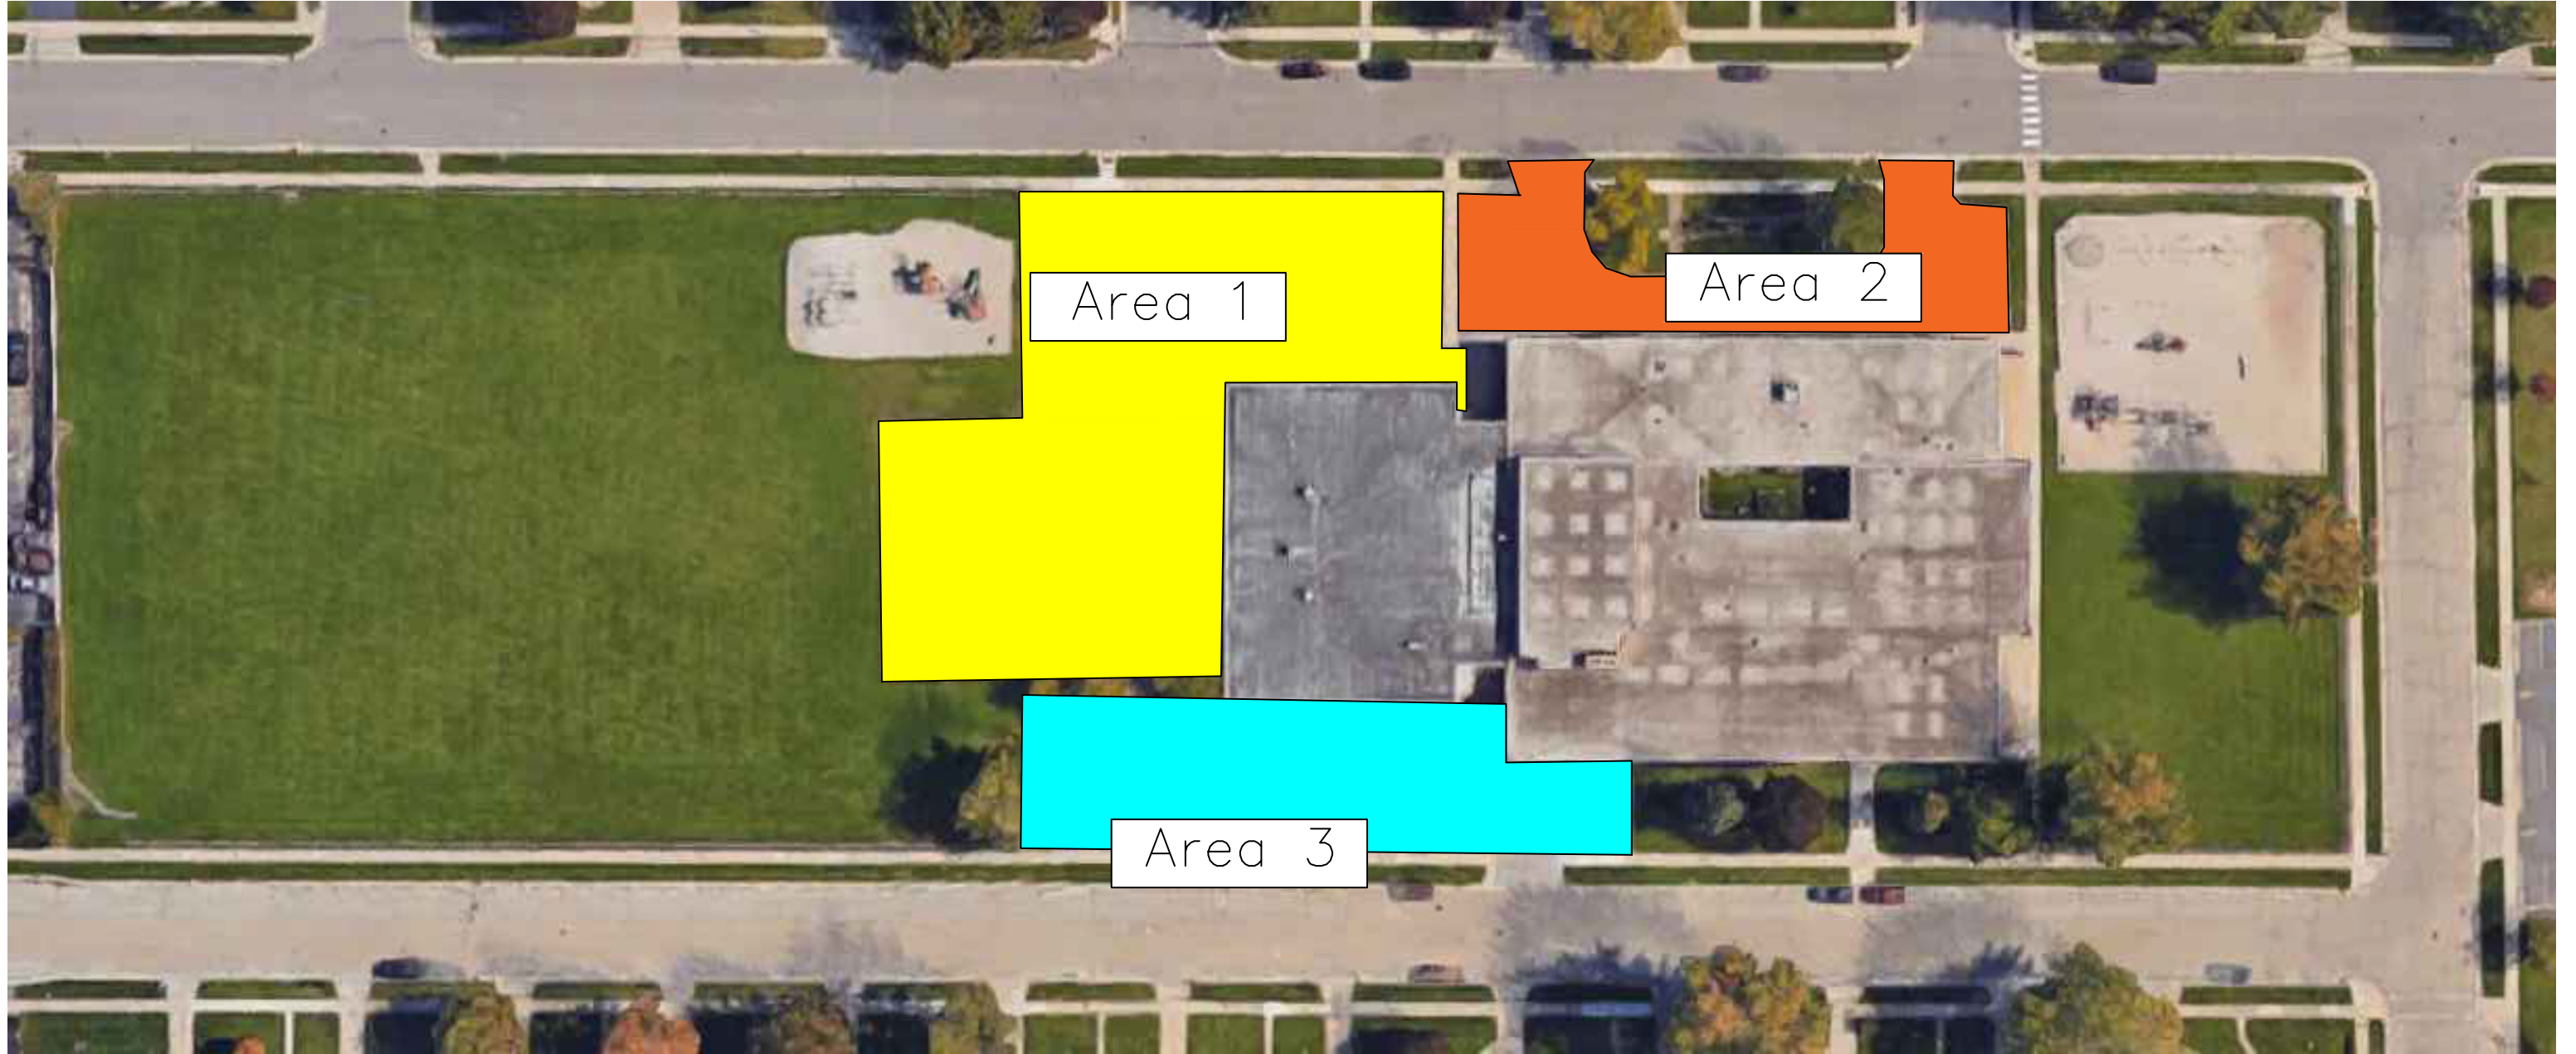
SITE PLAN
not to scale

- Distresses Present:
 - Block cracking (base failure)
 - Surface weathering
 - Depressions due to base settling
- Recommended Repair:
 - Remove existing pavement and 12 inches of base and/or subgrade
 - Place 12 inches of base aggregate dense
 - Pave 3 inches of asphaltic pavement
 - Paint all pavement markings for a parking lot

- Distresses Present:
 - Block cracking (base failure)
 - Surface weathering
 - Depressions due to base settling
 - Potholes
- Recommended Repair:
 - Remove existing pavement and 12 inches of base and/or subgrade
 - Place 12 inches of base aggregate dense
 - Pave 4 inches of asphaltic pavement
 - Paint all pavement markings for a parking lot

- Distresses Present:
 - Fatigue cracking due to base failure
 - Surface weathering
 - Thermal cracking
 - Depressions due to base settling
 - Potholes
- Recommended Repair:
 - Remove existing pavement and 12 inches of base and/or subgrade
 - Place 12 inches of base aggregate dense
 - Pave 4 inches of asphaltic pavement
 - Paint all pavement markings for a parking lot

- Distresses Present:
 - Spalling at edges of sidewalk in areas
 - Large cracks in sidewalk that poses a tripping hazard
 - One area of sidewalk is sloped towards the building, preventing proper drainage
 - Curb & gutter is cracked with pieces missing
 - Large cracks in concrete in front of the bike racks
- Recommended Repair:
 - Remove and replace the areas of sidewalk that have spalling or cracked
 - Remove and replace section of sidewalk that is sloped towards the building
 - Remove and replace cracked curb & gutter

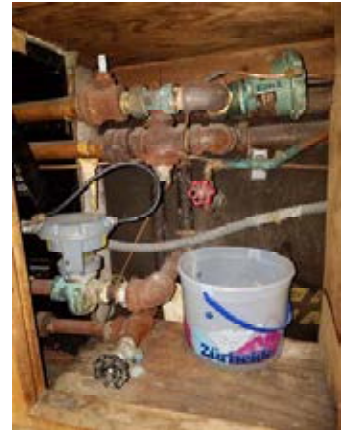
- A. Water is supplied to the building by two water meters that appears to be 1 ½" each. Both connect to the Municipal water system. The water services are at their limit and could not support any future additions.
- B. The majority of the water distribution piping in the building is a mix of black iron and copper. The water distribution piping appears to be in fair condition.
- C. The building has no fire sprinkler system.

- A. The water distribution piping in the original building and 1969 addition are at the end of their life expectancy. We would recommend replacing the existing pipe and fittings with new type "L" copper tube and fittings.
- B. If there are any new additions or major remodeling planned, a new larger water service will need to be provided.
- C. If a complete fire sprinkler system is preferred for the building, a new 6" water service will need to be provided.

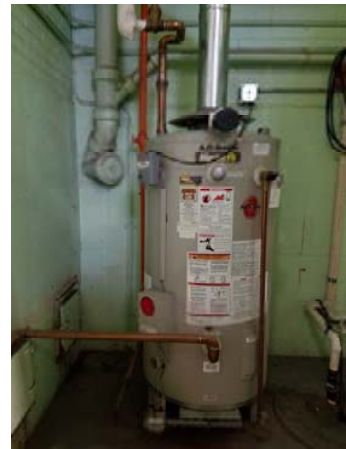
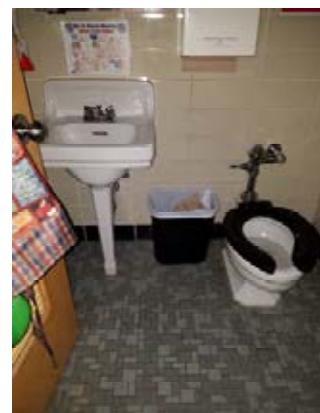
- A. The existing plumbing fixtures in the building are a combination of various styles and ages. Most of the fixtures are original to the building age they were installed. Some of the fixtures have been replaced with newer water efficient and ADA compliant fixtures.

- B. The water closets are floor set with flush valves. They do not appear to be water conserving or ADA compliant. The fixtures are old and in fair condition.

- C. The urinals in the building are floor set with flush valves. The fixtures are old and are in fair condition.
- D. The lavatories in the building are a mix of drop in and wall mount fixtures with multiple styles of faucets. They do not appear to be water conserving or ADA compliant and are in fair condition.

- E. The drinking fountains in the building are mix of wall hung china drinking fountains and electric water coolers. They are not ADA compliant and are in fair condition.

- F. The classroom sinks are vitreous china single bowl sinks with various types of faucets and drinking fountains. The fixtures are not ADA compliant and are in fair condition.

- A. The water closets should be replaced with new water conserving and ADA compliant fixtures.
- B. The urinals should be replaced with new water conserving and ADA compliant fixtures.
- C. The lavatories should be replaced with new water conserving and ADA compliant fixtures.
- D. The older electric water coolers should be replaced with new ADA compliant fixtures with a bottle filler.
- E. The faucets on the classroom sinks should be replaced with new ADA compliant faucets.
