8 TULLAR ELEMENTARY

TULLAR ELEMENTARY: BUILDING SYSTEMS SUMMARY

TULLAR ELEMENTARY: ENGINEER REPORT - PLUMBING

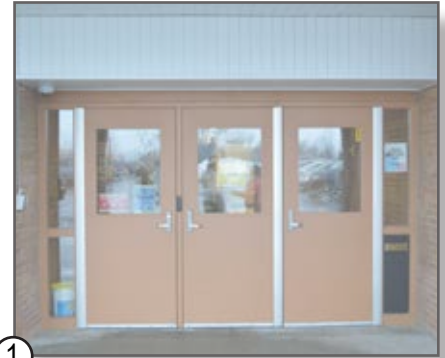
① HOLLOW METAL DOORS & HOLLOW METAL FRAME; STAFF INDICATED CONCERN

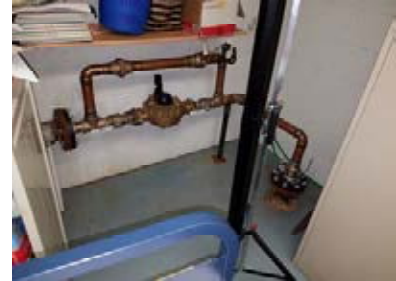
- A. Water is supplied to the building by what appears to be 2" water service which connects to the Municipal water system. There is a water meter located in a storage room that has no heat source. The water service is at its limit and could not support any future additions.
- B. The majority of the water distribution piping in the building appears to be copper tube and fittings with some galvanized pipe and fittings in the original building. The water distribution piping appears to be in fair condition.
- C. The existing building has no fire sprinkler system.

- D. The water distribution piping in the original building, 1953 and 1957 additions are at the end of their life expectancy. We would recommend replacing the existing pipe and fittings with new type "L" copper tube and fittings.
- E. If there are any new additions or major remodeling planned, a new larger water service will need to be provided.
- F. If a complete fire sprinkler system is preferred for the building, a new 6" water service will need to be provided.

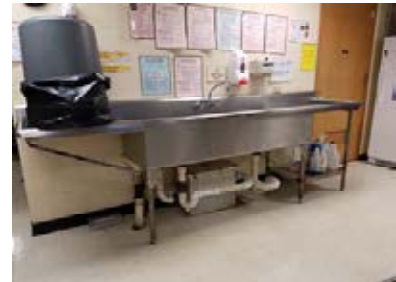
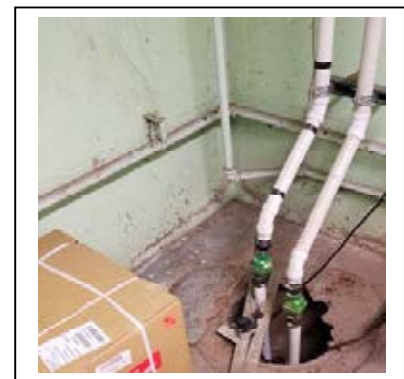
- A. The sanitary waste from the building flows by gravity out the building and connects to the Municipal sanitary sewer system.
- B. The sanitary waste and vent piping appear to be in good condition with no reported challenges.
- C. The building has a prep kitchen with a 2-compartment pot sink with floor mounted grease interceptor. Additional (2) sinks a grease interceptor under the sink. There is no disposal. A commercial dishwasher is in place. All appear to be in good condition with no reported challenges in operation.
- D. The existing roof water is collected by mix of internal roof drains and conductors and gutter and downspout which flow by gravity out the building and connect to the Municipal storm sewer system.
- E. There are multiple clearwater sump pumps located in the basement level for removing groundwater. Some of the

pumps have been replaced with new pumps. The sump systems appear to be in fair to good condition.

- A. The sanitary sewer system in the original building, 1954 addition and 1957 addition are nearing the end of their life expectancy. We would recommend the existing sewer located below the floor be inspected with a camera and may need to be replaced pending outcome of the scope.
- B. The storm sewer system in the original building, 1954 addition, and 1957 addition are nearing the end of their life expectancy. We would recommend the existing sewer located below the floor be inspected with a camera and may need to be replaced pending outcome of the scope.
- C. The existing clearwater sump pumps should be monitored and repaired or replaced as necessary.
