9 WASHINGTON SCHOOL OF EARLY LEARNING

WASHINGTON SCHOOL OF EARLY LEARNING: BUILDING EVOLUTION

WASHINGTON SCHOOL OF EARLY LEARNING: BUILDING SYSTEMS SUMMARY

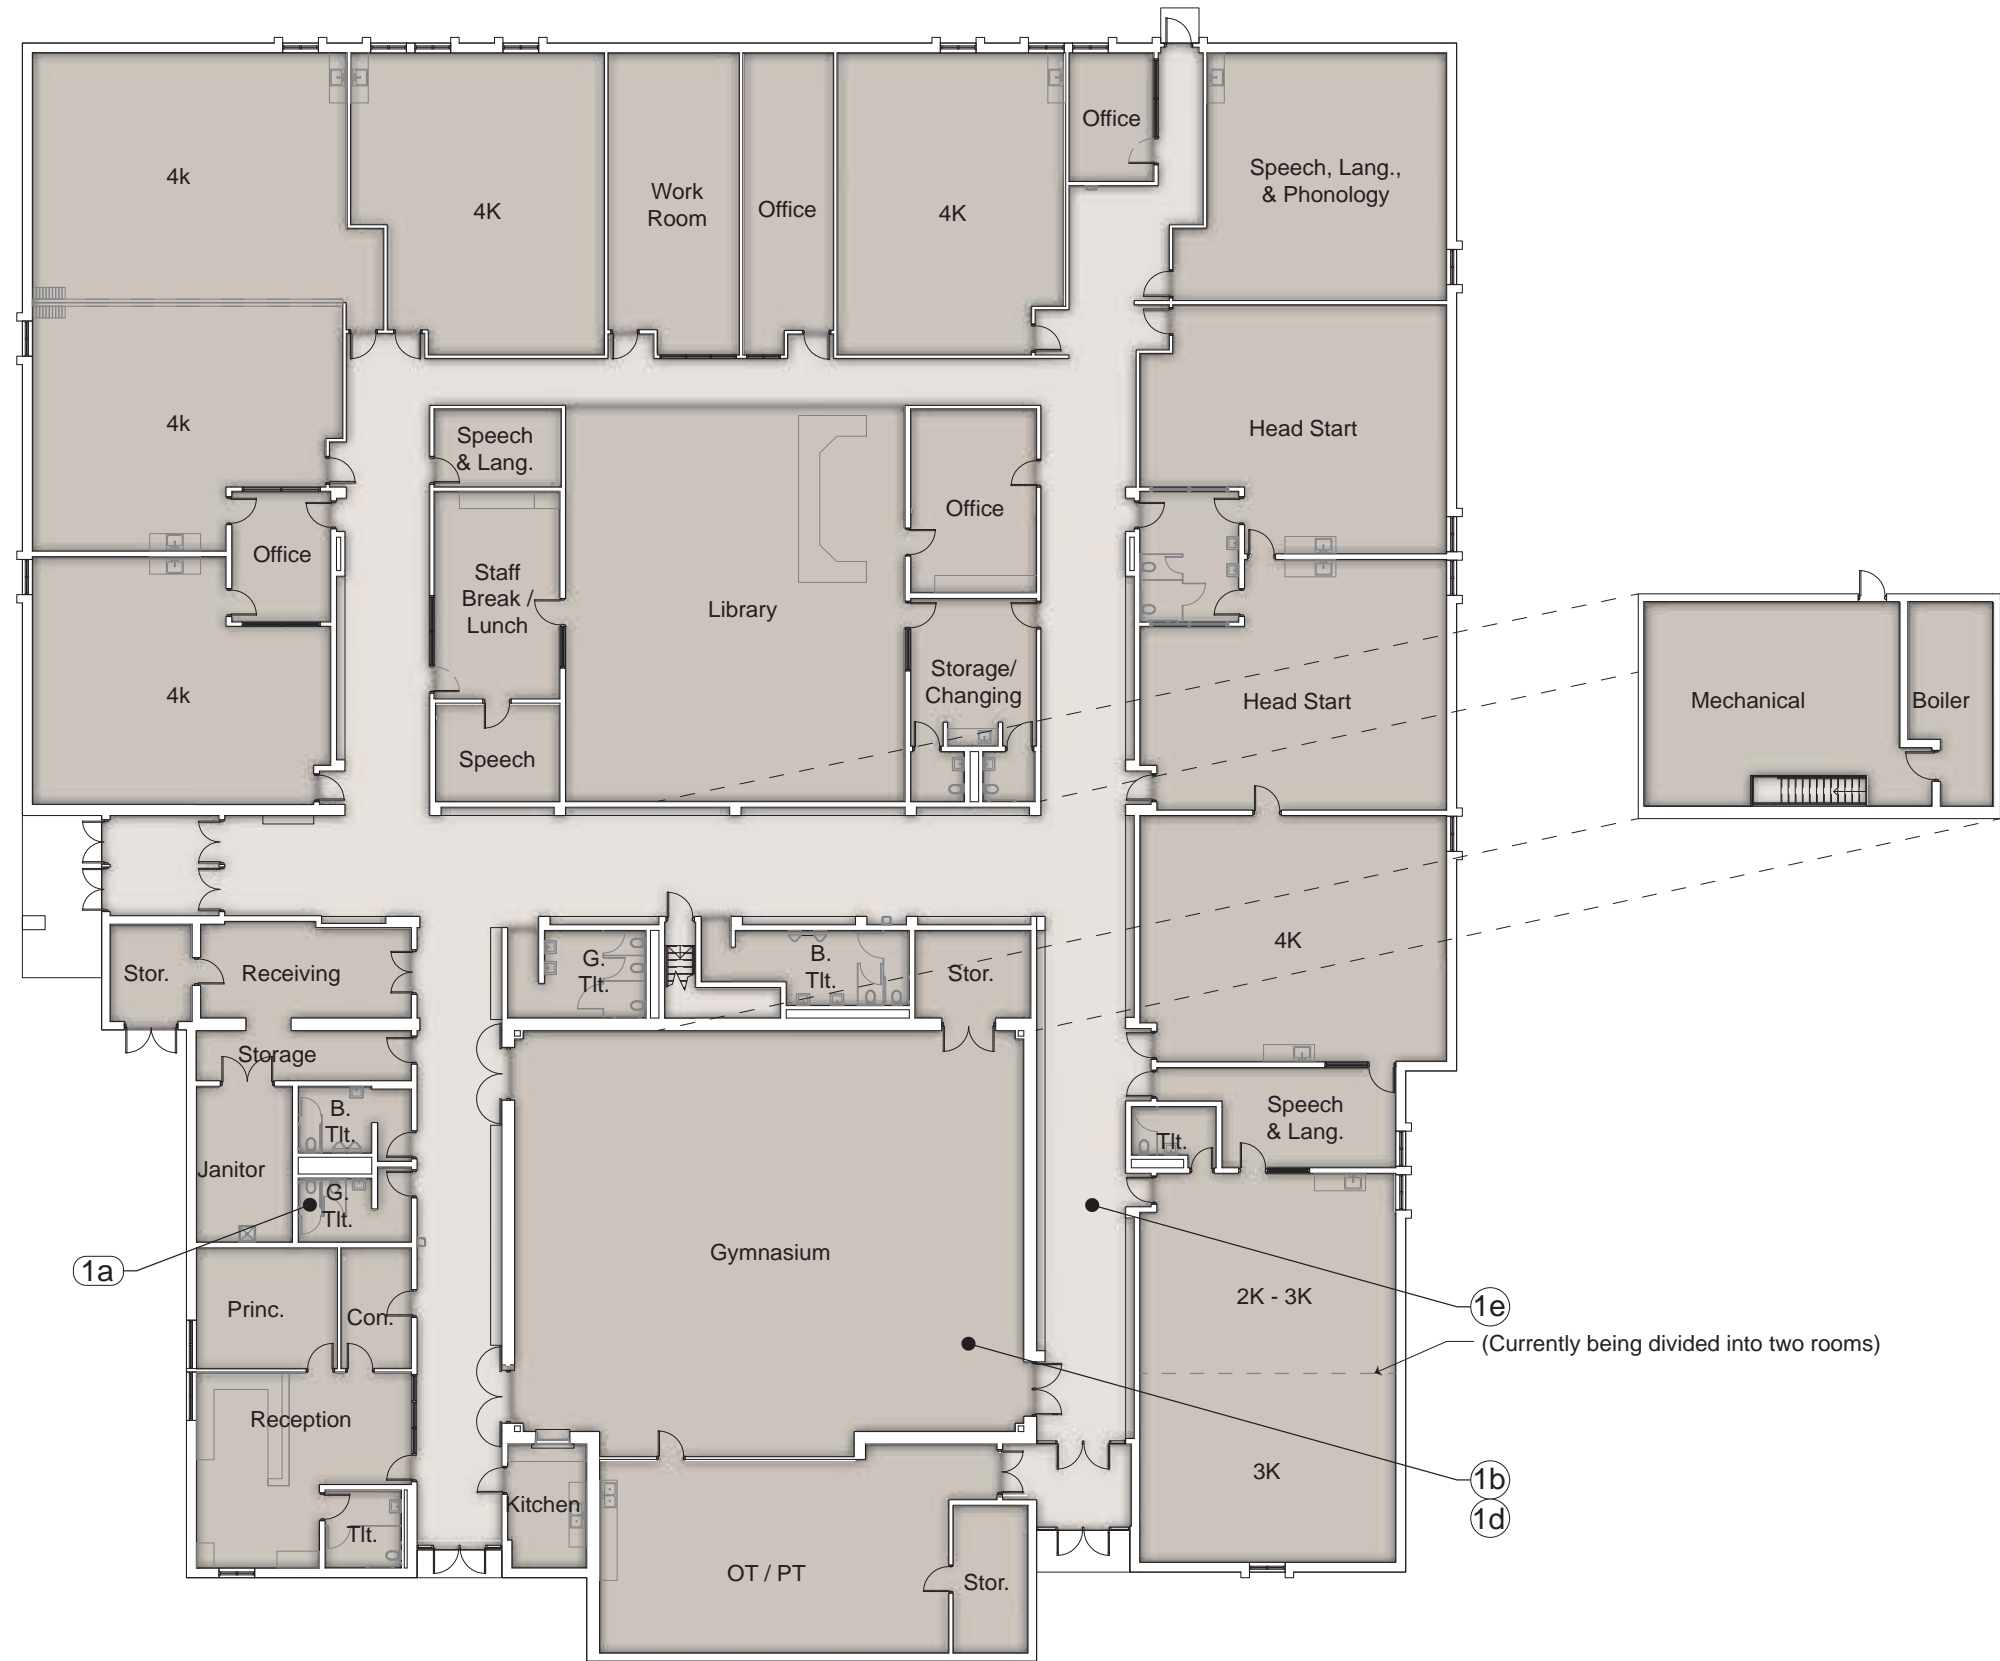
FIRST FLOOR PLAN
not to scale

- a. Cracking present in walls at the base of floor tiles in the bathrooms

- b. Gymnasium contains tectum panels at the ceiling and upper half of the walls; this material is dated and worn, and the ceiling contains stained areas at the edge conditions, possibly due to water damage
- c. Many of the ceiling tiles are dated, with some tiles chipped/missing pieces and many bowing, bending and separating from the ceiling grid; older, small ceiling panels appear mismatched due to replacement of single panels over time

- d. Gymnasium wood flooring is dated and worn, with areas throughout that appear stripped/peeling
- e. Terrazzo flooring contains large cracks, especially near the vestibules and where the floor transitions into the wall base at brick walls

- a. Some windows have cracks in the glass panes

- b. Door #1 at the main entrance is dated and worn

- c. Staining is present on the underside of the roof canopy

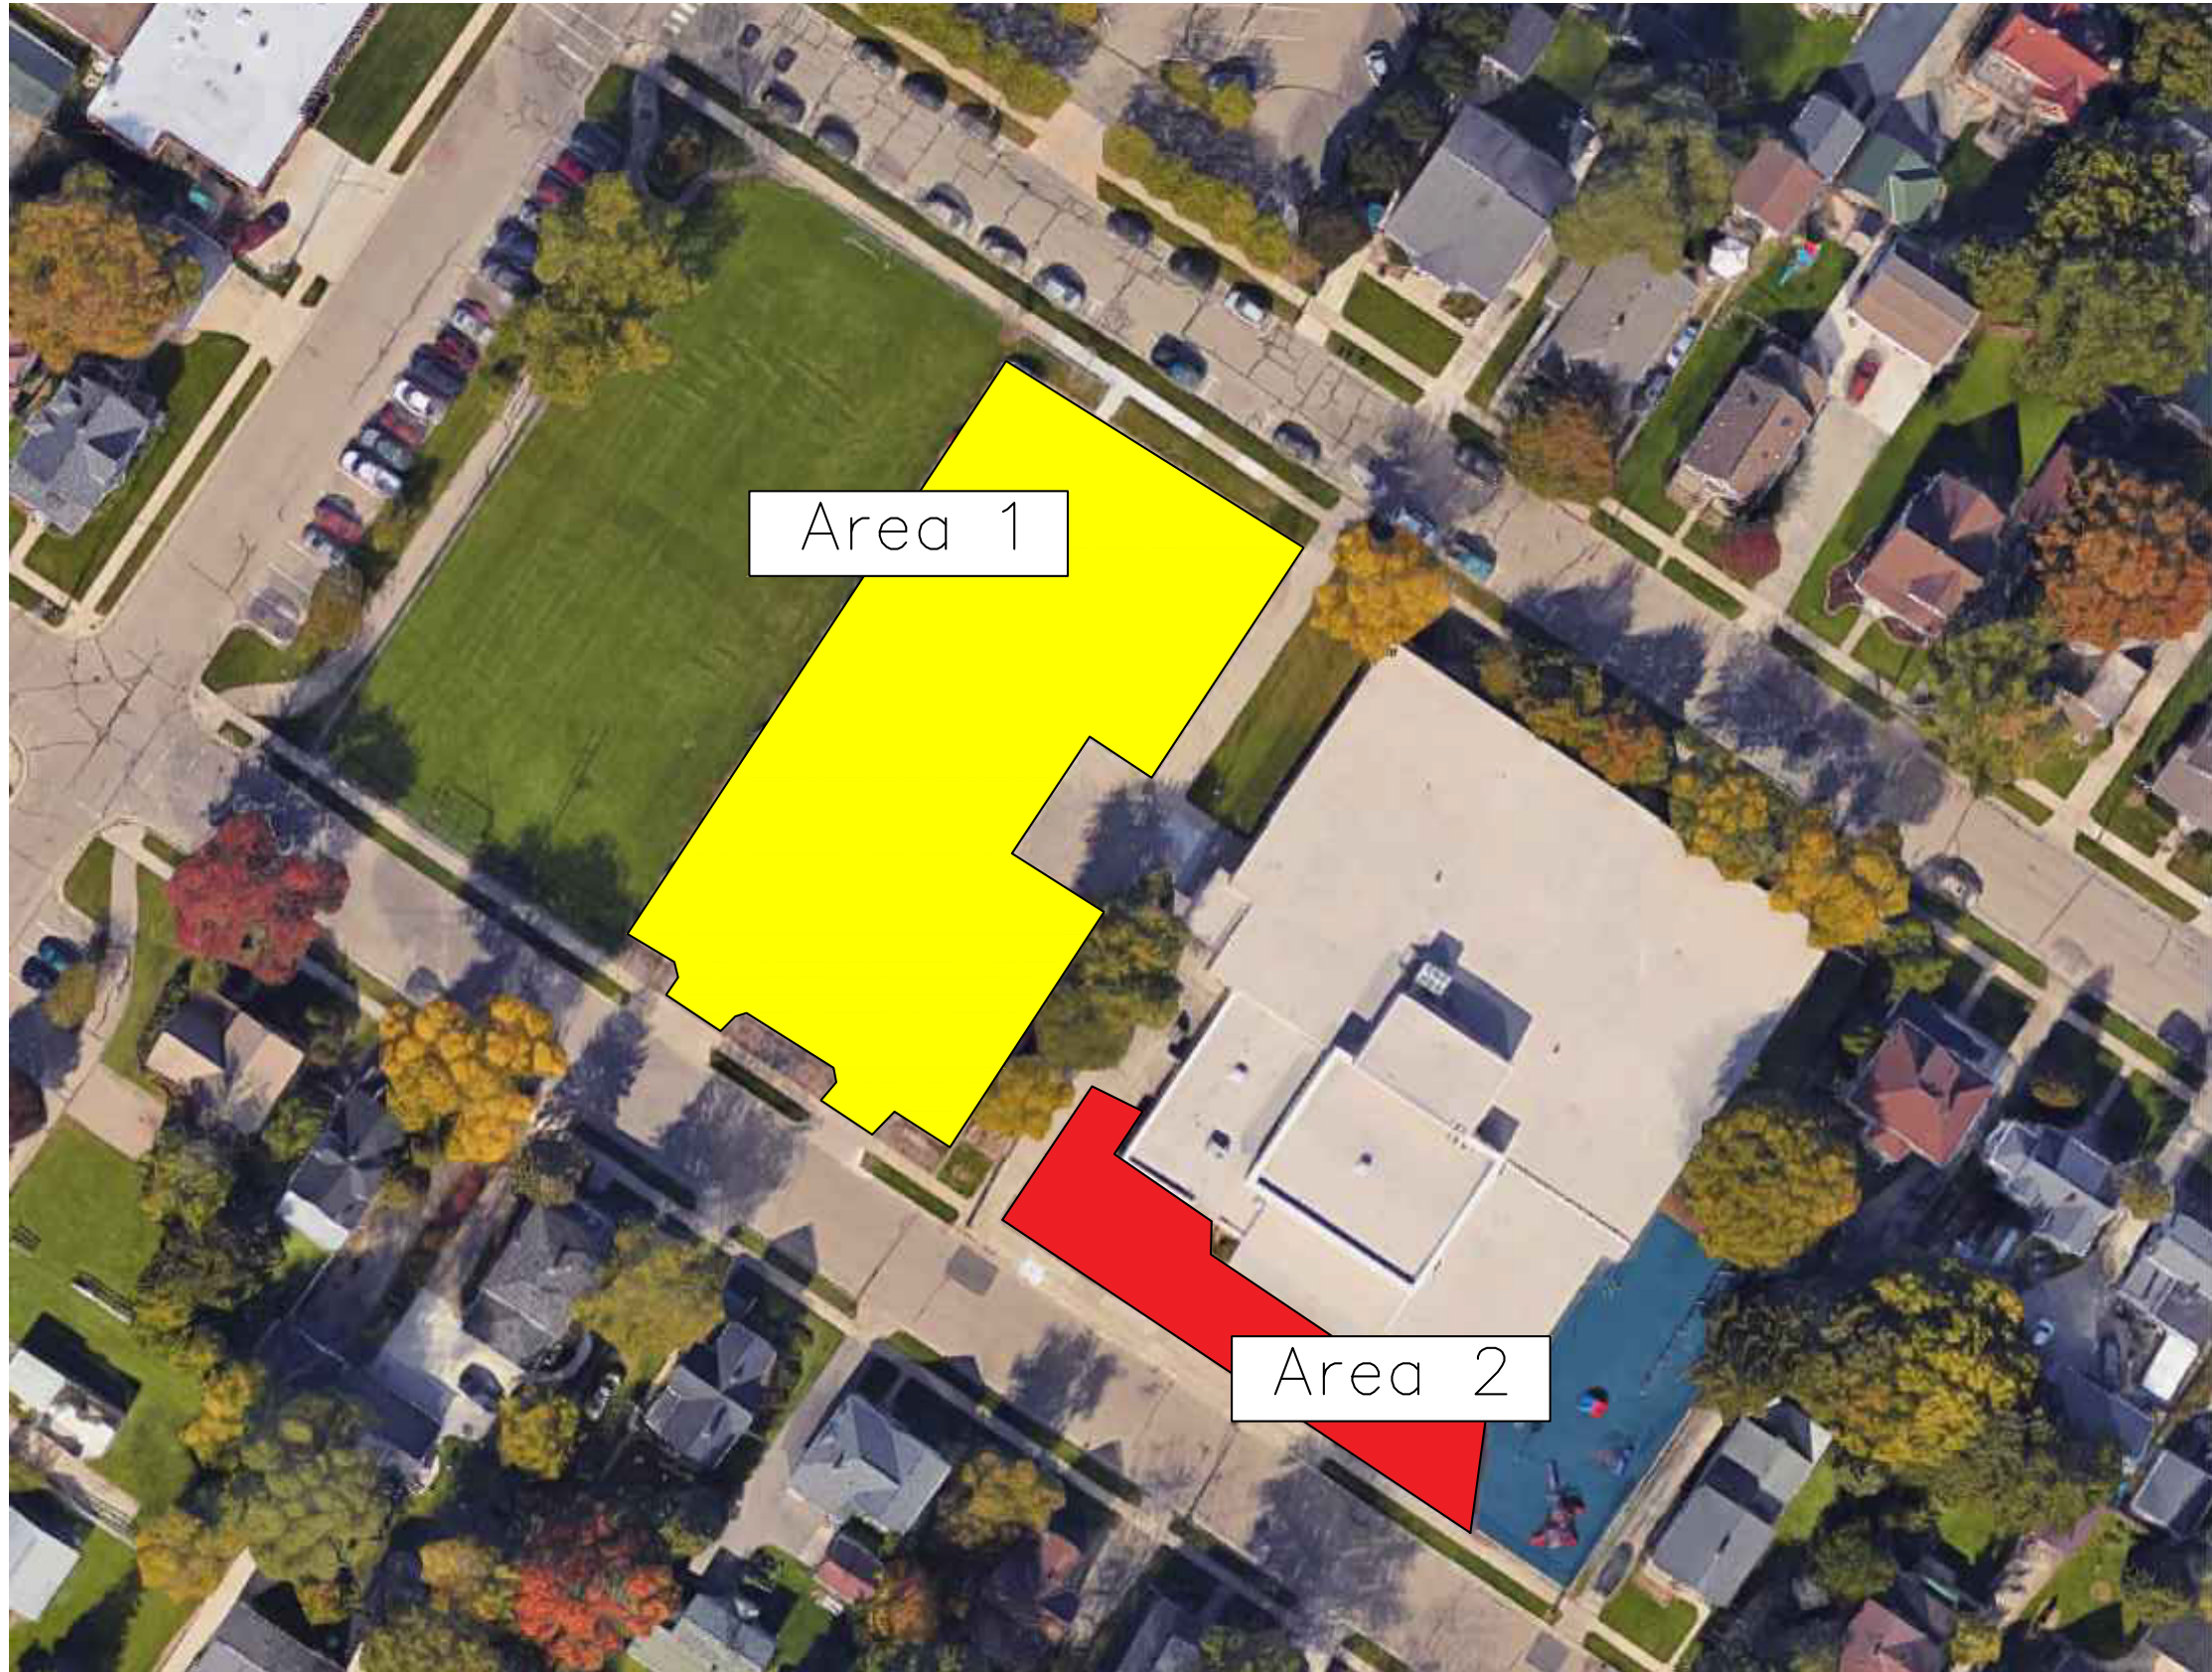
SITE PLAN
not to scale

- Existing pavement is in great condition; re-evaluate in 2-5 years

- Patch Failure
- Thermal cracking
- Raveling
- Surface weathering

- Spalling at edges of sidewalk in areas
- Large cracks in sidewalk that poses a tripping hazard

- There is no dumpster enclosure, nor is there enclosure around electrical units on site

- Remove and replace the areas of sidewalk that have spalling or cracked

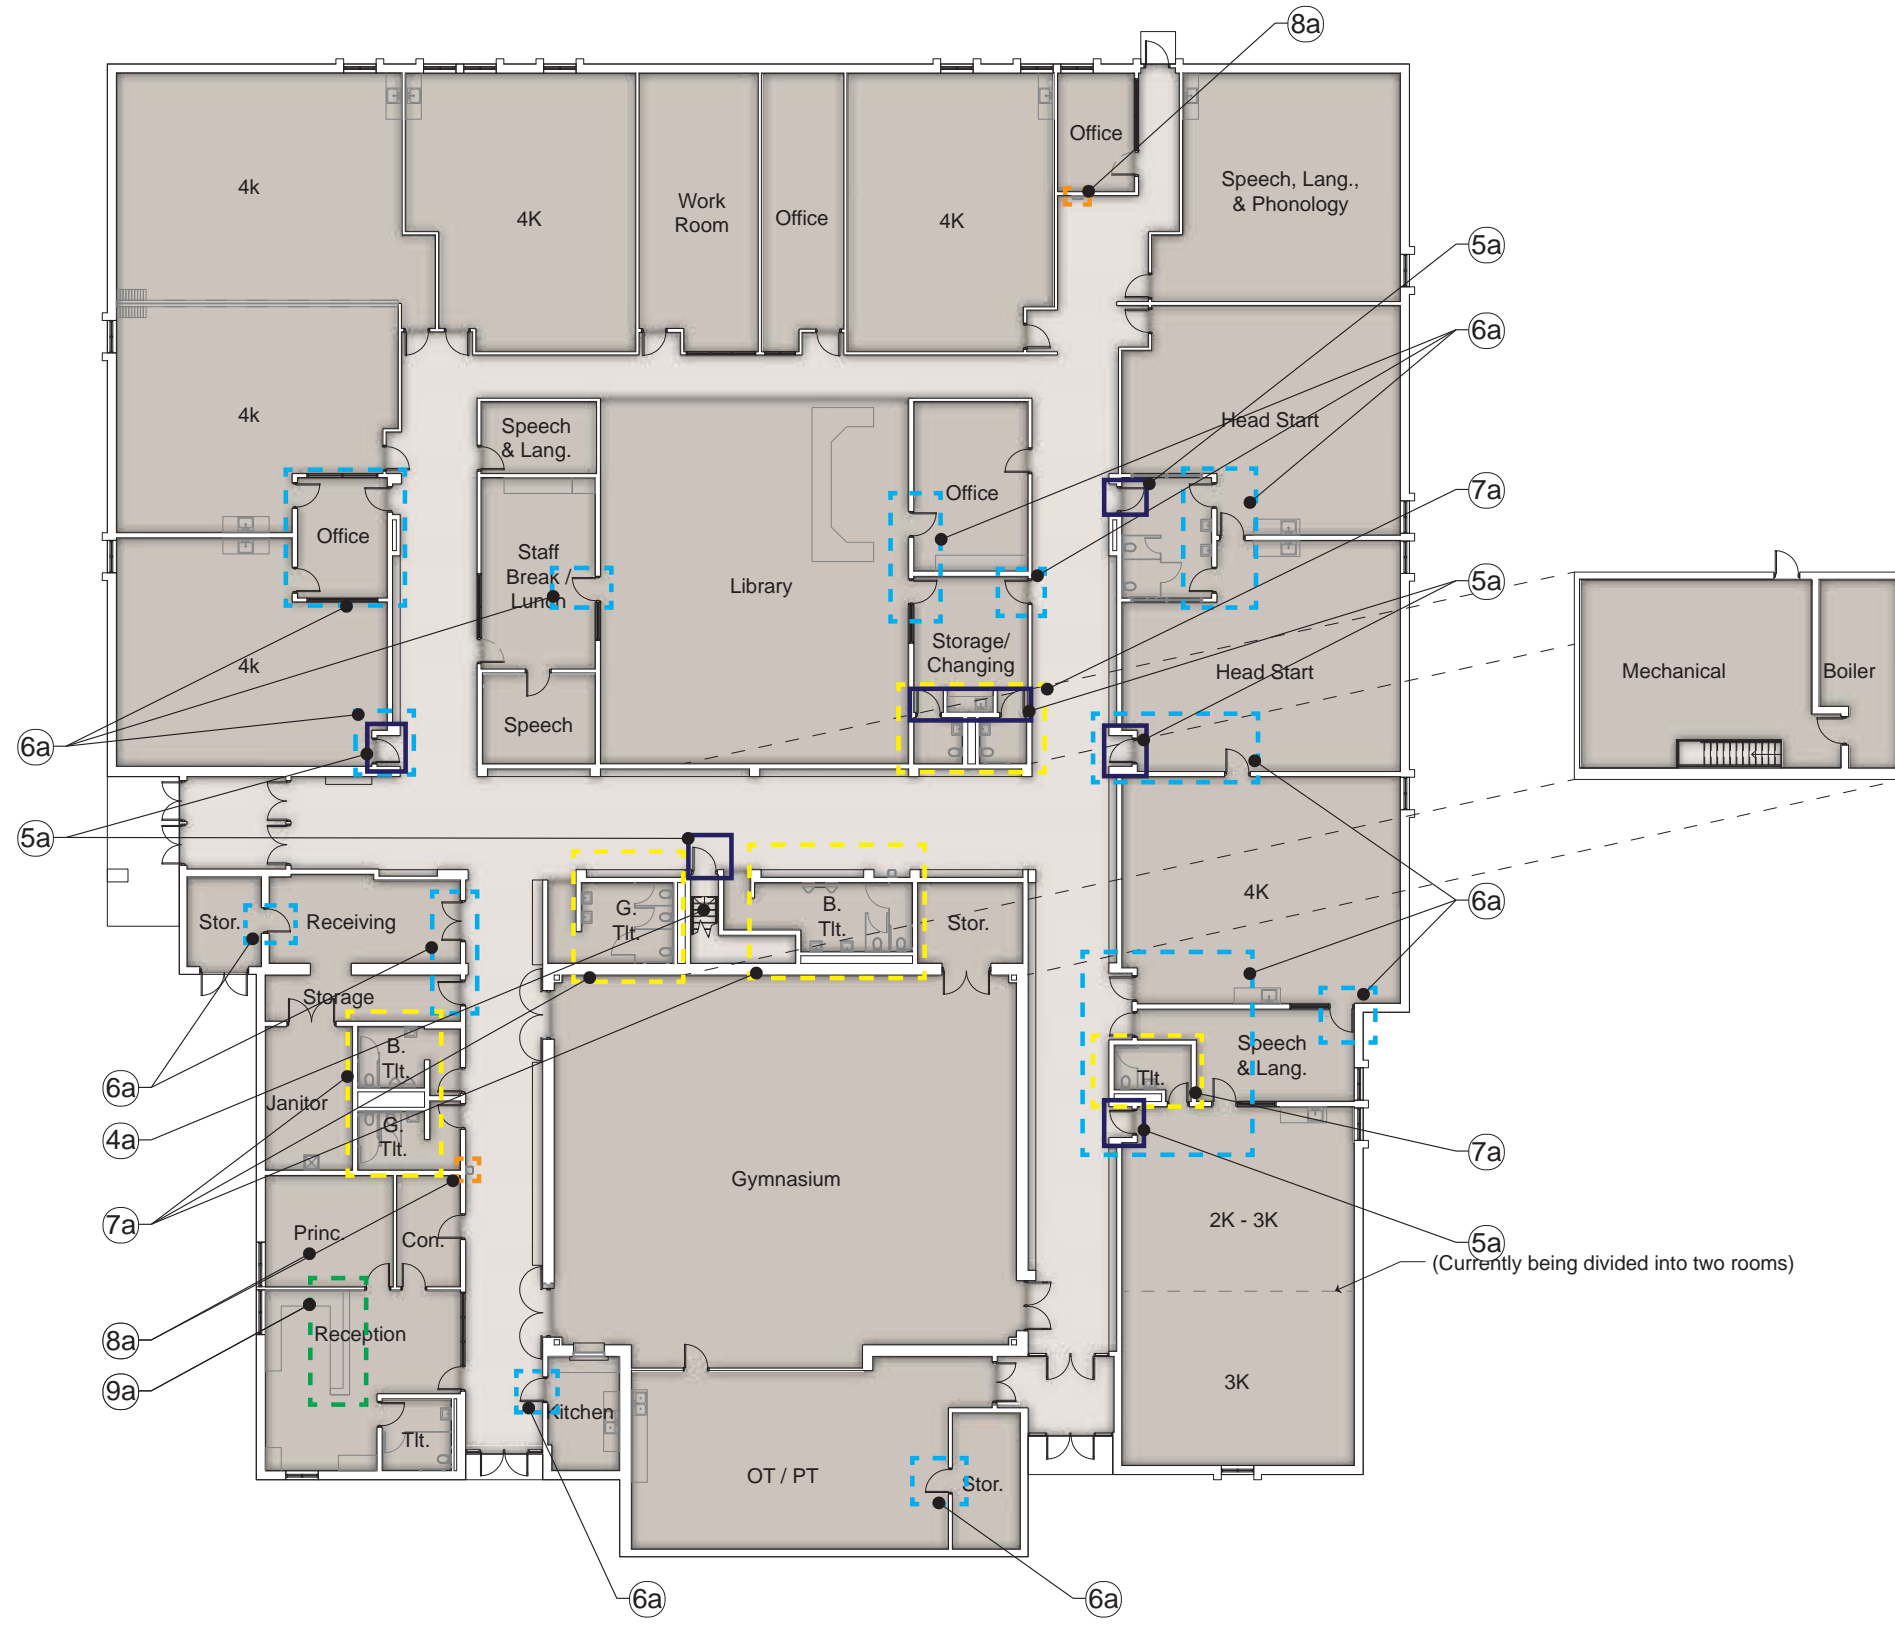
FIRST FLOOR PLAN
not to scale

9a. There are counter-tops that do not meet the above criteria for meeting accessibility standards.

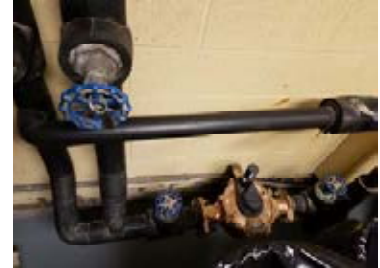
- A. Water is supplied to the building by what appears to be 2" water service which connects to the Municipal water system. There is a water meter located in the building. The water service is at its limit and could not support any future additions.
- B. The majority of the water distribution piping in the building appears to be copper tube and fittings with some galvanized pipe and fittings in the original building. The water distribution piping appears to be in fair condition.
- C. The building has no fire sprinkler system.

- A. The water distribution piping in the building are at the end of their life expectancy. We would recommend replacing the existing pipe and fittings with new type "L" copper tube and fittings.
- B. If there are any new additions or major remodeling planned, a new larger water service will need to be provided.
- C. If a complete fire sprinkler system is preferred for the building, a new 6" water service will need to be provided.

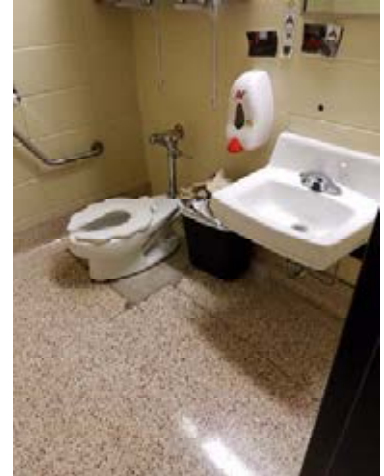
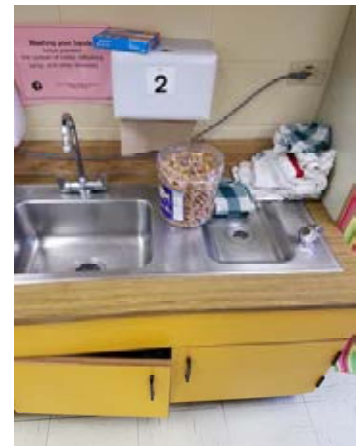
- A. The existing plumbing fixtures in the building are a combination of various styles and ages. Most of the fixtures are original to the building age they were installed. Some of the fixtures have been replaced with newer water efficient and ADA compliant fixtures.

- B. The water closets are floor and wall set, flush valve type fixtures. They do not appear to be water conserving or ADA compliant. The fixtures are old and in fair condition.

- C. The urinals in the building are floor set with flush valves. The fixtures are not water conserving. The fixtures are old and are in fair condition.

- D. The lavatories in the building are wall hung with multiple styles of faucets. They do not appear to be water conserving or ADA compliant and are in fair condition.

- E. The drinking fountains in the building are vitreous china drinking fountains and wall hung electric water coolers. They are not ADA compliant and are in fair condition. The fixtures are in good condition.

- F. The classroom sinks are single bowl, stainless steel drop-in sinks with varying types of faucets and separate drinking fountain. The fixtures are not ADA compliant and are in fair condition.

- A. The water closets should be replaced with new water conserving and ADA compliant fixtures.
- B. The urinals should be replaced with new water conserving and ADA compliant fixtures.
- C. The lavatories should be replaced with new water conserving and ADA compliant fixtures.
- D. The drinking fountains should be replaced with new ADA compliant fixtures with a bottle filler.
- E. The faucets on the classroom sinks should be replaced with new ADA compliant faucets.
