# 10 WILSON ELEMENTARY

**WILSON ELEMENTARY: NEEDS ASSESSMENT**

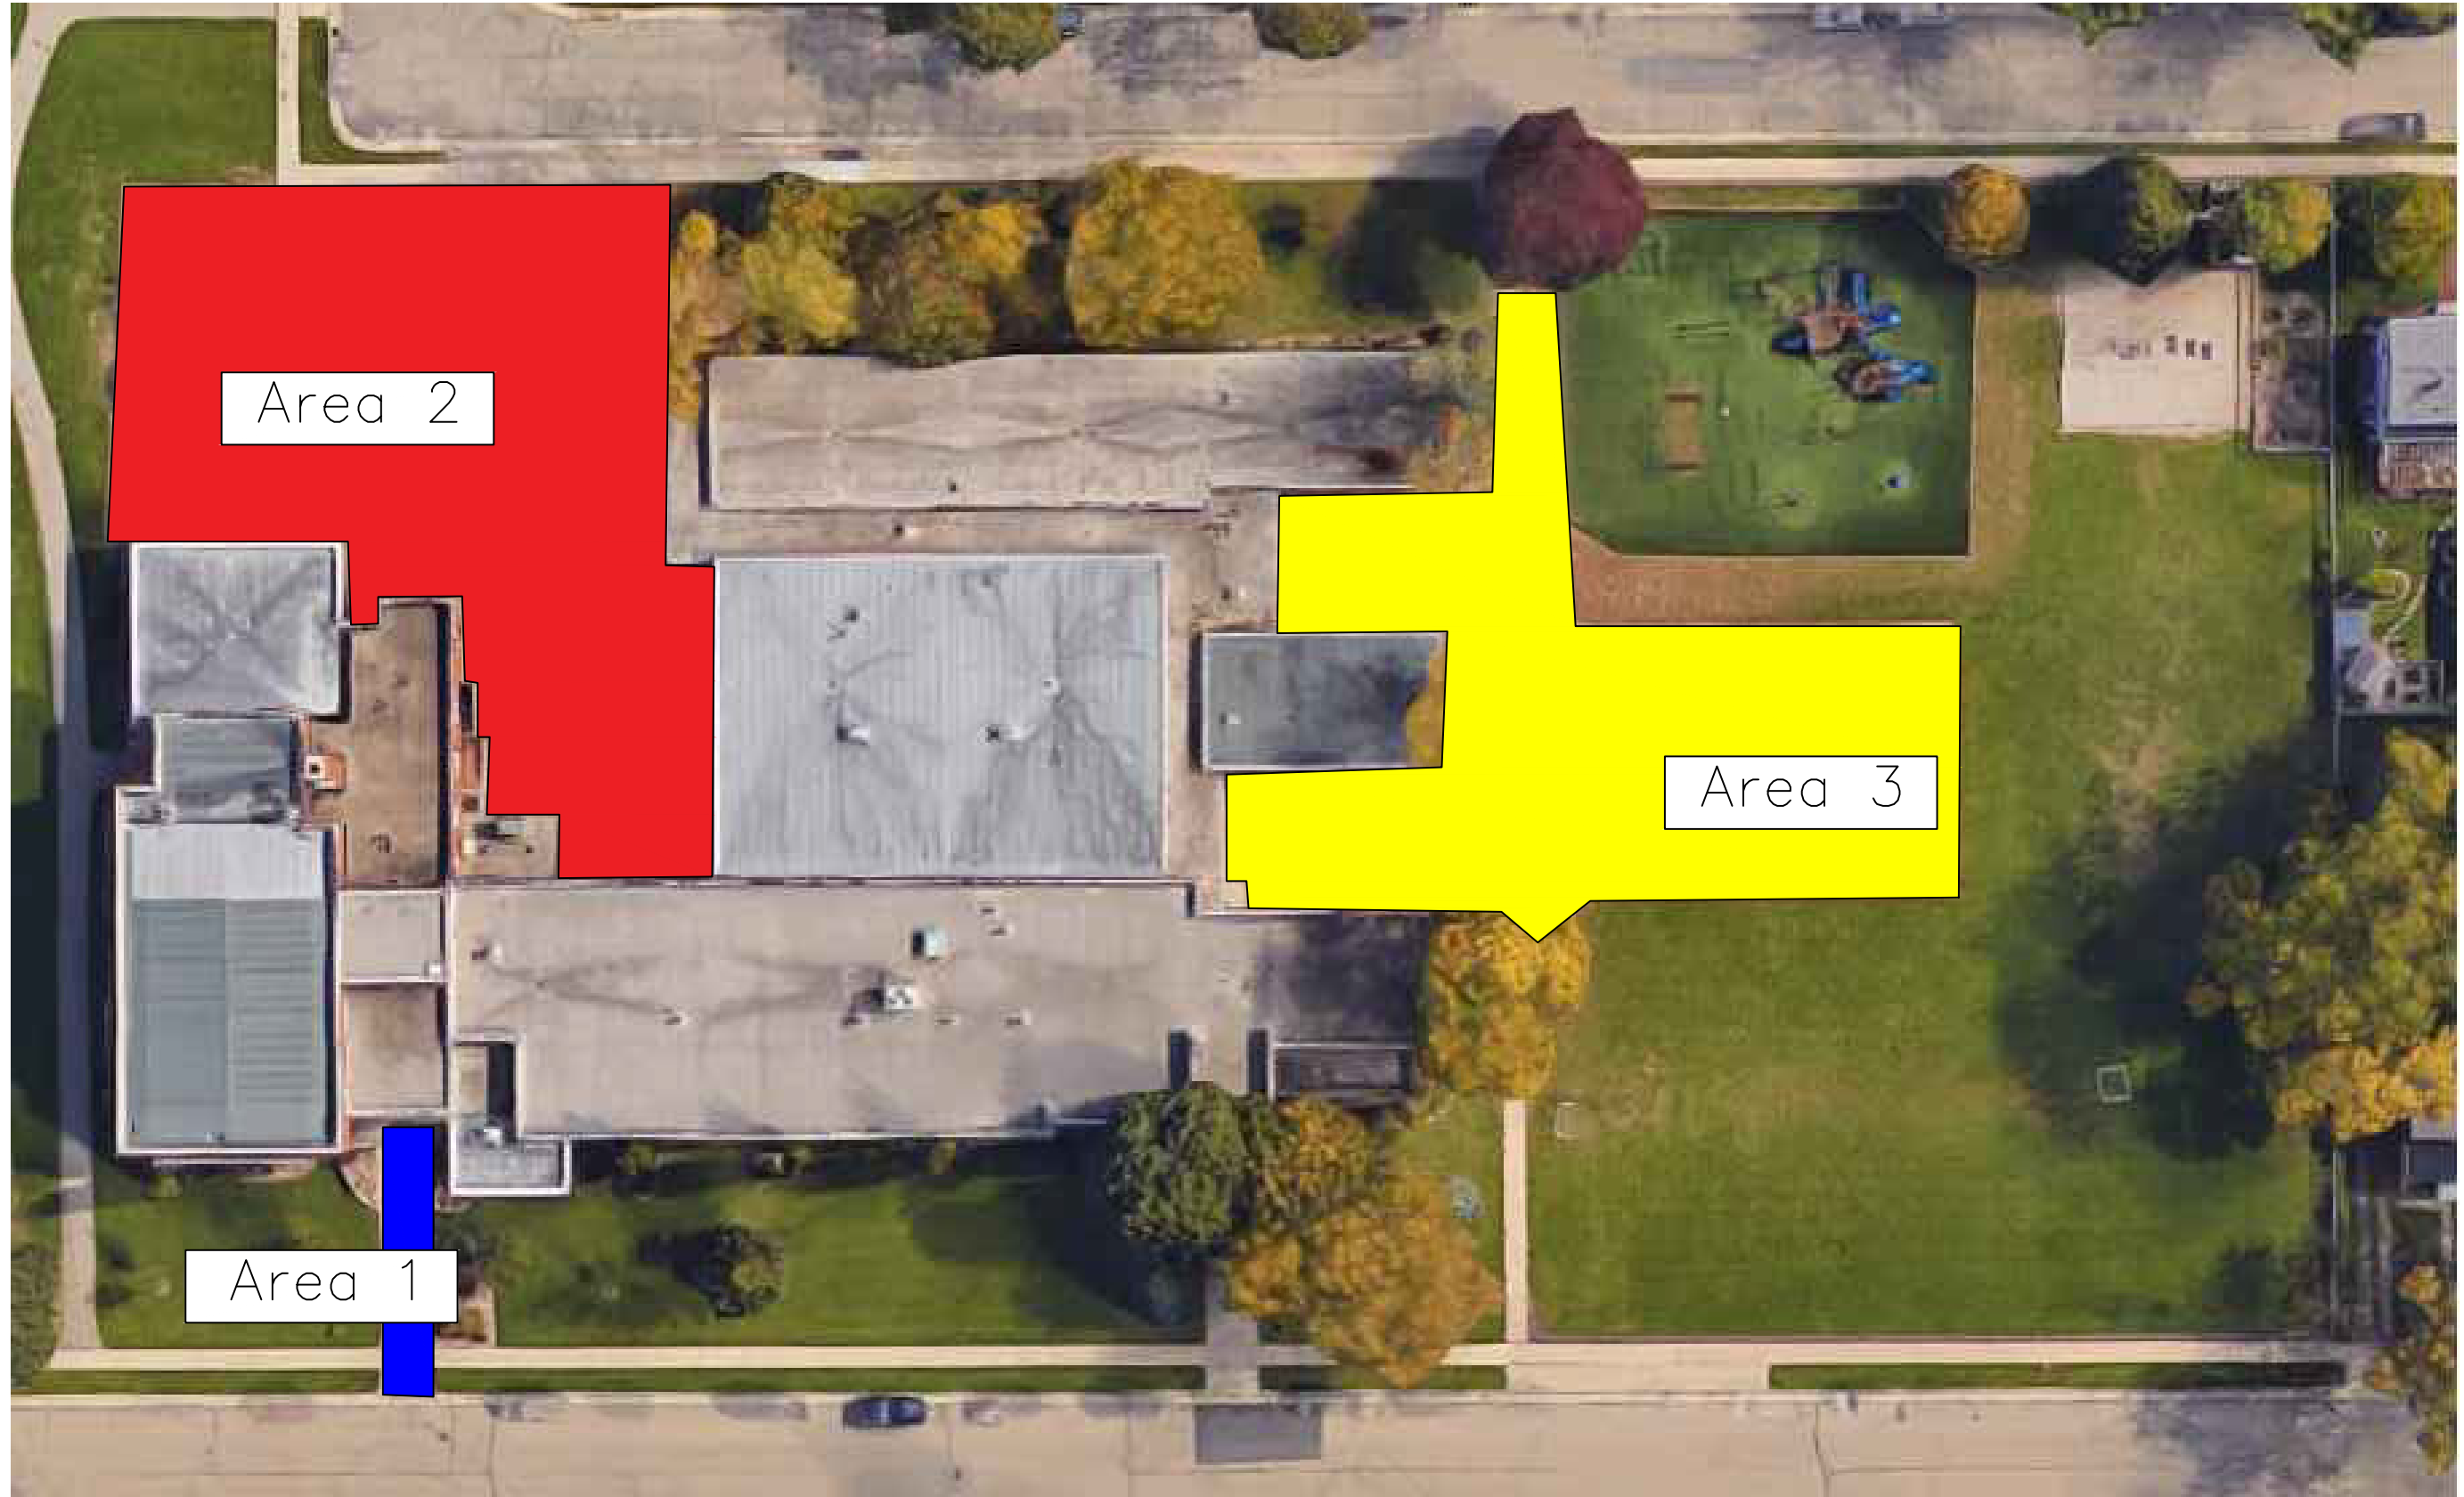
SITE PLAN  
not to scale

- Distresses Present:
  - No hand rails
  - Concrete walk is too steep
- Recommended Repair:
  - Remove existing concrete
  - Place 12 inches of base aggregate dense
  - Grade to proper slope
  - Place 6-inch concrete walk
  - Add handrails

- Distresses Present:
  - Thermal cracking
  - Raveling
  - Surface weathering
  - Depressions due to base settling
  - Fatigue cracking due to base failure
- Recommended Repair:
  - Remove existing pavement and 12 inches of base and/or subgrade
  - Place 12 inches of base aggregate dense
  - Pave 4 inches of asphaltic pavement
  - Paint all pavement markings for a parking lot

- Distresses Present:
  - Thermal cracking
  - Raveling
  - Surface weathering
  - Depressions due to base settling
- Recommended Repair:
  - Remove existing pavement and 12 inches of base and/or subgrade
  - Place 12 inches of base aggregate dense
  - Grade the area to better drain to the existing inlets
  - Pave 3 inches of asphaltic pavement
  - Paint all pavement markings for a basketball court

- Distresses Present:
  - Spalling at edges of sidewalk in areas
  - Large cracks in sidewalk that poses a tripping hazard
  - Entrance apron to the staff parking lot is very steep
- Recommended Repair:
  - Remove and replace the areas of sidewalk that have spalling or cracked
  - Fix grade at parking lot apron

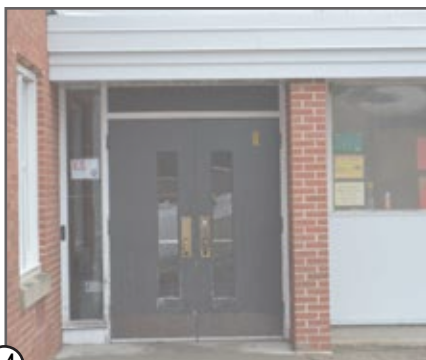
⑭ WOOD DOORS & WOOD FRAME

- f. Nearly all wood frame exterior doors are worn and rotting
- g. Steel frame doors were recently replaced

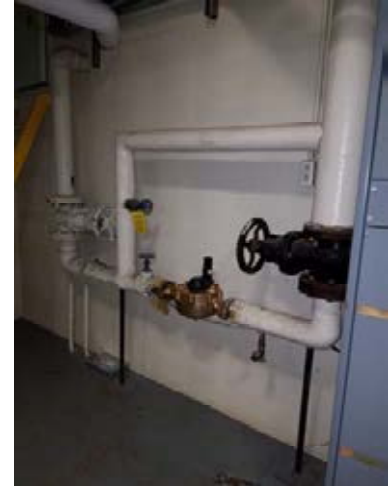
- A. Water is supplied to the building by what appears to be 4" water service which connects to the Municipal water system. There is a water meter located in the boiler room. The water service is at its limit and could not support any future additions.
- B. The majority of the water distribution piping in the building appears to be copper tube and fittings with some galvanized pipe and fittings. The water distribution piping appears to be in fair condition.
- C. There is no fire suppression system in the building.

- A. The water distribution piping in the original building and the 1952 addition are at the end of their life expectancy. We would recommend replacing the existing pipe and fittings with new type "L" copper tube and fittings.
- B. If there are any new additions or major remodeling planned, a new larger water service will need to be provided.
- C. If a complete fire sprinkler system is preferred for the building, a new 6" water service will need to be provided.

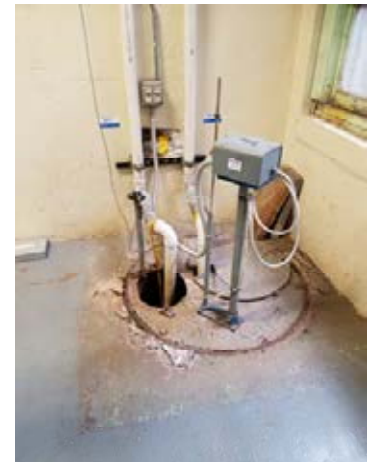
- A. The sanitary waste from the building flows by gravity out the building and connects to the Municipal sanitary sewer system.
- B. The sanitary waste piping type could not be identified. There are no reported challenges with the sewer piping.
- C. The building has a prep kitchen with a 2-compartment sink and disposal. There is no interior grease interceptor.
- D. Classroom sinks do not have solids traps installed on the waste piping.
- E. The existing roof water is collected by internal roof drains and conductors which flow by gravity out the building and connect to the Municipal storm sewer system.
- F. There is a clearwater sump pump located in the basement level for removing groundwater. The sump system appears to be in fair to good condition.

- A. The sanitary sewer system in the original building 1952 addition are nearing the end of their life expectancy. We would recommend the existing sewer located below the floor be inspected with a camera and may need to be replaced pending outcome of the scope.
- B. The sink where art project are completed should have solids traps added to the waste piping.
- C. The storm sewer system in the original building and 1952 addition are nearing the end of their life expectancy. We would recommend the existing sewer located below the floor be inspected with a camera and may need to be replaced pending outcome of the scope.
- D. The existing clearwater sump pump should be monitored and repaired or replaced as necessary.
