1 CLAYTON ELEMENTARY

CLAYTON ELEMENTARY: BUILDING EVOLUTION

CLAYTON ELEMENTARY: EXISTING SITE PLAN

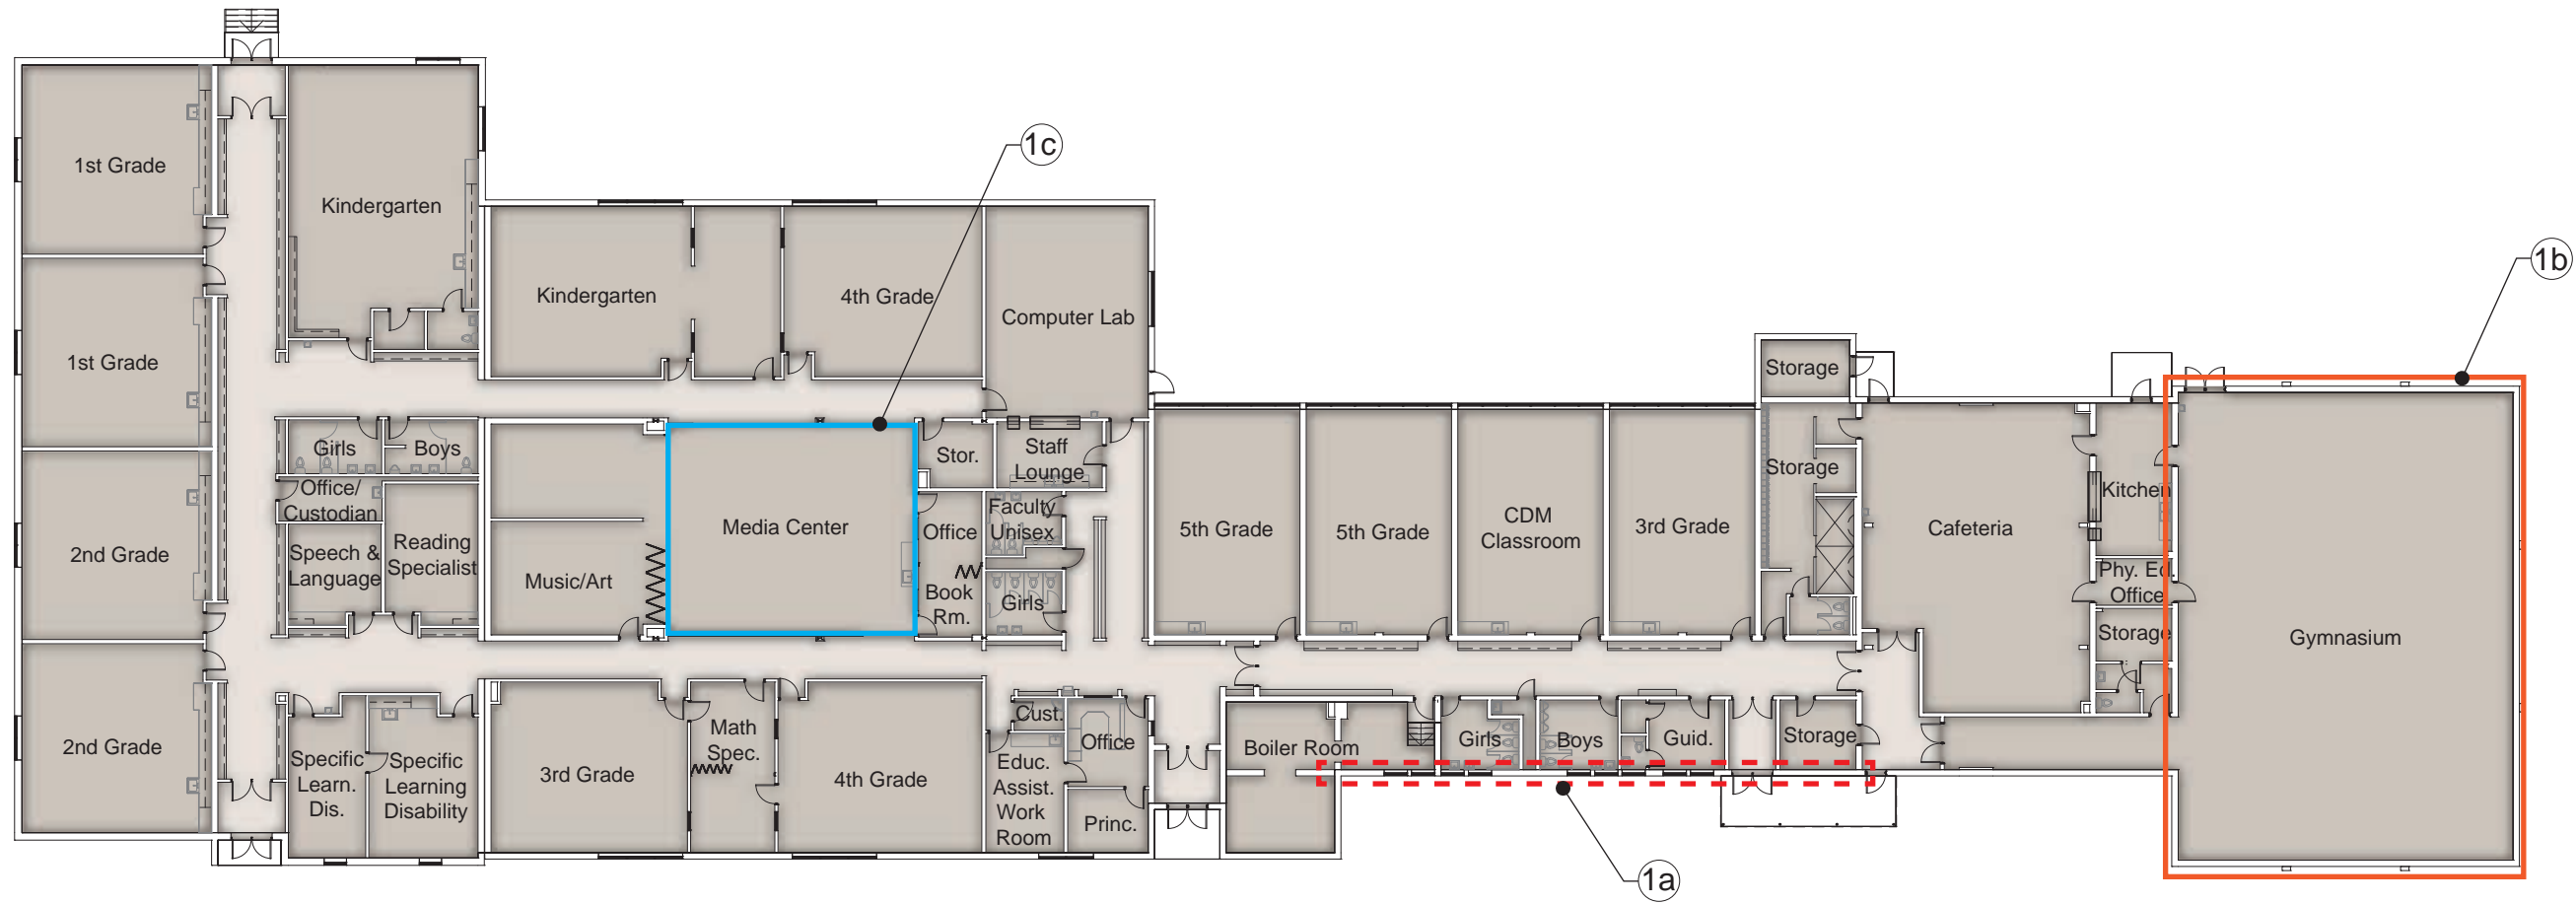
FIRST FLOOR PLAN
not to scale

- a. Water leaks into the building at the foundation wall in the tunnels.

- b. Gymnasium ceiling is stained and shows signs of water damage; staff reported that during winter months, condensation and snow on the roof cause leaks into the ceiling below
- c. Staff indicated areas of potential asbestos ceiling tile in the IMC/Library

- d. Much of flooring is stained, worn, cracking and in need of repair; excessive tile cracking present within interior entry to school
- e. Staff indicated areas of potential asbestos tile in classroom areas

- a. There are multiple areas of discoloration and staining present on the exterior of the building, possibly due to water damage; this is especially present at sills, gutters, and on brick in the back of the building
- b. Concrete masonry block walls have areas of discoloration and paint peeling

- c. Some exterior doors are worn/faded and peeling

- d. New roofs needed for some portions of the building
- e. Sand from roofs is often blown into gutters and becomes trapped
- f. Many gutters have large openings along the front of the downspout and appear to have trouble directing water as intended

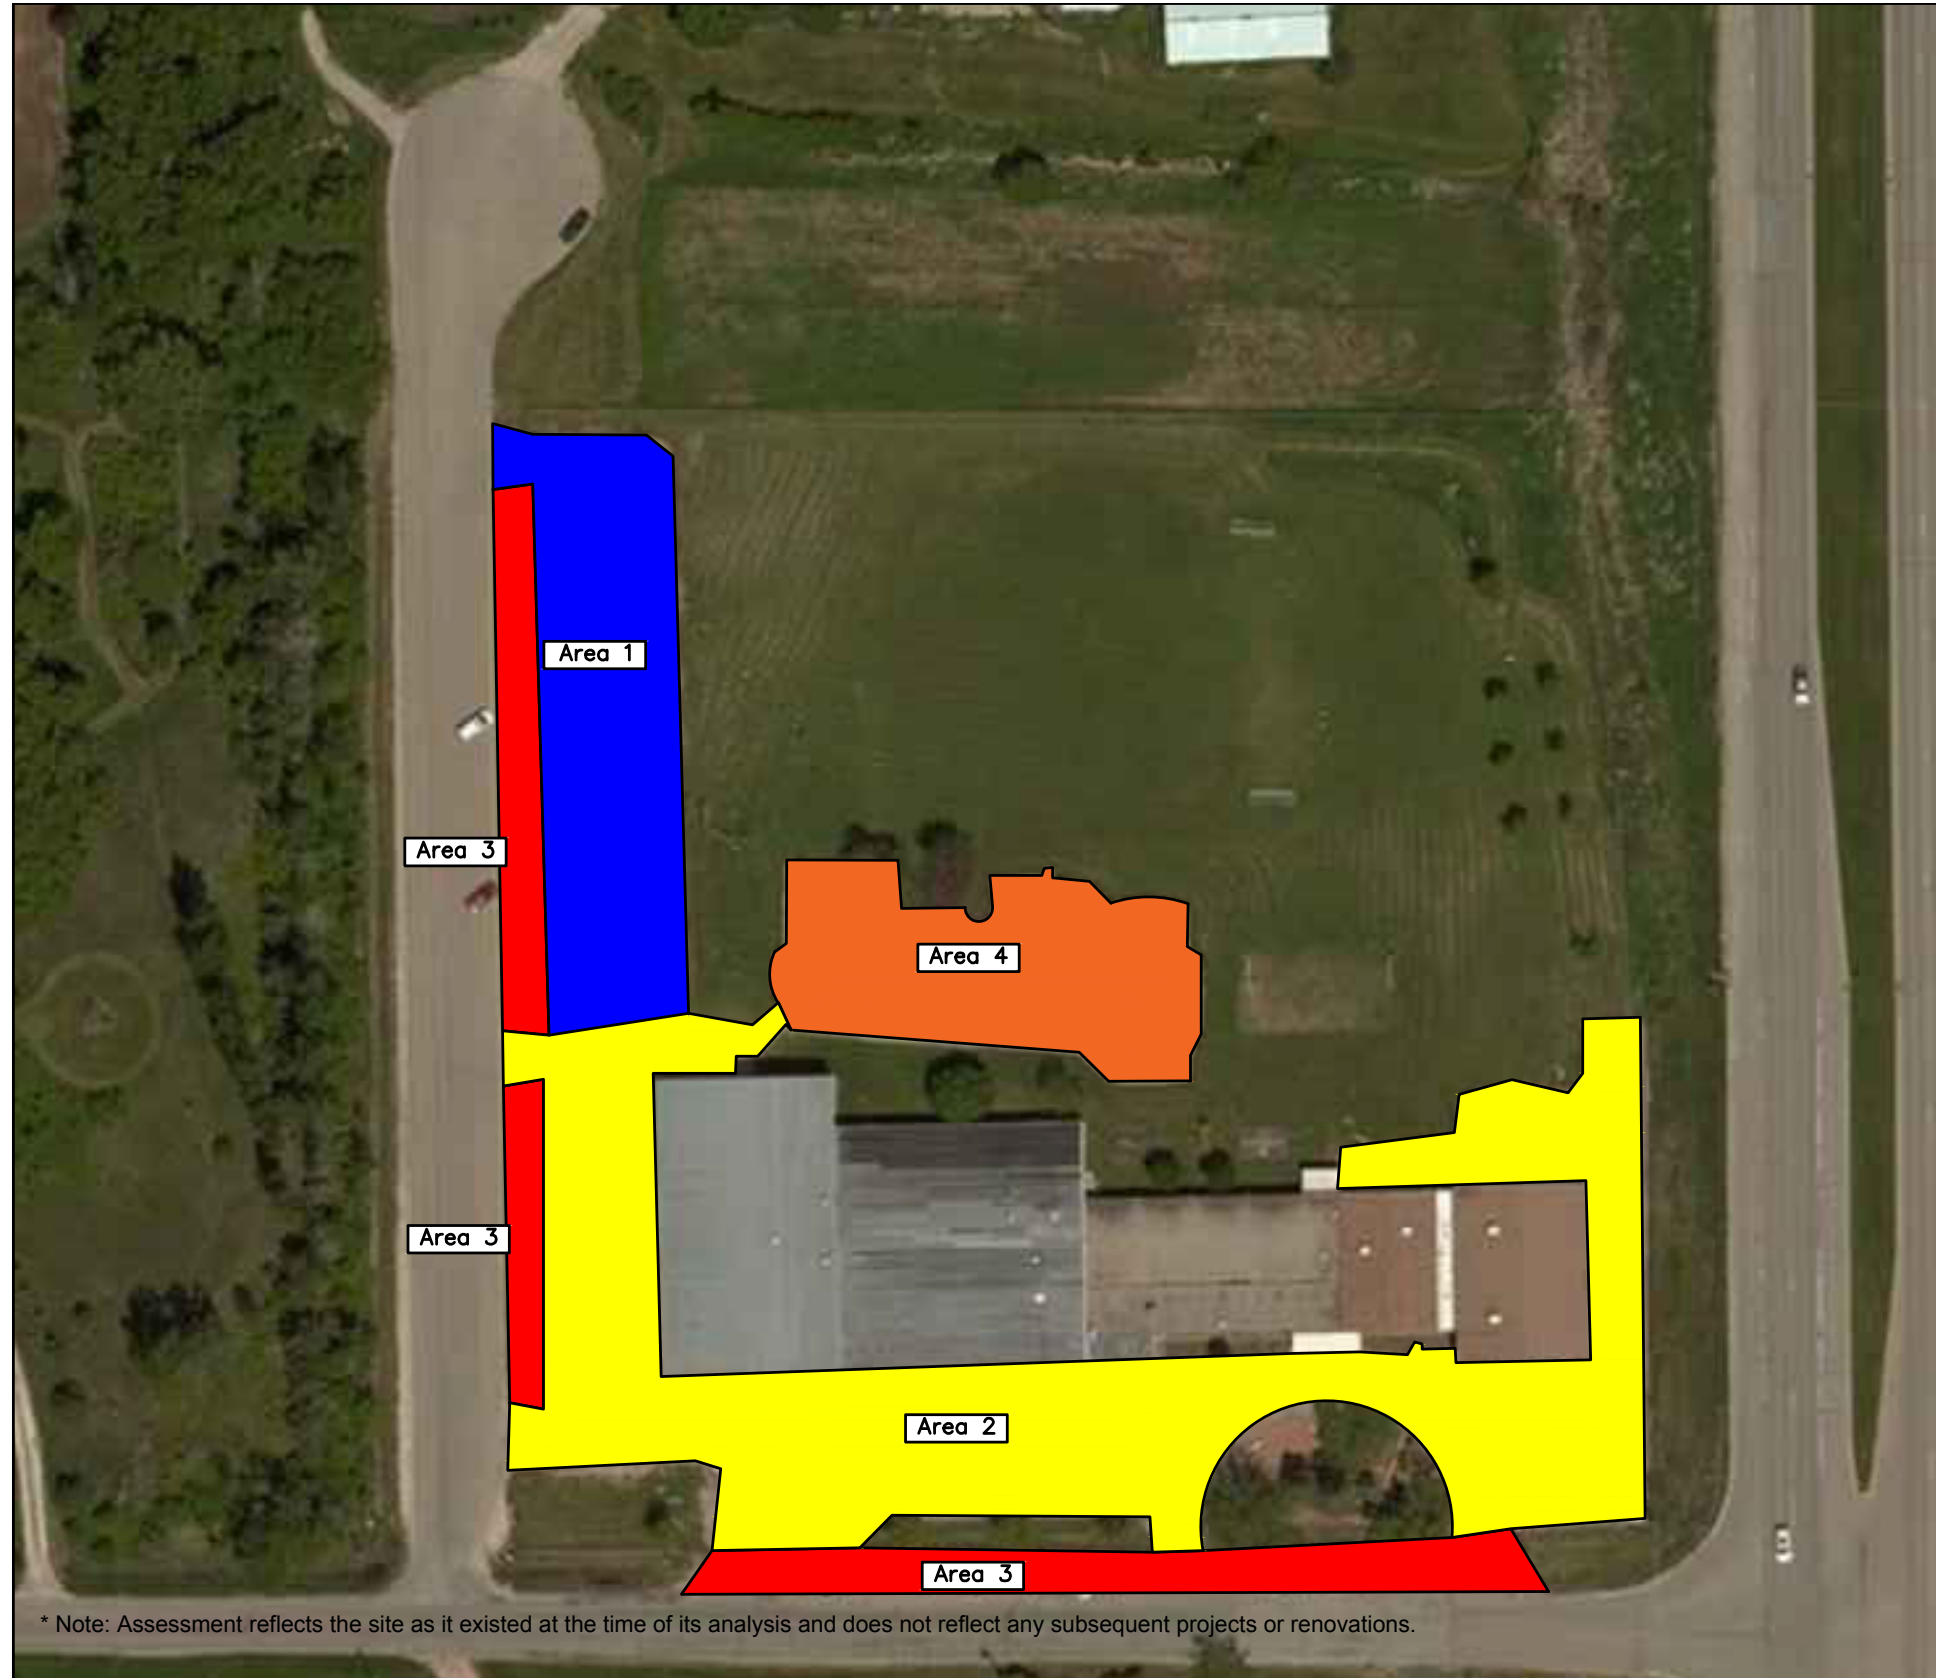
SITE PLAN
not to scale

- No dumpster enclosure exists
- Playground equipment appears newer; swing-set is dated

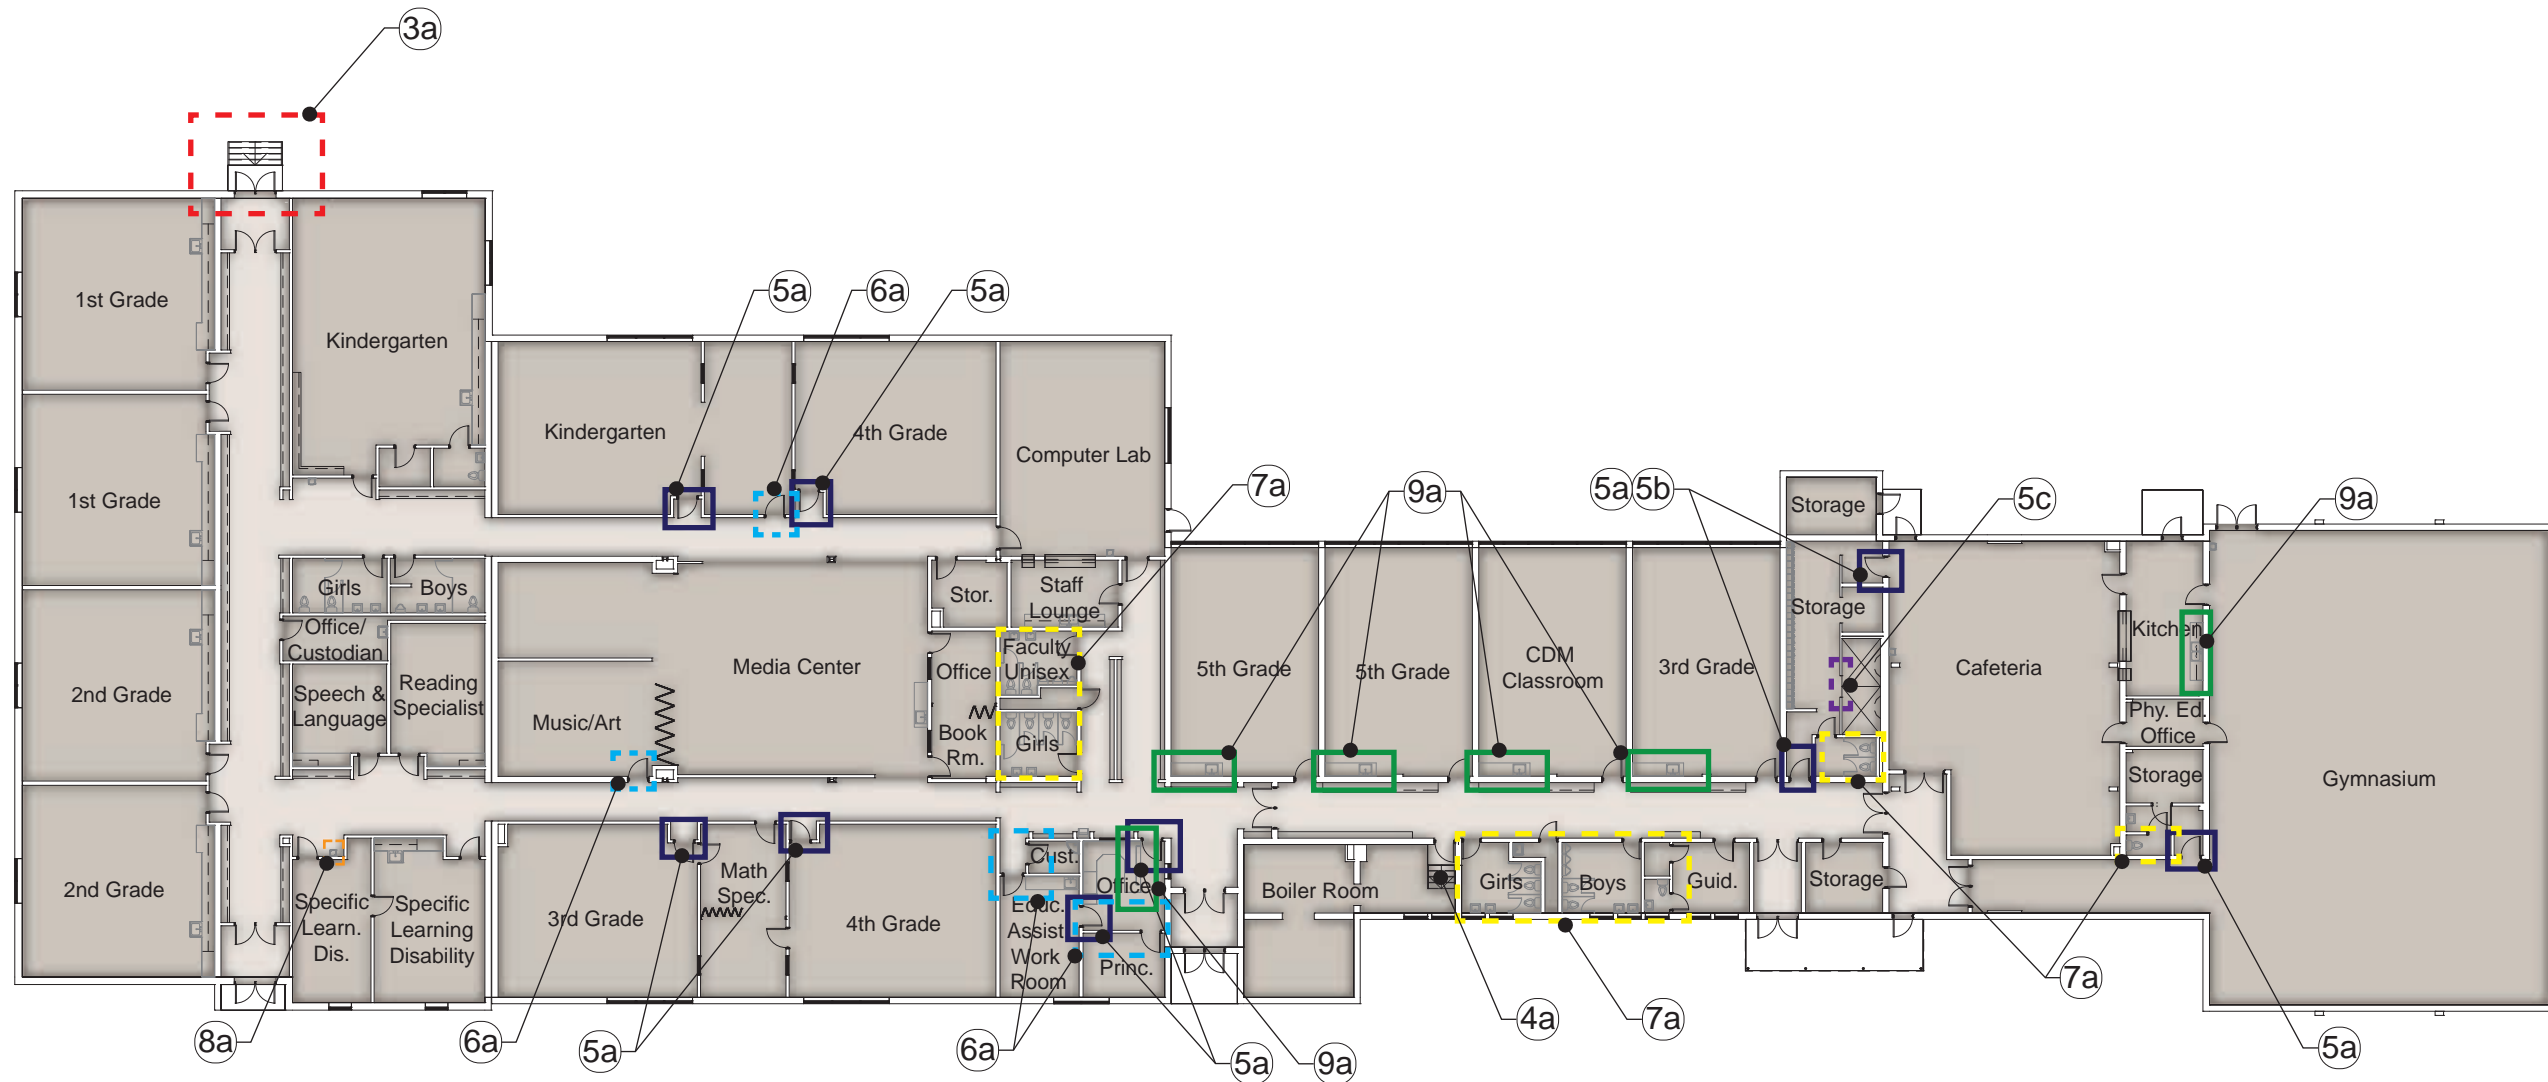
FIRST FLOOR PLAN
not to scale

9a. There are countertops that do not meet the above criteria for accessibility standards.

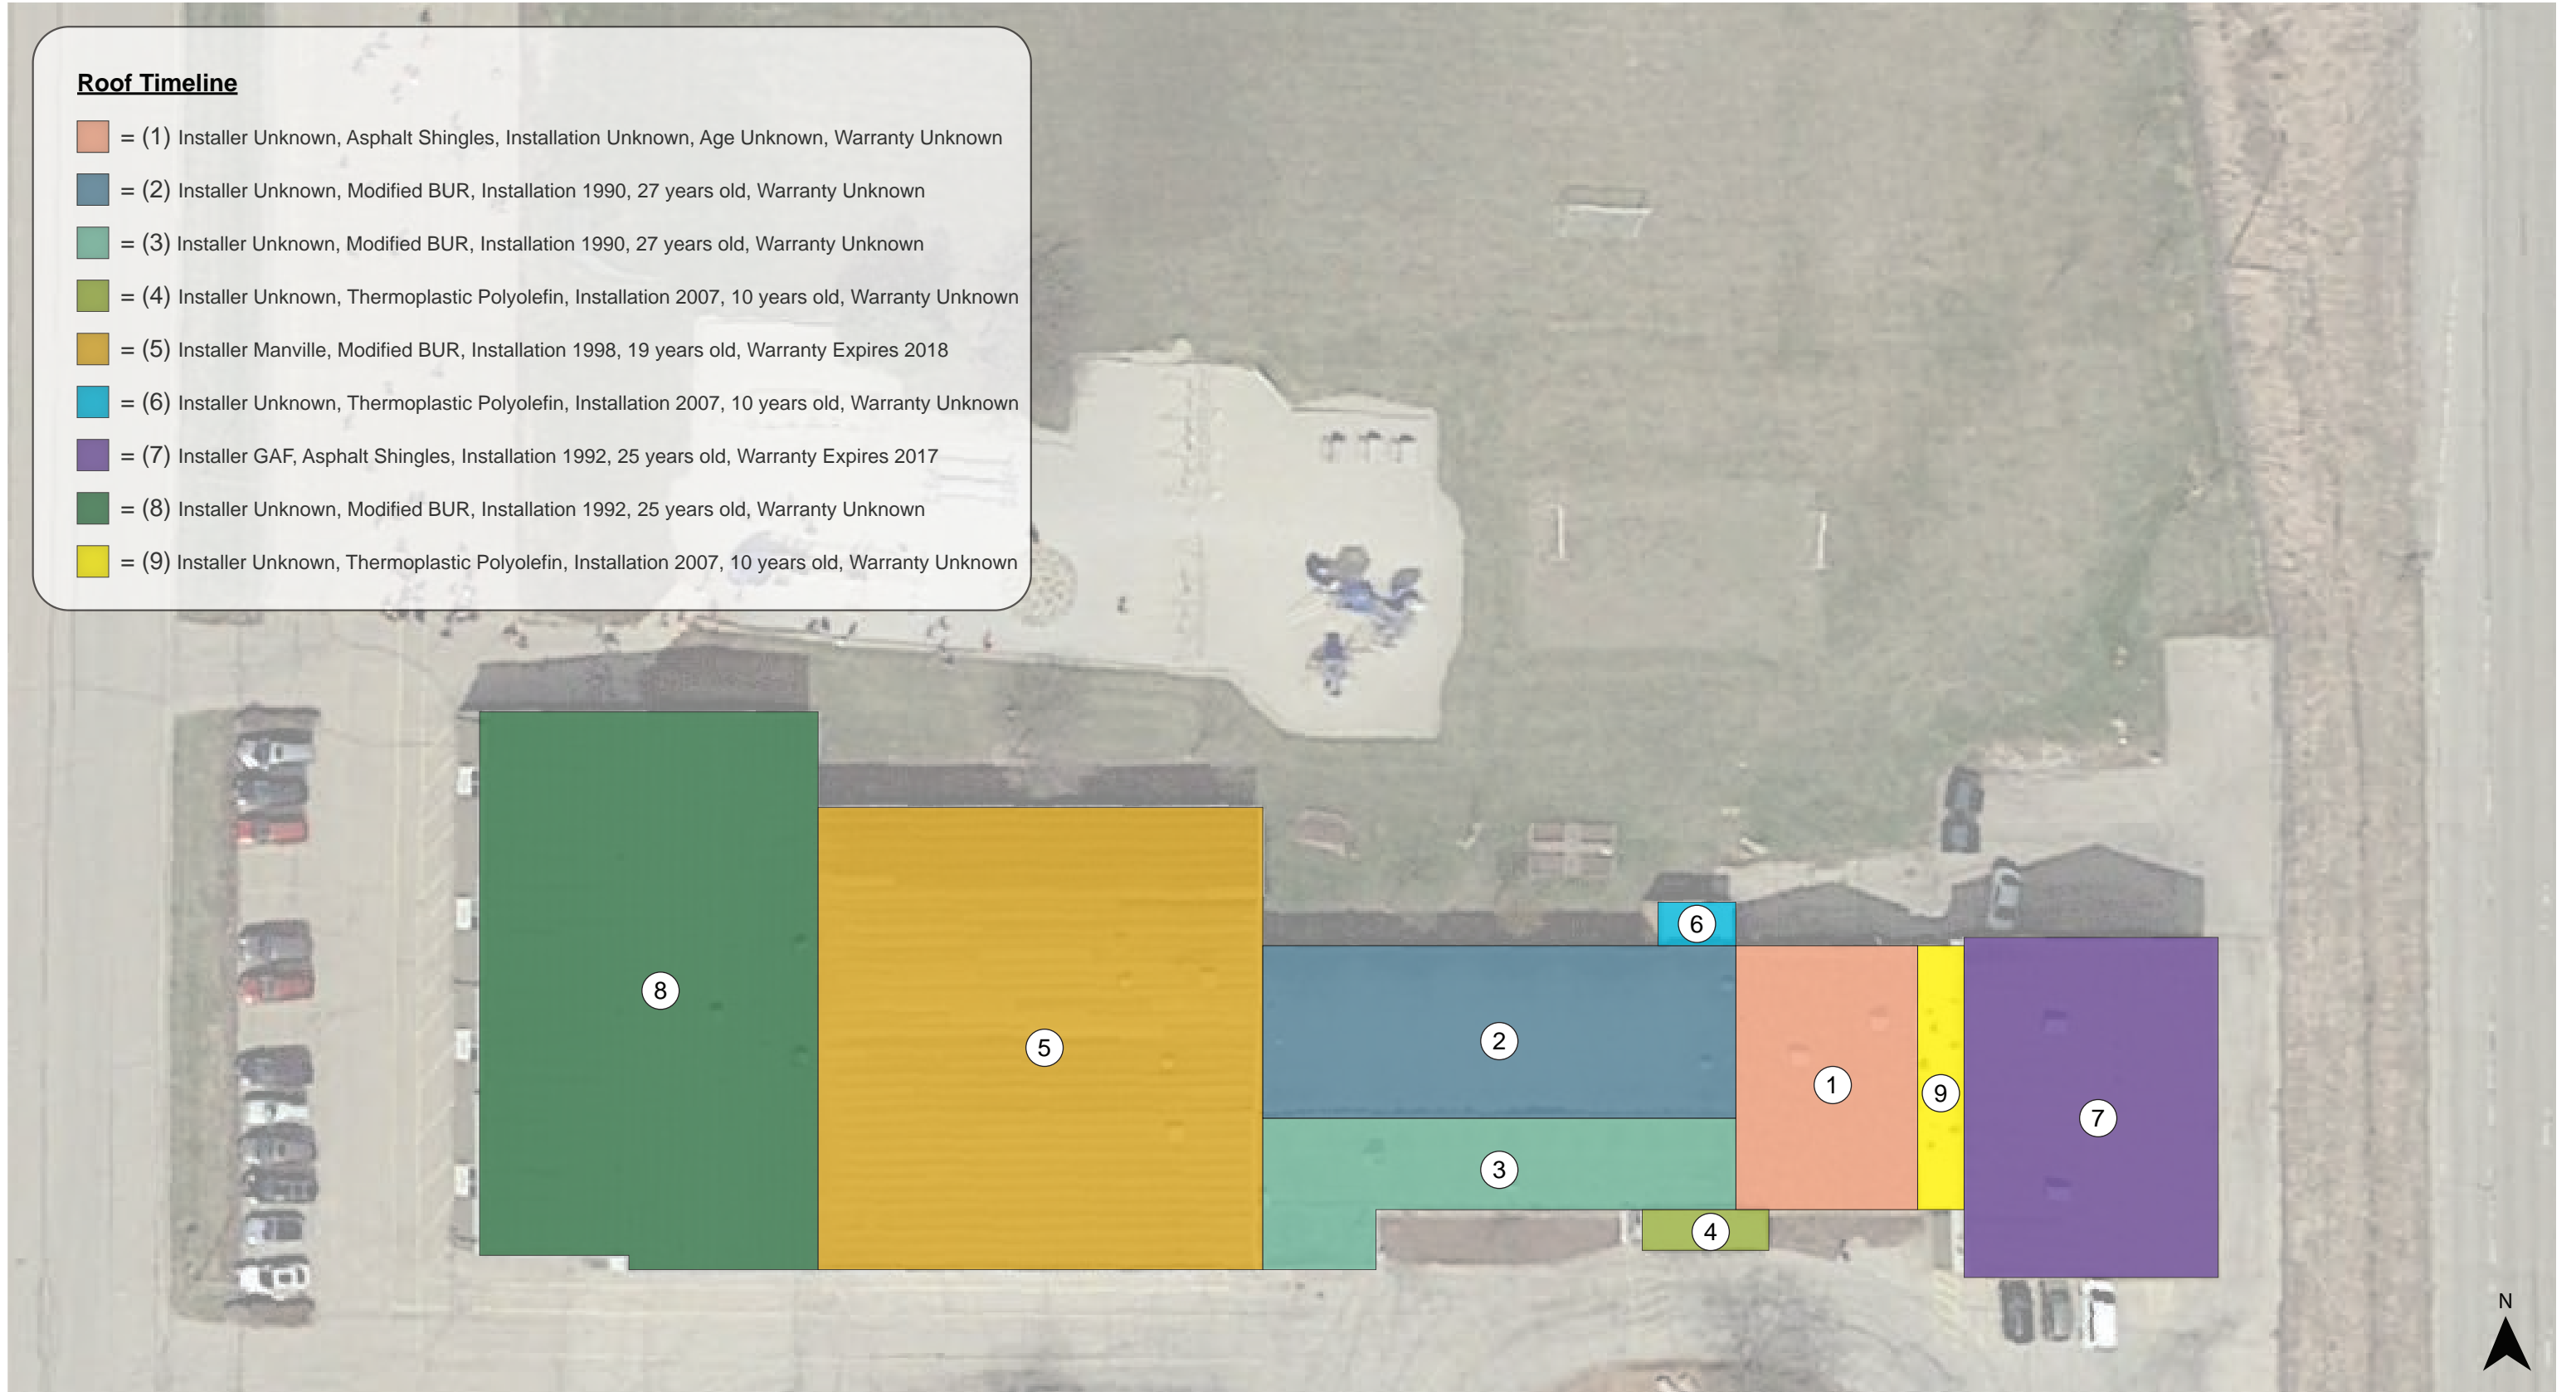
ROOF PLAN
not to scale

- = (1) Installer Unknown, Asphalt Shingles, Installation Unknown, Age Unknown, Warranty Unknown
- = (2) Installer Unknown, Modified BUR, Installation 1990, 27 years old, Warranty Unknown
- = (3) Installer Unknown, Modified BUR, Installation 1990, 27 years old, Warranty Unknown
- = (4) Installer Unknown, Thermoplastic Polyolefin, Installation 2007, 10 years old, Warranty Unknown
- = (5) Installer Manville, Modified BUR, Installation 1998, 19 years old, Warranty Expires 2018
- = (6) Installer Unknown, Thermoplastic Polyolefin, Installation 2007, 10 years old, Warranty Unknown
- = (7) Installer GAF, Asphalt Shingles, Installation 1992, 25 years old, Warranty Expires 2017
- = (8) Installer Unknown, Modified BUR, Installation 1992, 25 years old, Warranty Unknown
- = (9) Installer Unknown, Thermoplastic Polyolefin, Installation 2007, 10 years old, Warranty Unknown
