2 COOLIDGE ELEMENTARY

COOLIDGE ELEMENTARY: BUILDING EVOLUTION

COOLIDGE ELEMENTARY: BUILDING SYSTEMS SUMMARY

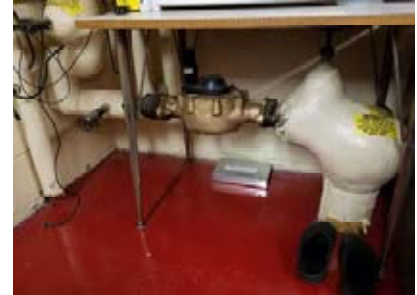
- A. Water is supplied to the building by what appears to be 2" water service which connects to the Municipal water system. There is a water meter located in the Receiving Room. The water service is at its limit and could not support any future additions.
- B. The majority of the water distribution piping in the building appears to be copper tube and fittings with some galvanized pipe and fittings in the original building. The water distribution piping appears to be in fair condition.
- C. The existing building has no fire suppression system.

- A. The water distribution piping in the original building and 1965 addition are at the end of their life expectancy. We would recommend replacing the existing pipe and fittings with new type "L" copper tube and fittings.
- B. If there are any new additions or major remodeling planned, a new larger water service will need to be provided.
- C. If a complete fire sprinkler system is preferred for the building, a new 6" water service will need to be provided.
