13 NEENAH HIGH SCHOOL

NEENAH HIGH SCHOOL: BUILDING EVOLUTION

NEENAH HIGH SCHOOL: BUILDING SYSTEMS SUMMARY

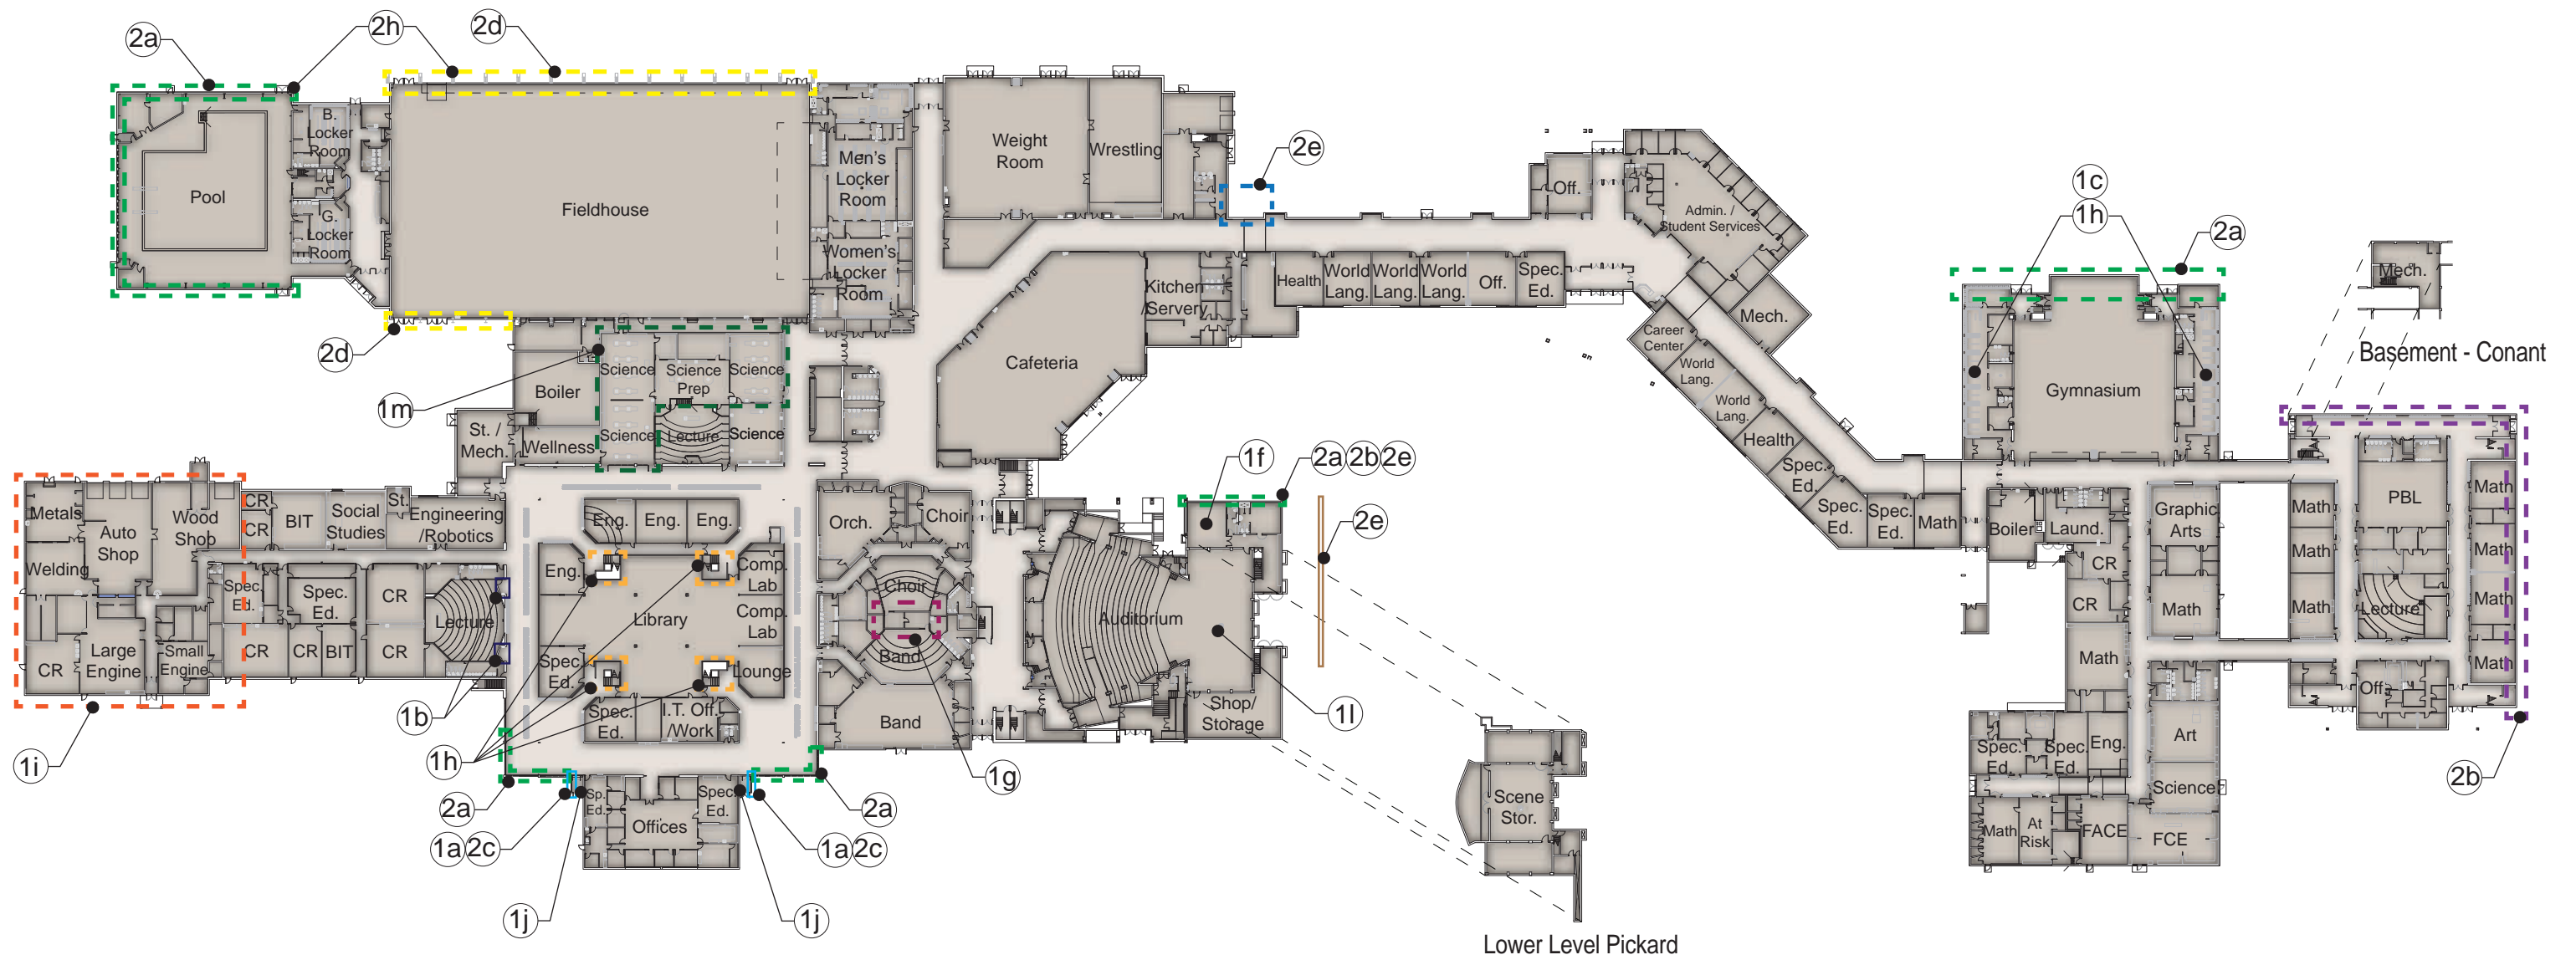
FIRST FLOOR PLAN
not to scale

- a. Some walls are cracking and have paint peeling/rubbing off, especially at the vestibules near the Library
- b. Some interior walls have staining, possibly due to water damage, and especially at the Little Theater, where staff reported issues with water leaking into the building
- c. Tile base in the Conant Locker Rooms is cracking/chipped off

- d. Some windows have metal screens on the interior that are bent, damaged and don't shut properly, especially in the Art Rooms

- e. Some ceiling tiles are dated while others are newer, with some tiles stained/showing signs of water damage and many bowing, bending and separating from the ceiling grid; there are a mix of tile types throughout the building, and some areas have ceiling tiles that are missing
- f. Staff reported that the ceiling in the Little Theater has multiple instances of water damage, where ceiling panels and acoustical material have been removed as a result
- g. Soffits in the Music Rooms have multiple openings that have been partially filled in or covered over time

- h. Treads at the stairs near the Library are extremely worn, stained, and peeling off
- i. Much of the hard-surface flooring is stained, worn, cracking/heaving, and there are multiple types of flooring throughout the building; flooring in the Technology Department is especially worn, stained and damaged
- j. Carpeting throughout the building is worn, dated and stained, especially at the vestibules near the Library
- k. Staff indicated areas of potential asbestos tile throughout the building
- l. Auditorium stage floor has multiple markings/damage from paint, and staff reported that set construction occurs on stage

- m. Some casework throughout the building is dated, worn and peeling, especially in some of the old Science classrooms/labs
- n. Locker Room lockers and benches are dated, worn, rusting and dented/damaged
- p. Pool bleachers are visibly worn, scratched, and have wood/finish peeling off

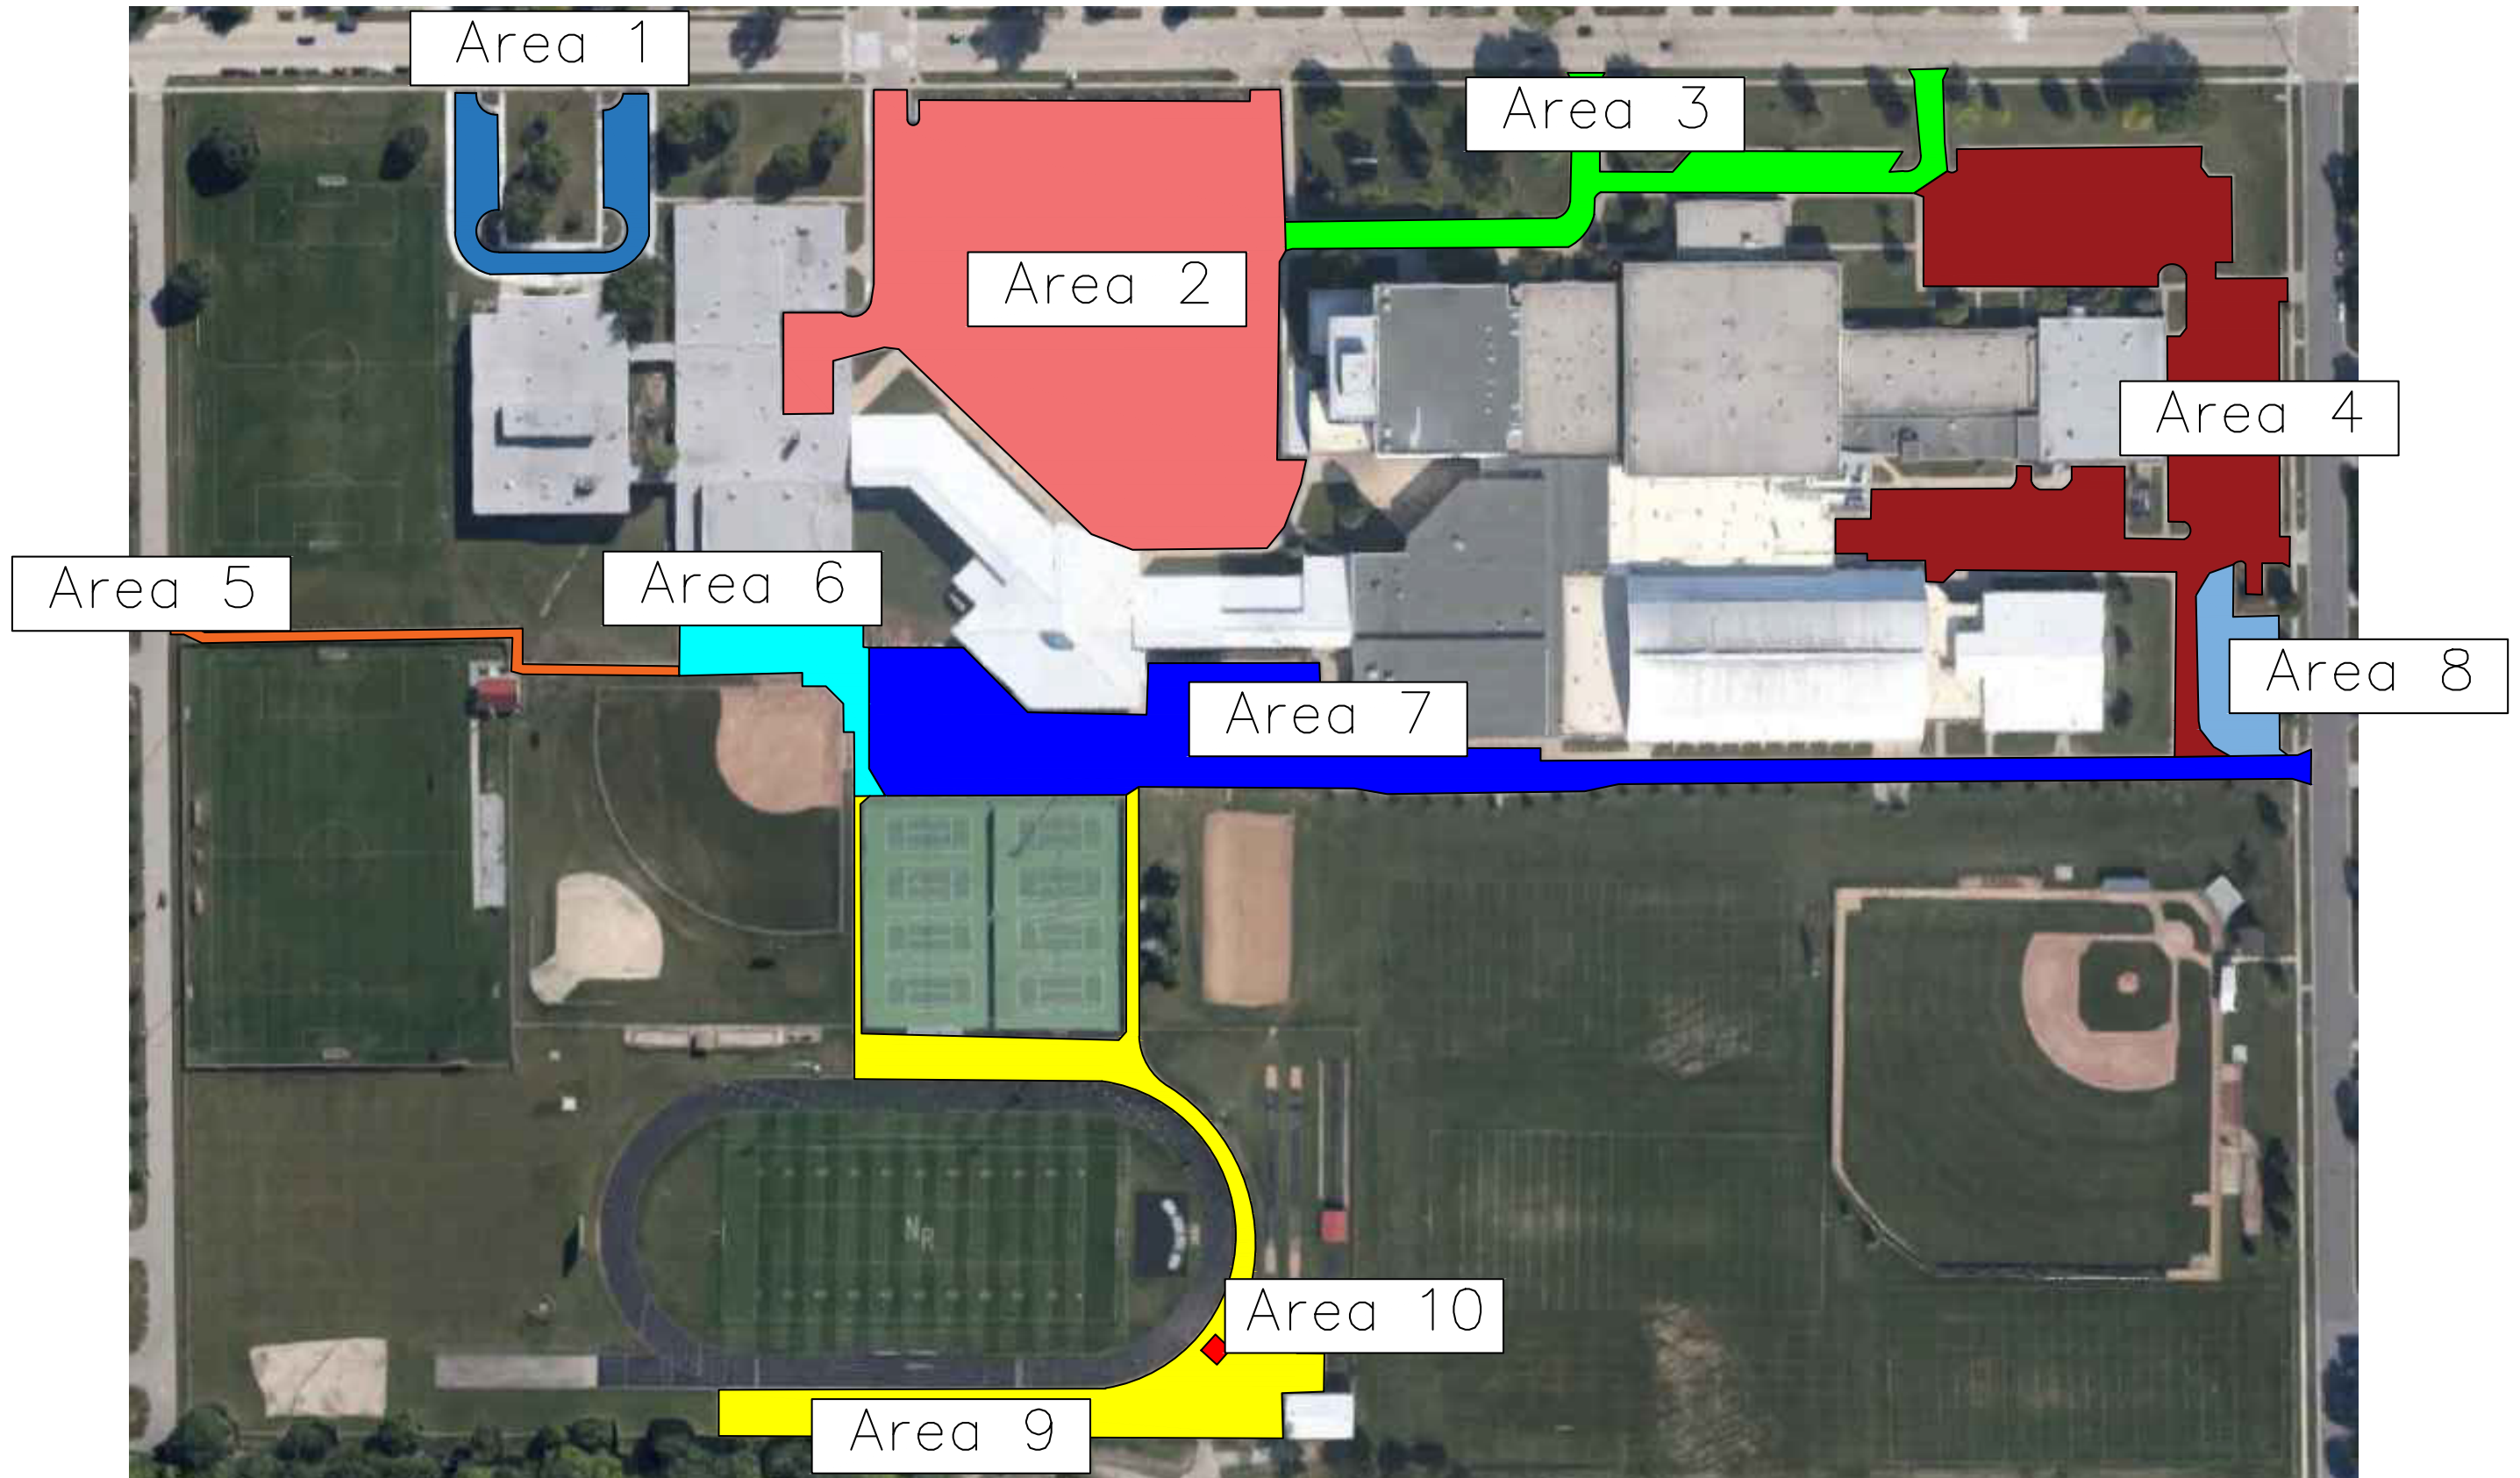
SITE PLAN
not to scale

- Benches attached to the building are dated, worn and rusting
- No dumpster enclosure exists

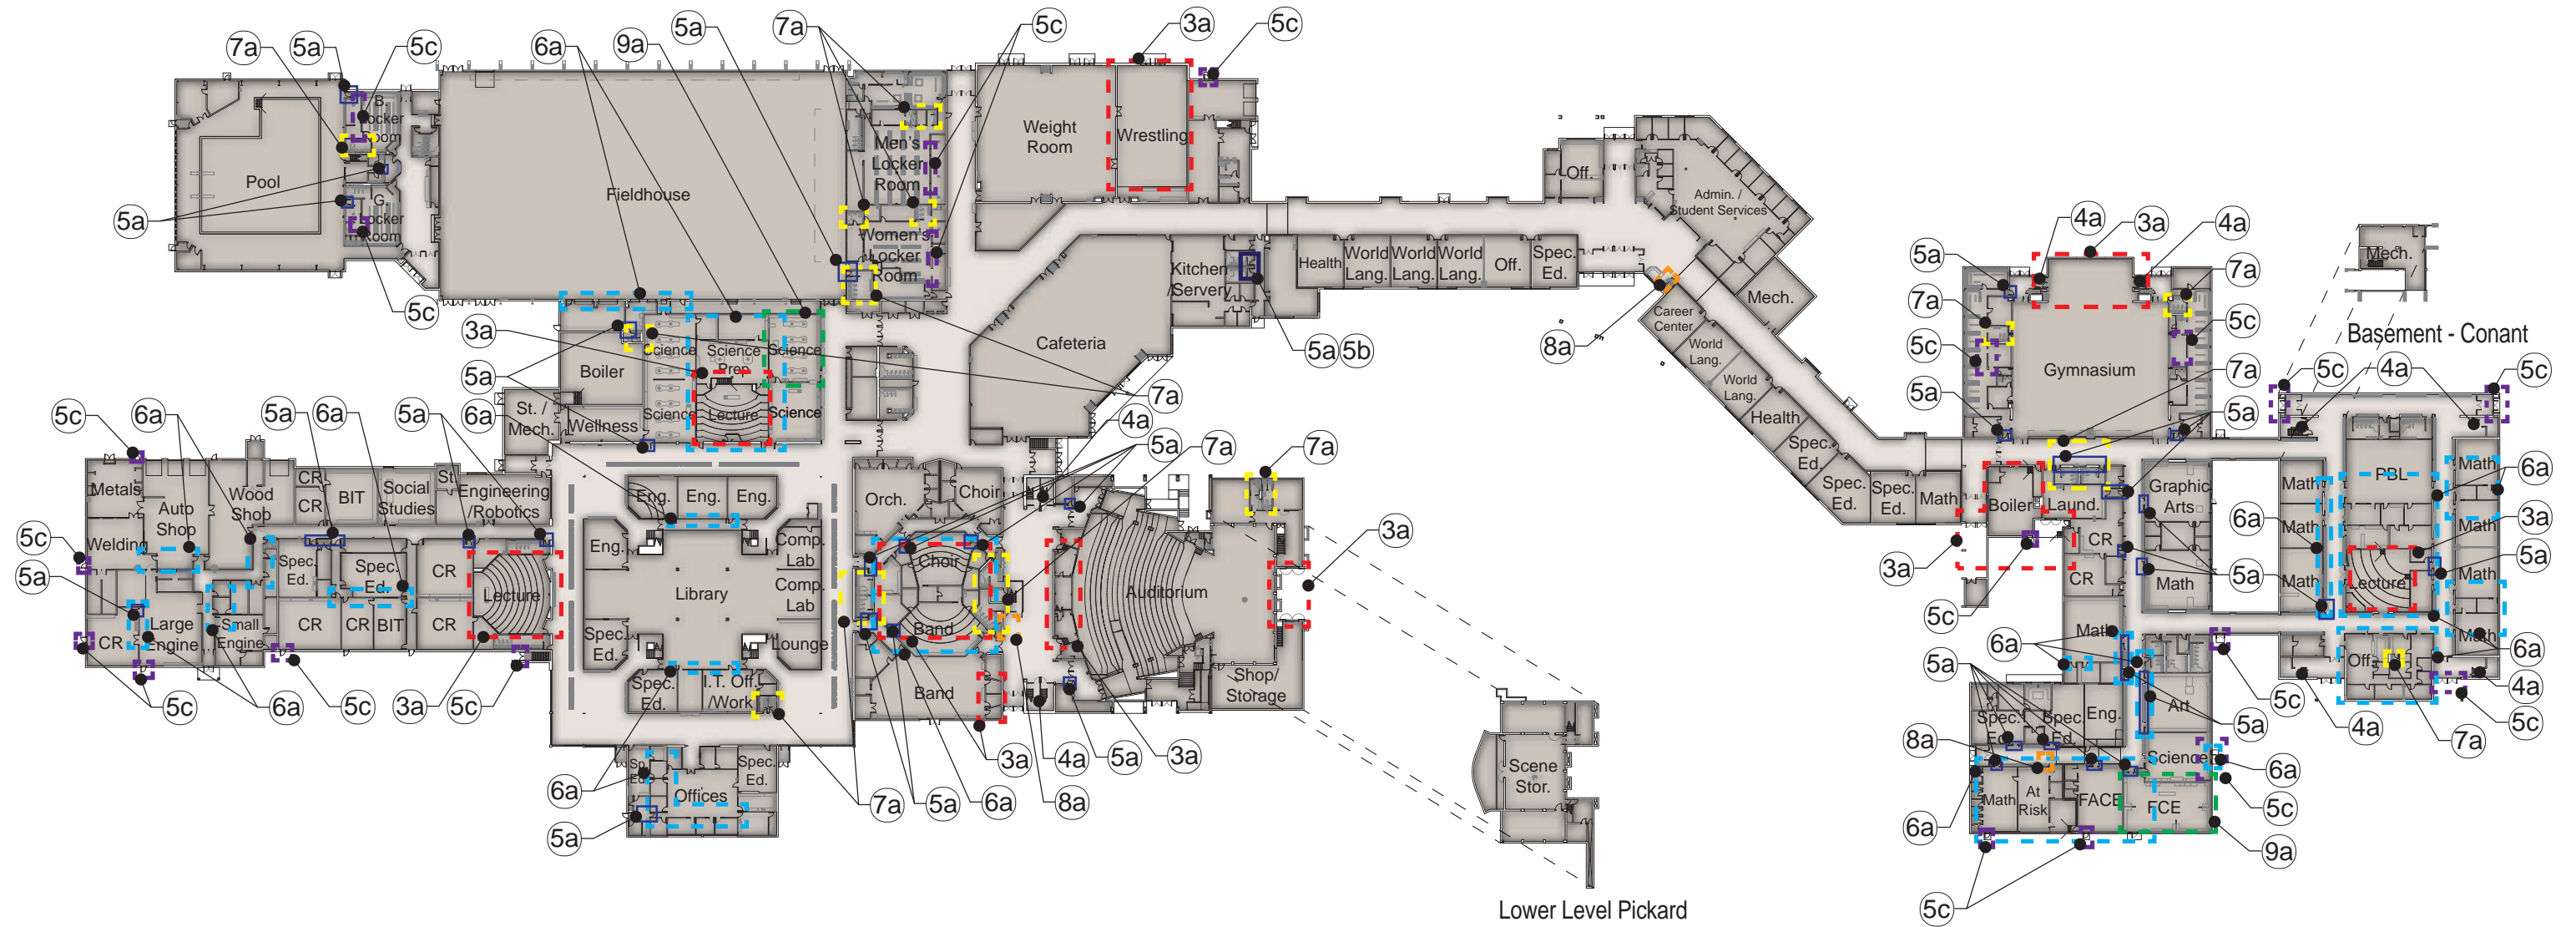
FIRST FLOOR PLAN
not to scale

9a. There are counter-tops that do not meet the above criteria for meeting accessibility standards.

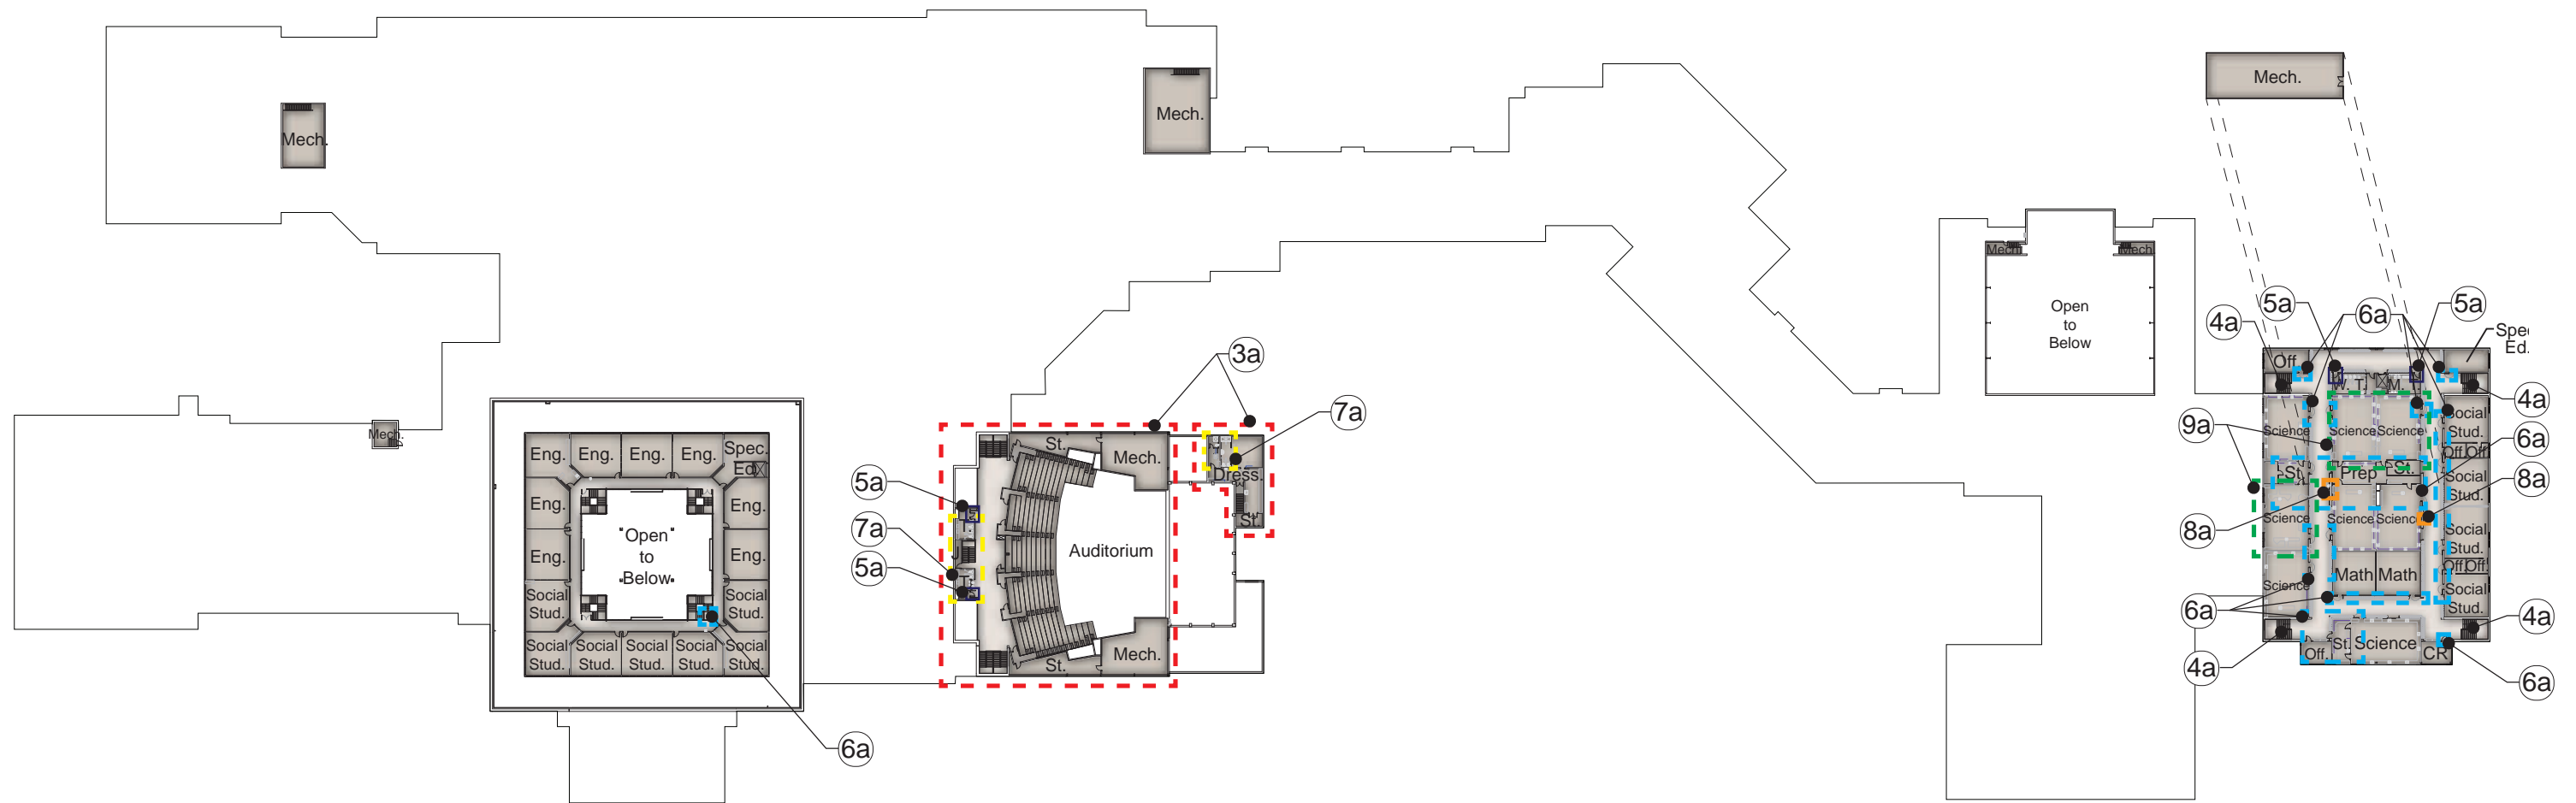
SECOND FLOOR PLAN
not to scale

9a. There are counter-tops that do not meet the above criteria for meeting accessibility standards.
