# 3 HOOVER ELEMENTARY

# HOOVER ELEMENTARY: BUILDING EVOLUTION

# HOOVER ELEMENTARY: SUMMARY OF STAFF SURVEY FEEDBACK

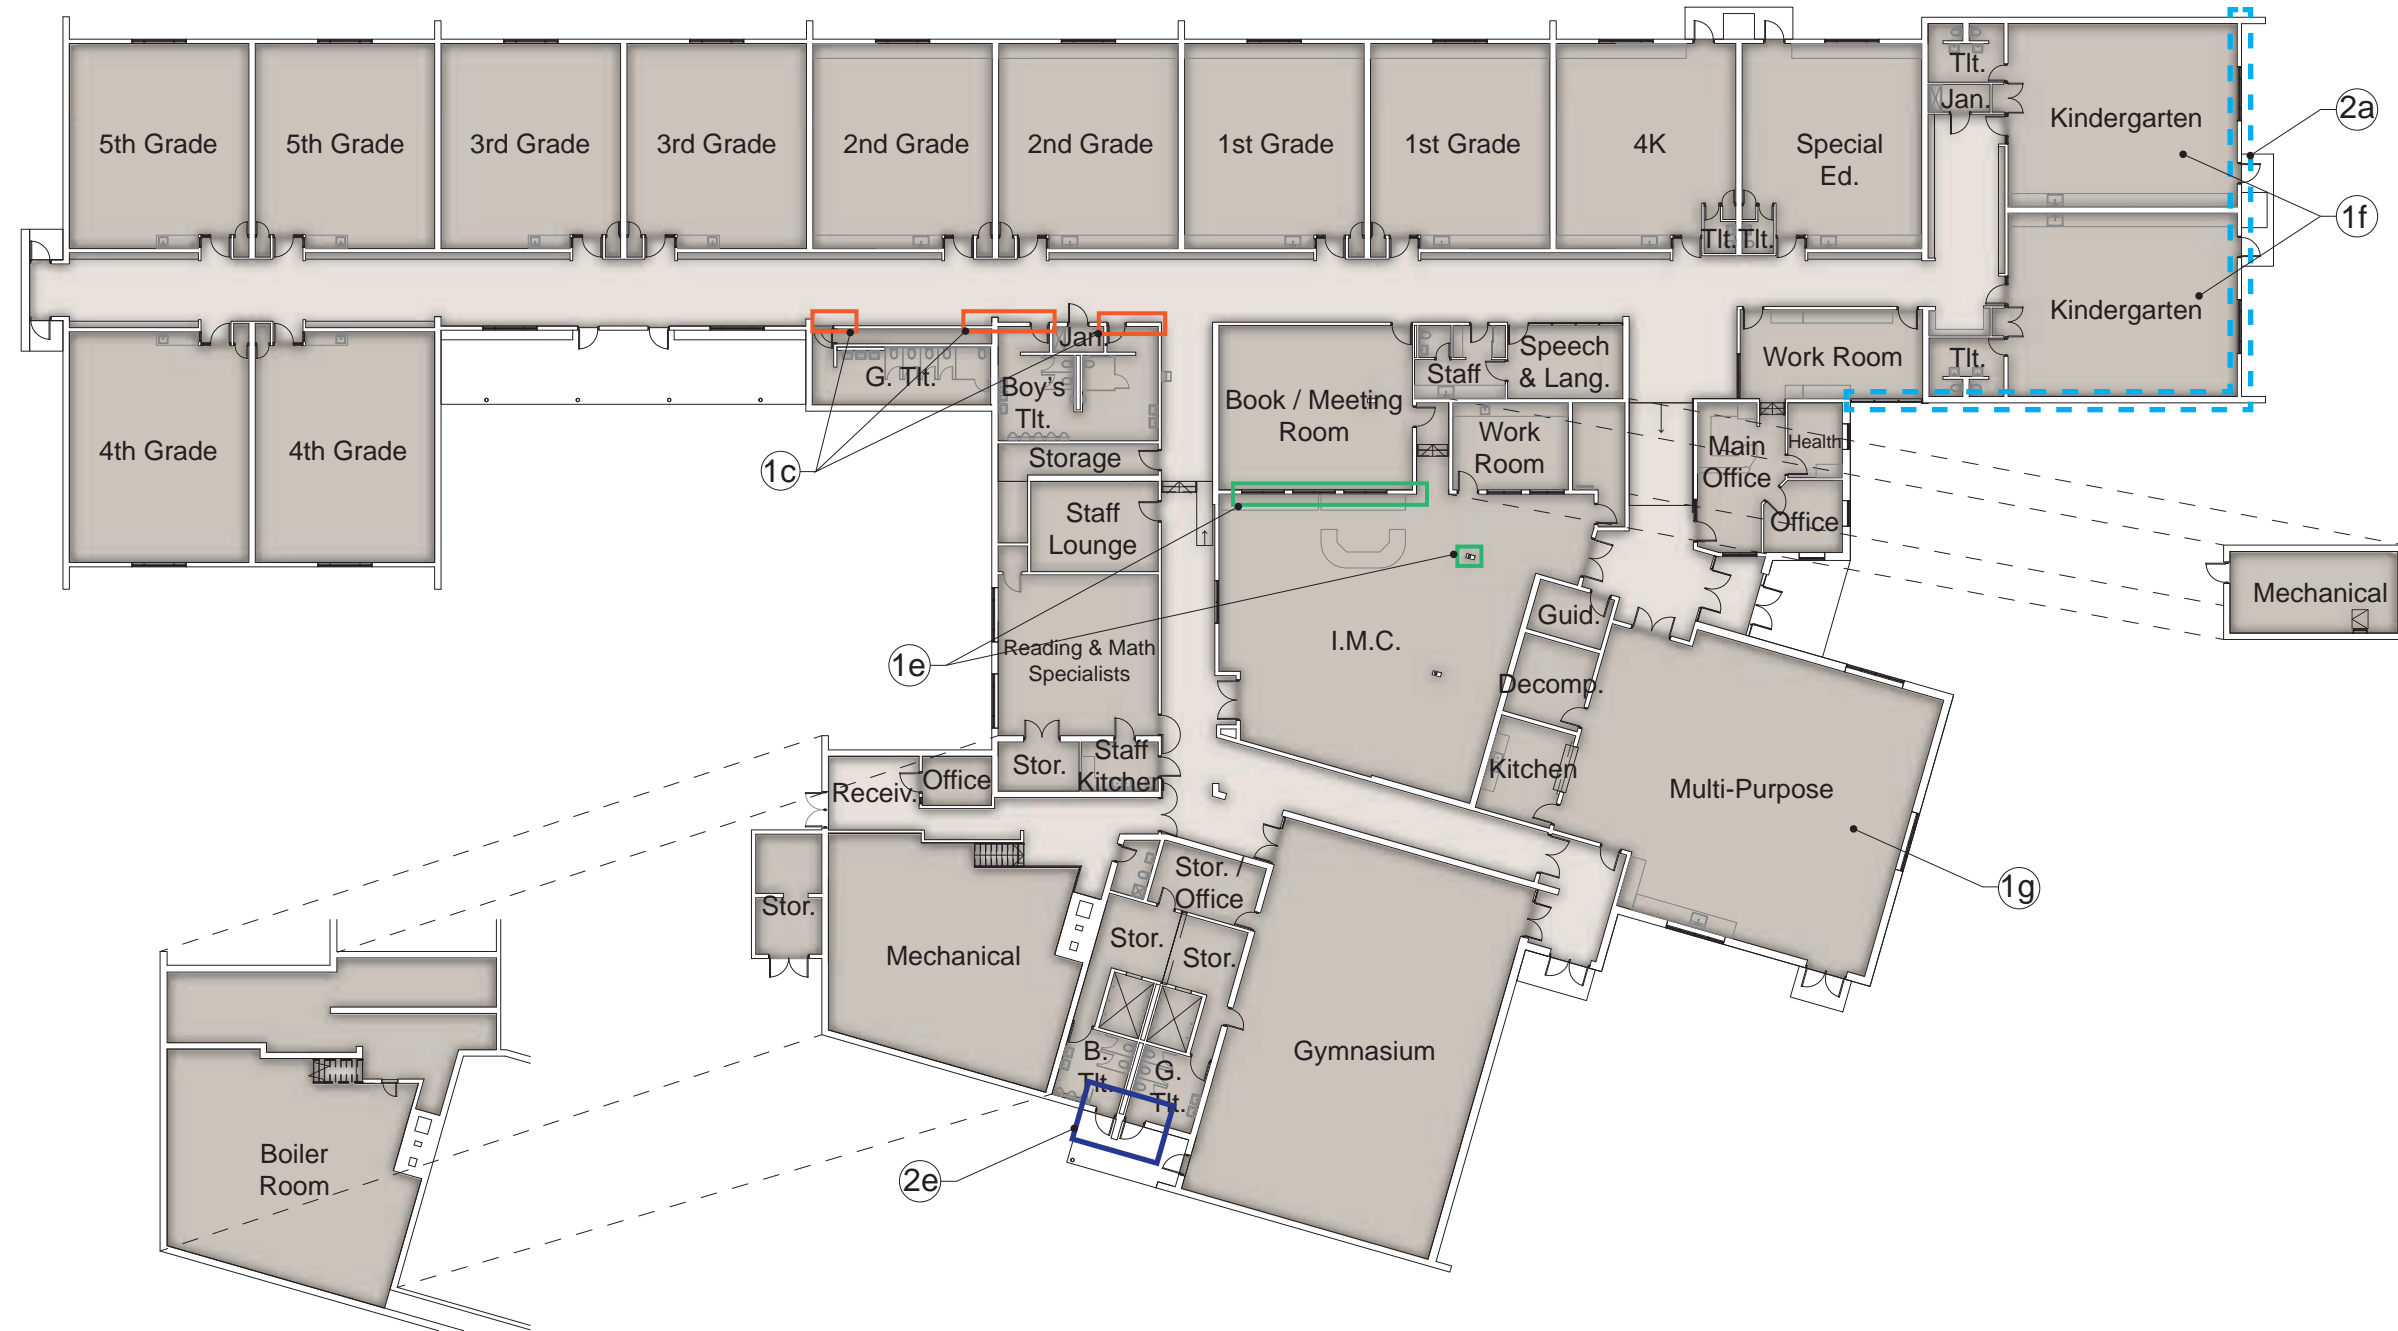
FIRST FLOOR PLAN  
not to scale

- d. Ceiling tiles are dated, with some tiles stained/showing signs of water damage and many bowing, bending and separating from the ceiling grid; there are a mix of tile types throughout the building
- e. There are areas of ceiling in the Library near the circulation desk, in which staff reported water to have leaked into the building; staining and/or paint peeling is present at these locations

- f. Carpeting in the Kindergarten classrooms is dated, worn and stained
- g. Much of the tile flooring throughout the building is dated, worn, stained, and cracking, especially in corridors and at the Cafeteria, where the flooring is heaving; tile flooring at the exterior doors is chipped/missing pieces of tile

- g. Staff indicated that while some portions of roof have been remediated/redone, there are areas of roof that have yet to be addressed and currently have problems with water leaking into the building

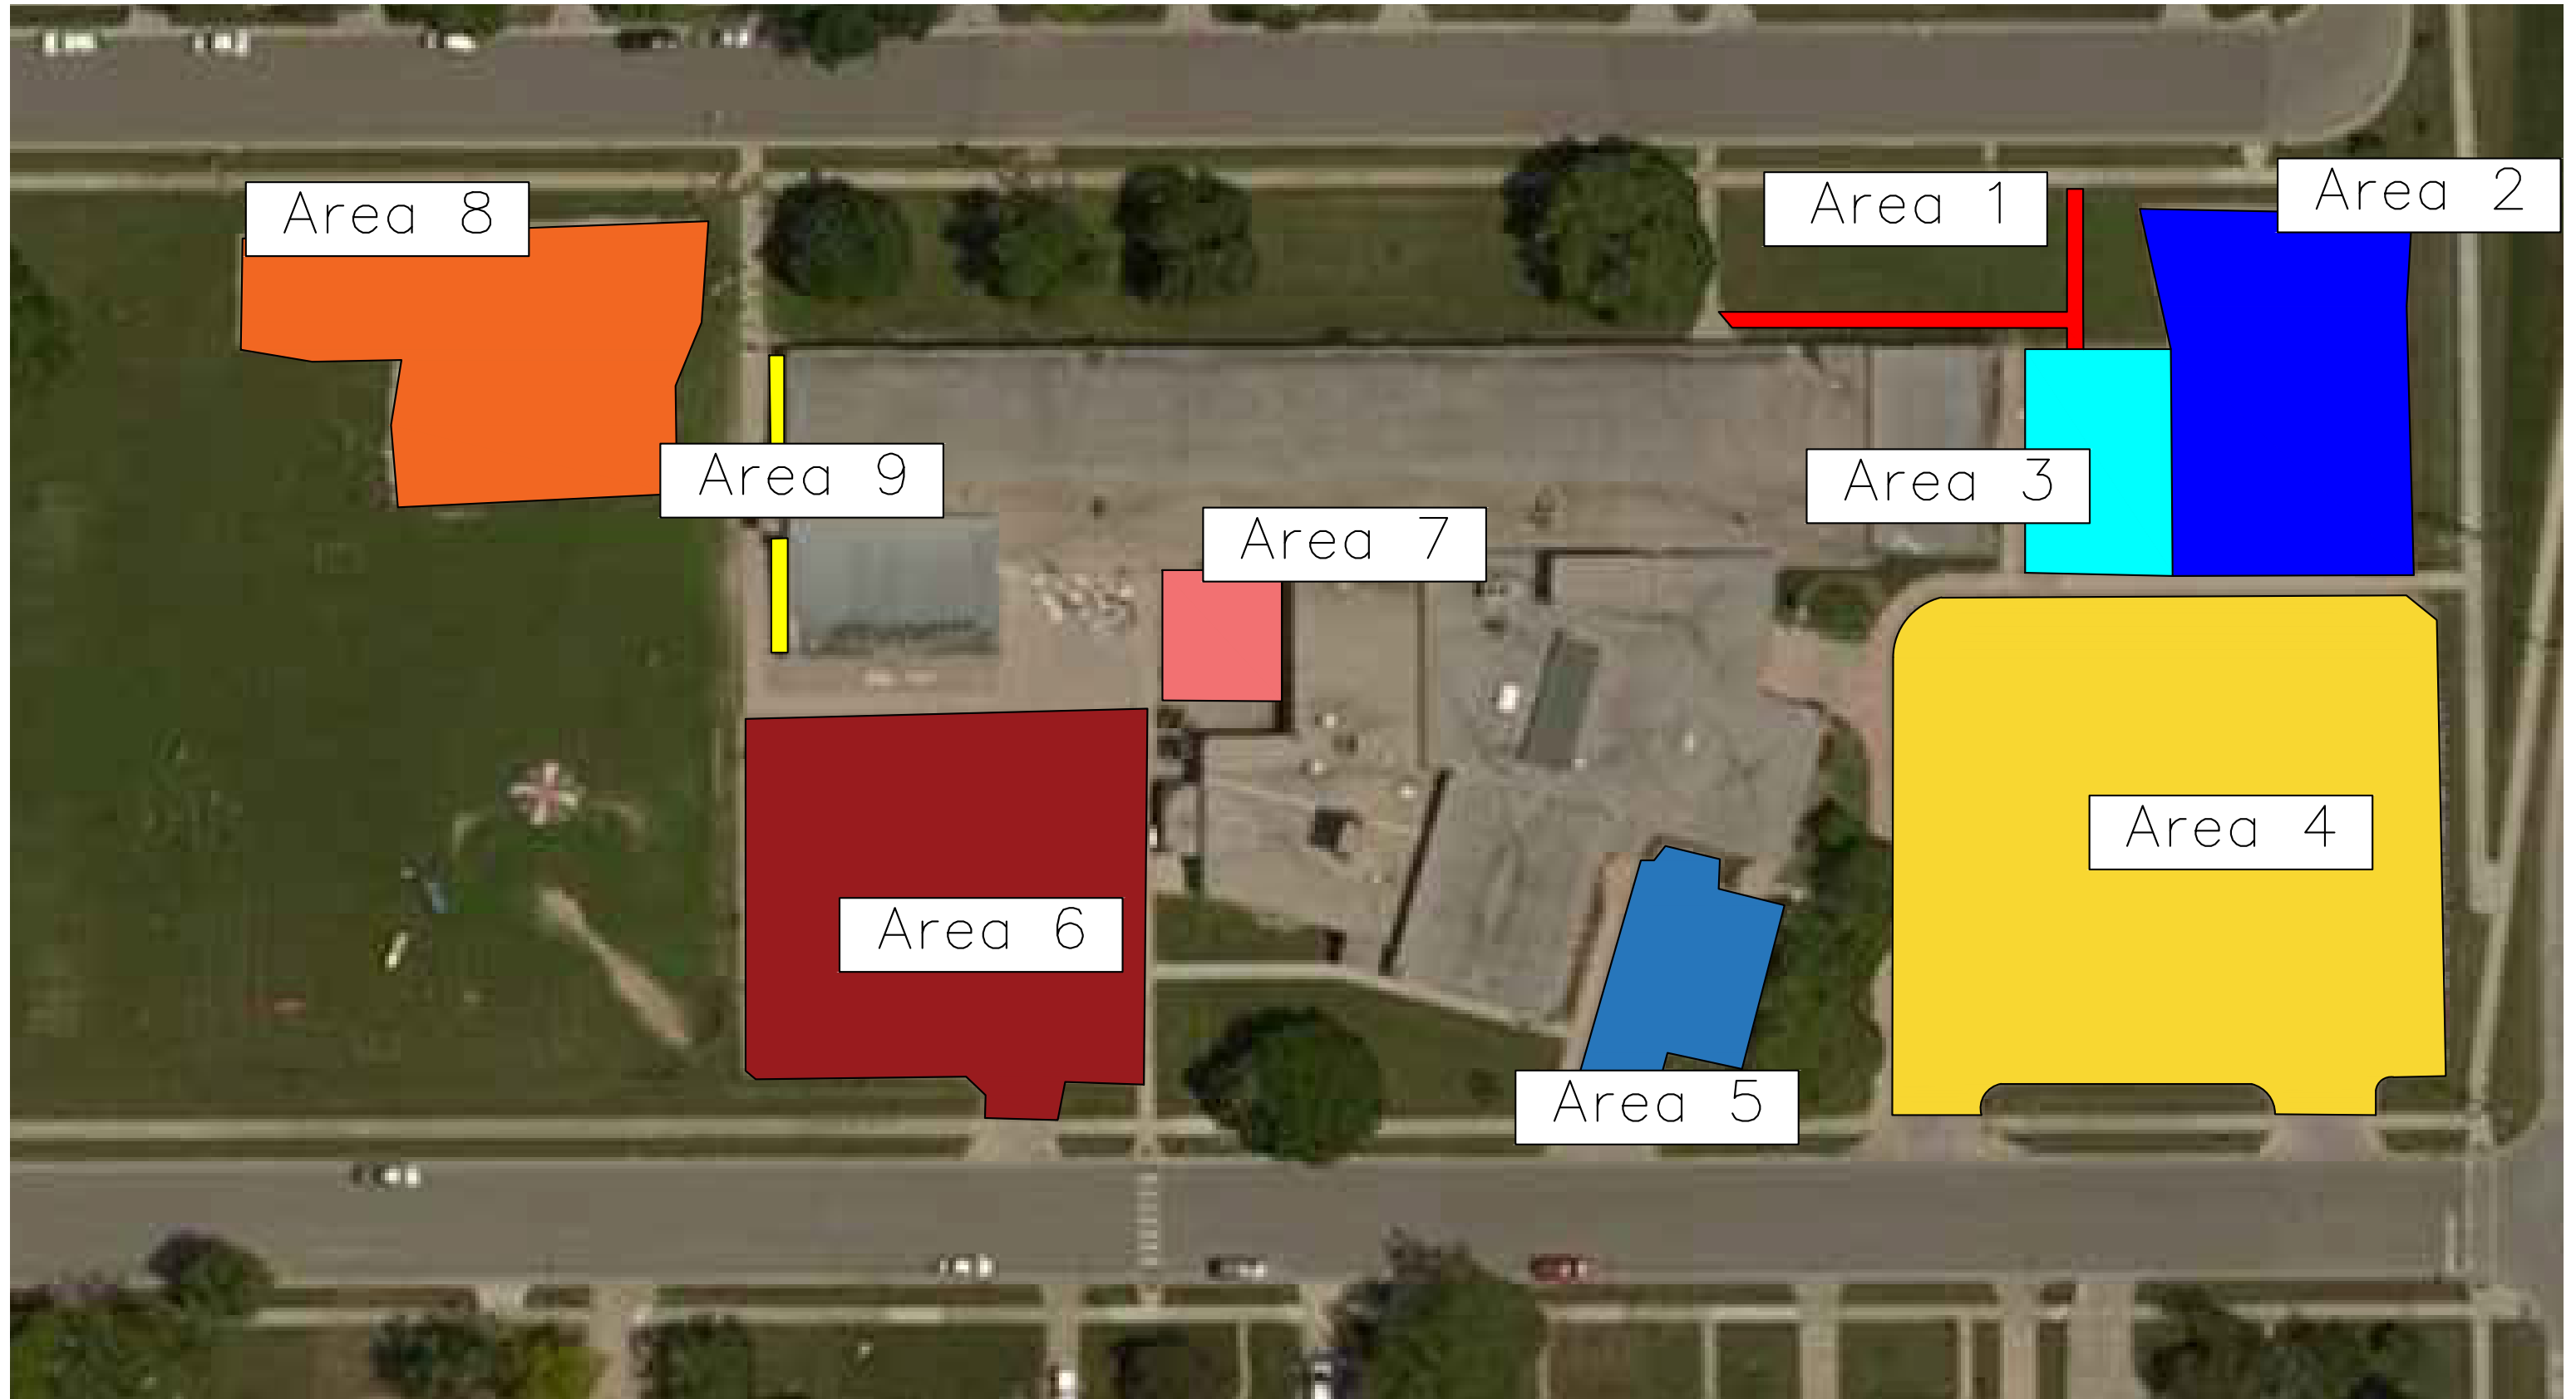
SITE PLAN  
not to scale

- Metal benches on site are dated, worn, and rusted/stained

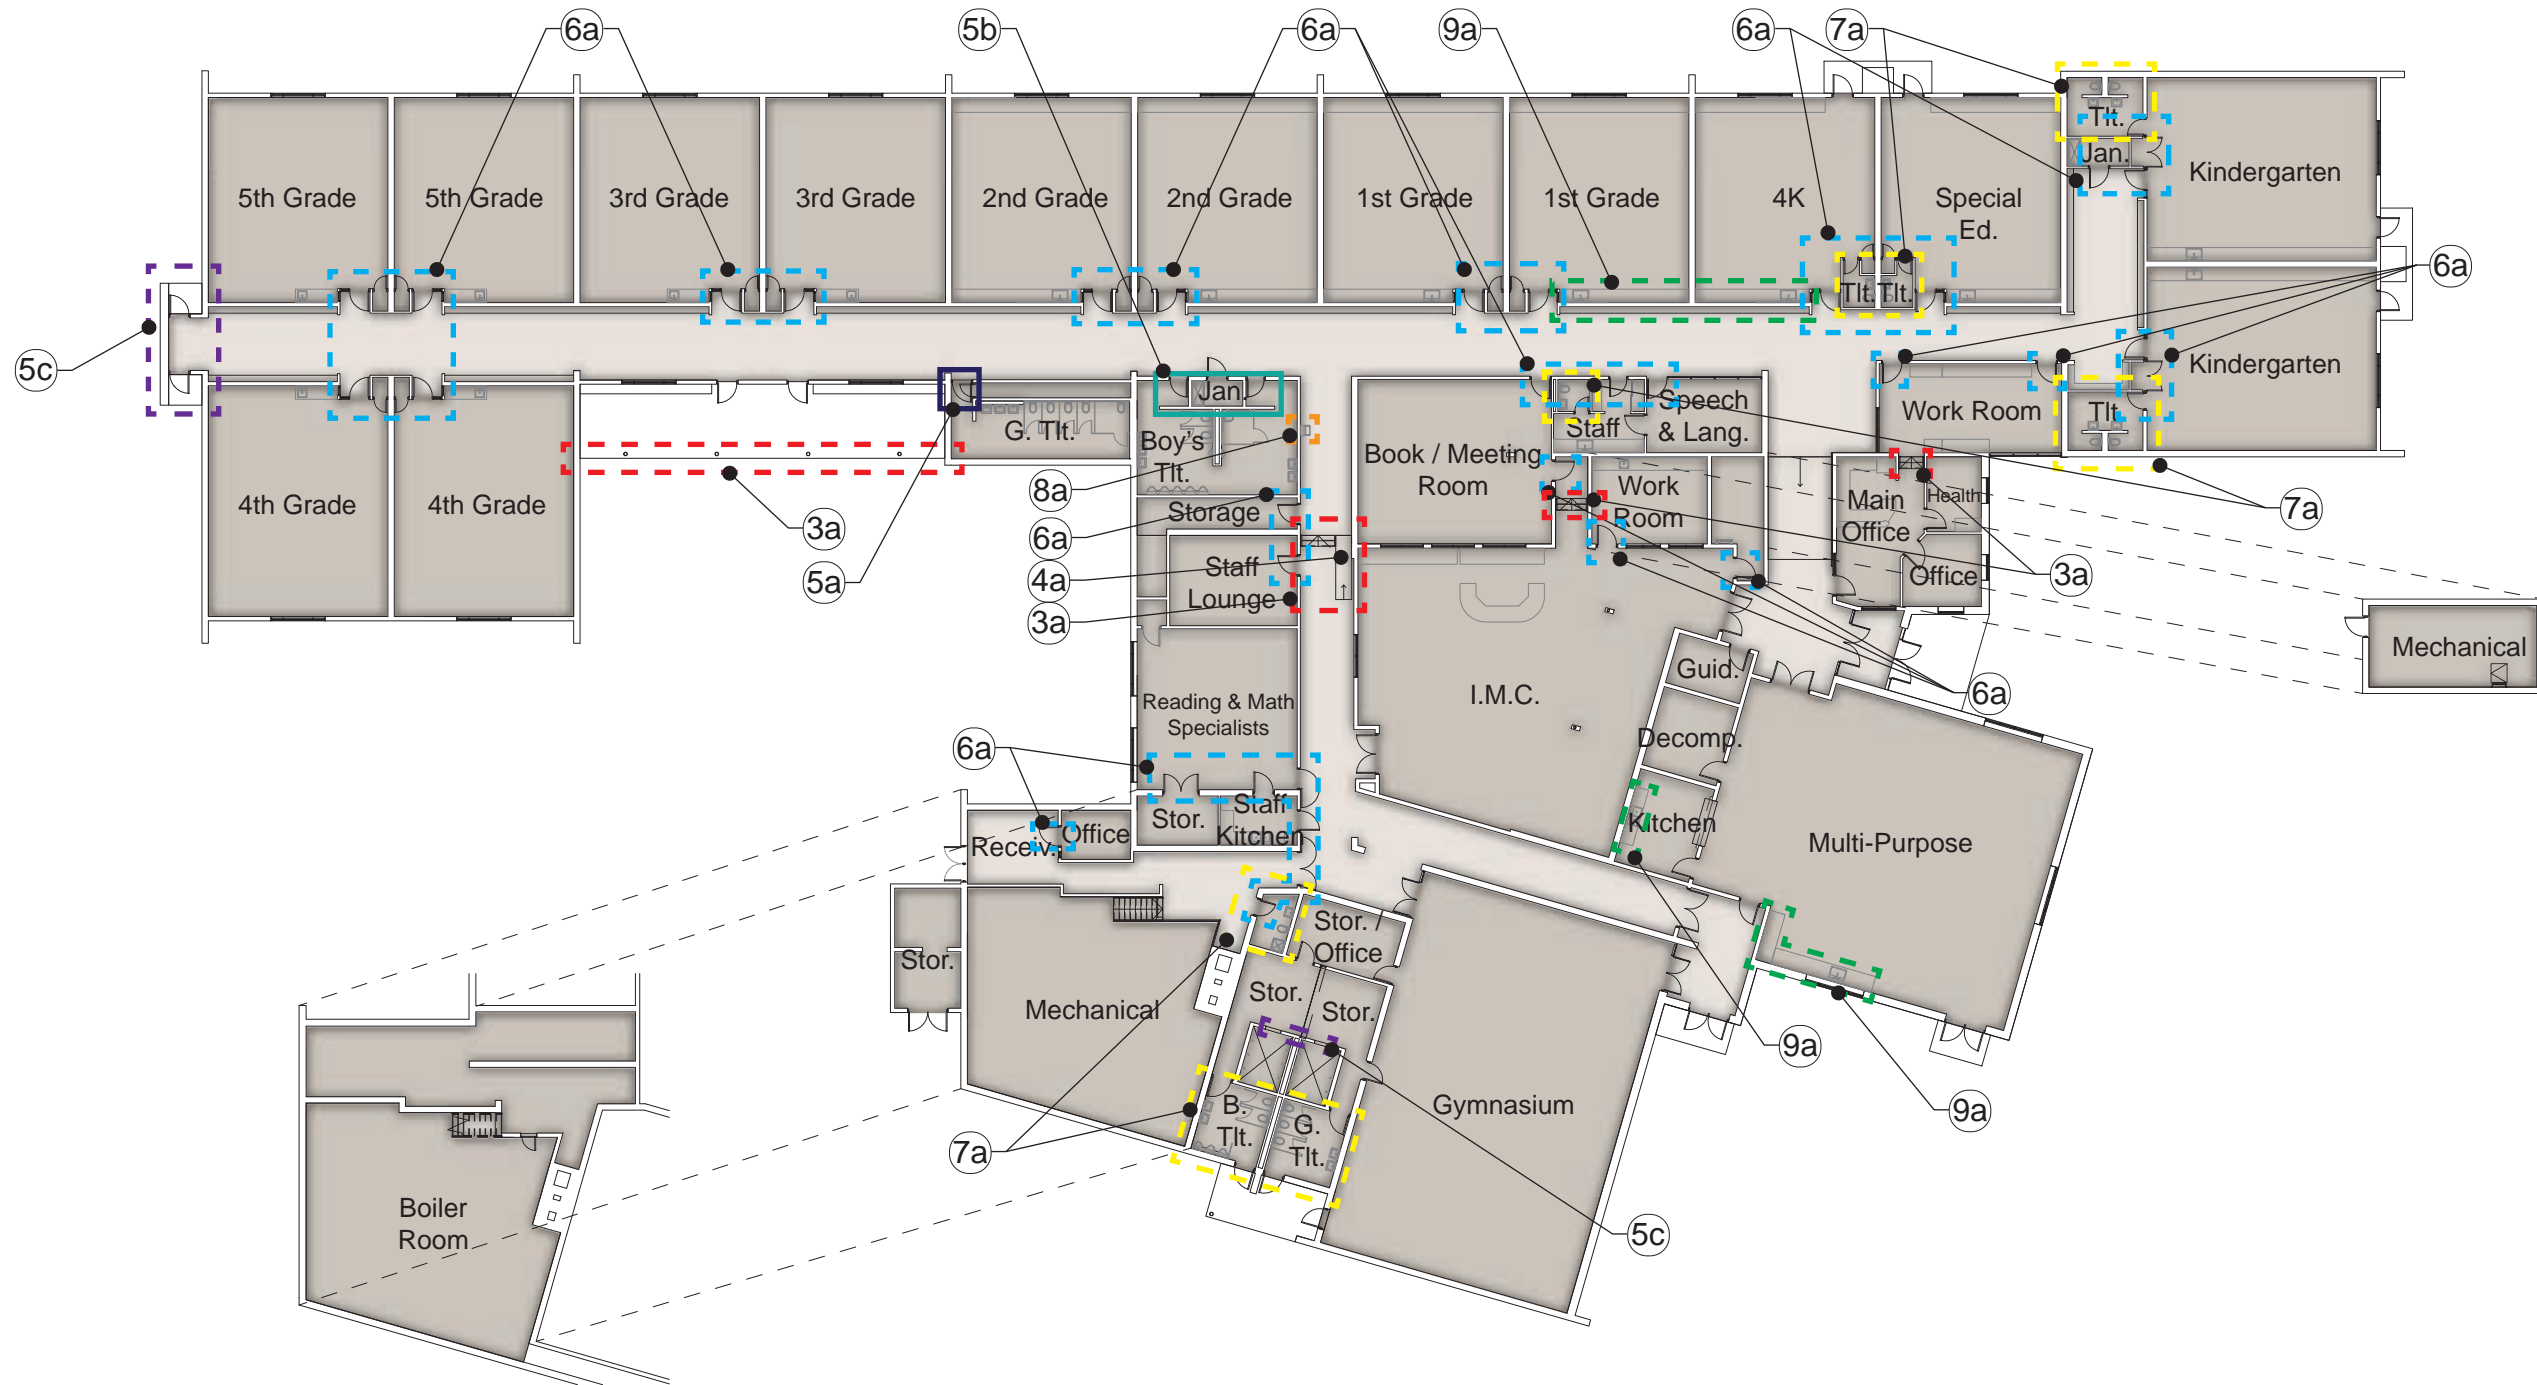
FIRST FLOOR PLAN  
not to scale

9a. There are counter-tops that do not meet the above criteria for meeting accessibility standards.
