4 LAKEVIEW ELEMENTARY

LAKEVIEW ELEMENTARY: BUILDING EVOLUTION

LAKEVIEW ELEMENTARY: BUILDING SYSTEMS SUMMARY

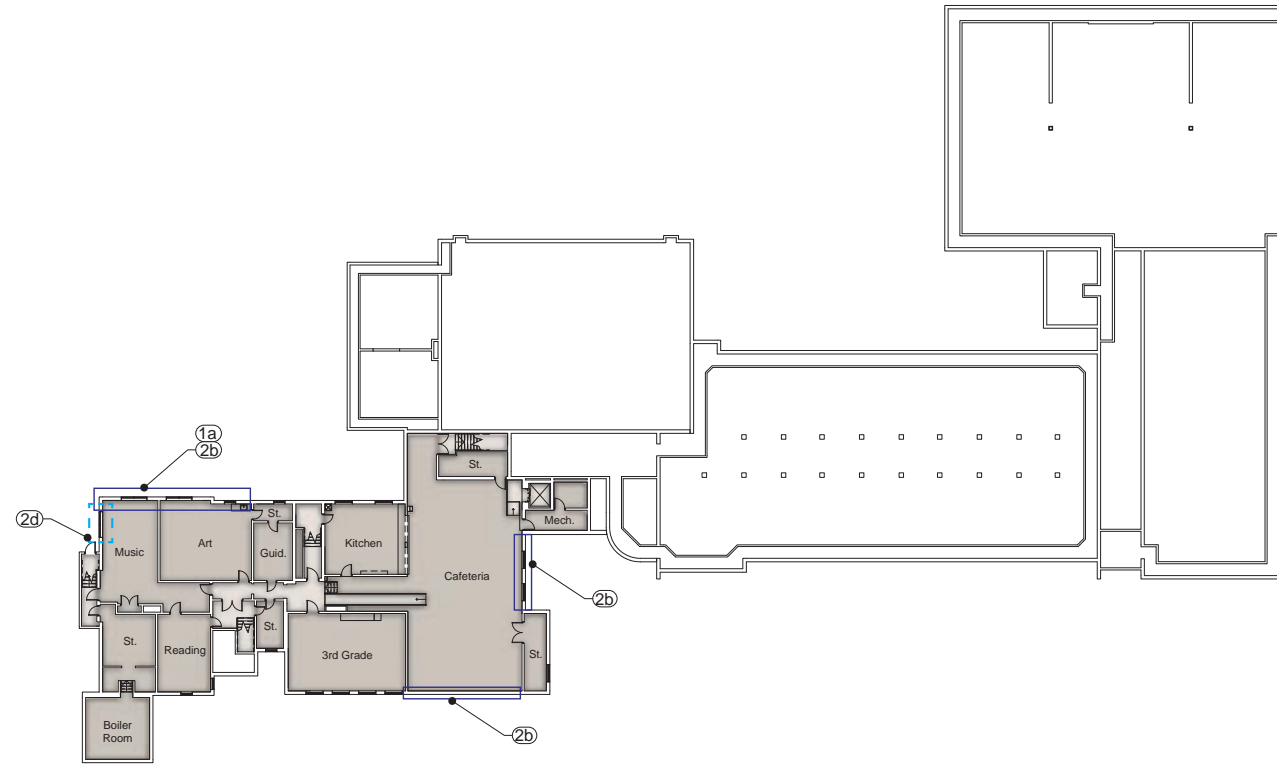
LOWER FLOOR PLAN
not to scale

- a. Exterior walls in the lower level of the building are cracking, and there were indications that water leaks into the building at these areas
- b. Classrooms on the East side of the building have cracking within the exterior walls and along the window frames

- c. Ceiling tiles are dated, with some tiles stained/showing signs of water damage and many bowing, bending and separating from the ceiling grid; there are a mix of tile types throughout the building

- d. Much of the hard-surface flooring is stained, worn, cracking/heaving and in need of repair; there are multiple types of flooring throughout the building
- e. There appears to be areas of potential asbestos tile throughout the building where 9"x9" tile flooring is present, and there were indications that some of these areas might have been covered with carpeting

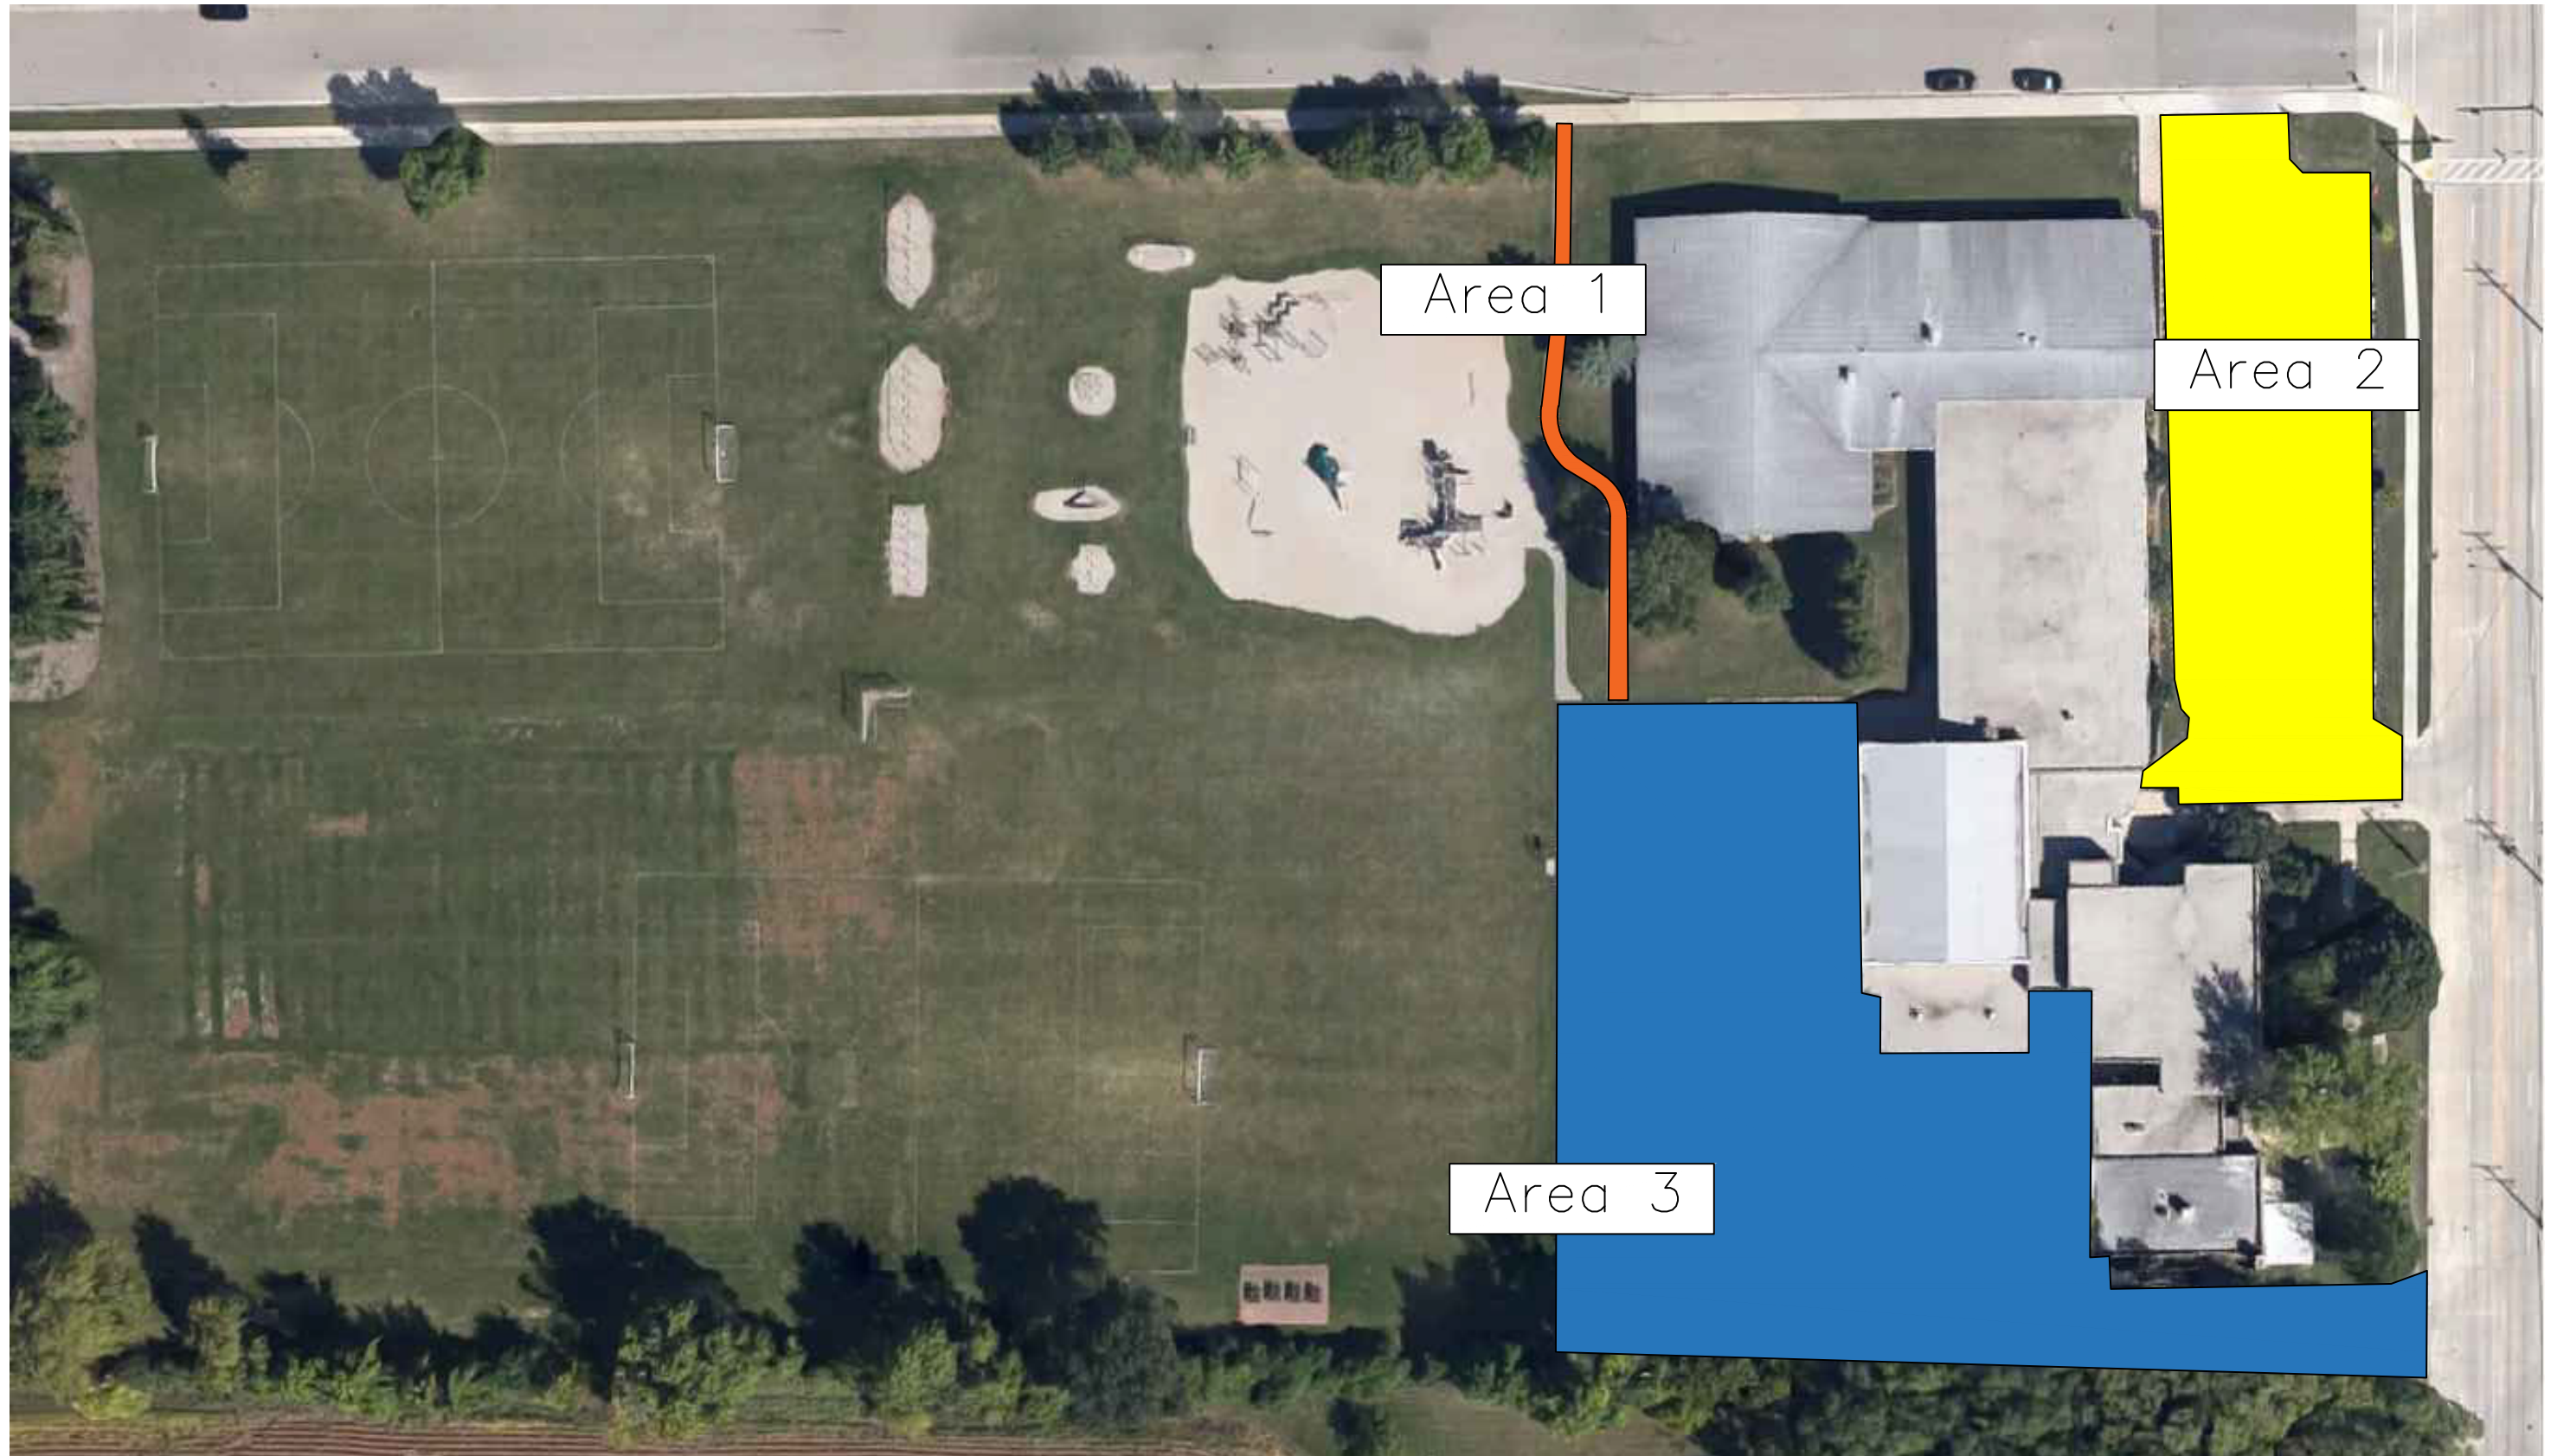
SITE PLAN
not to scale

- Distresses Present:
 - Thermal cracking
 - Surface weathering
- Recommended Repair:
 - Crack fill
 - Seal coat

- No dumpster enclosure exists
- Spiders are a concern as indicated by staff
- Staff indicated most recent pavement patching was done at the bus area this past summer

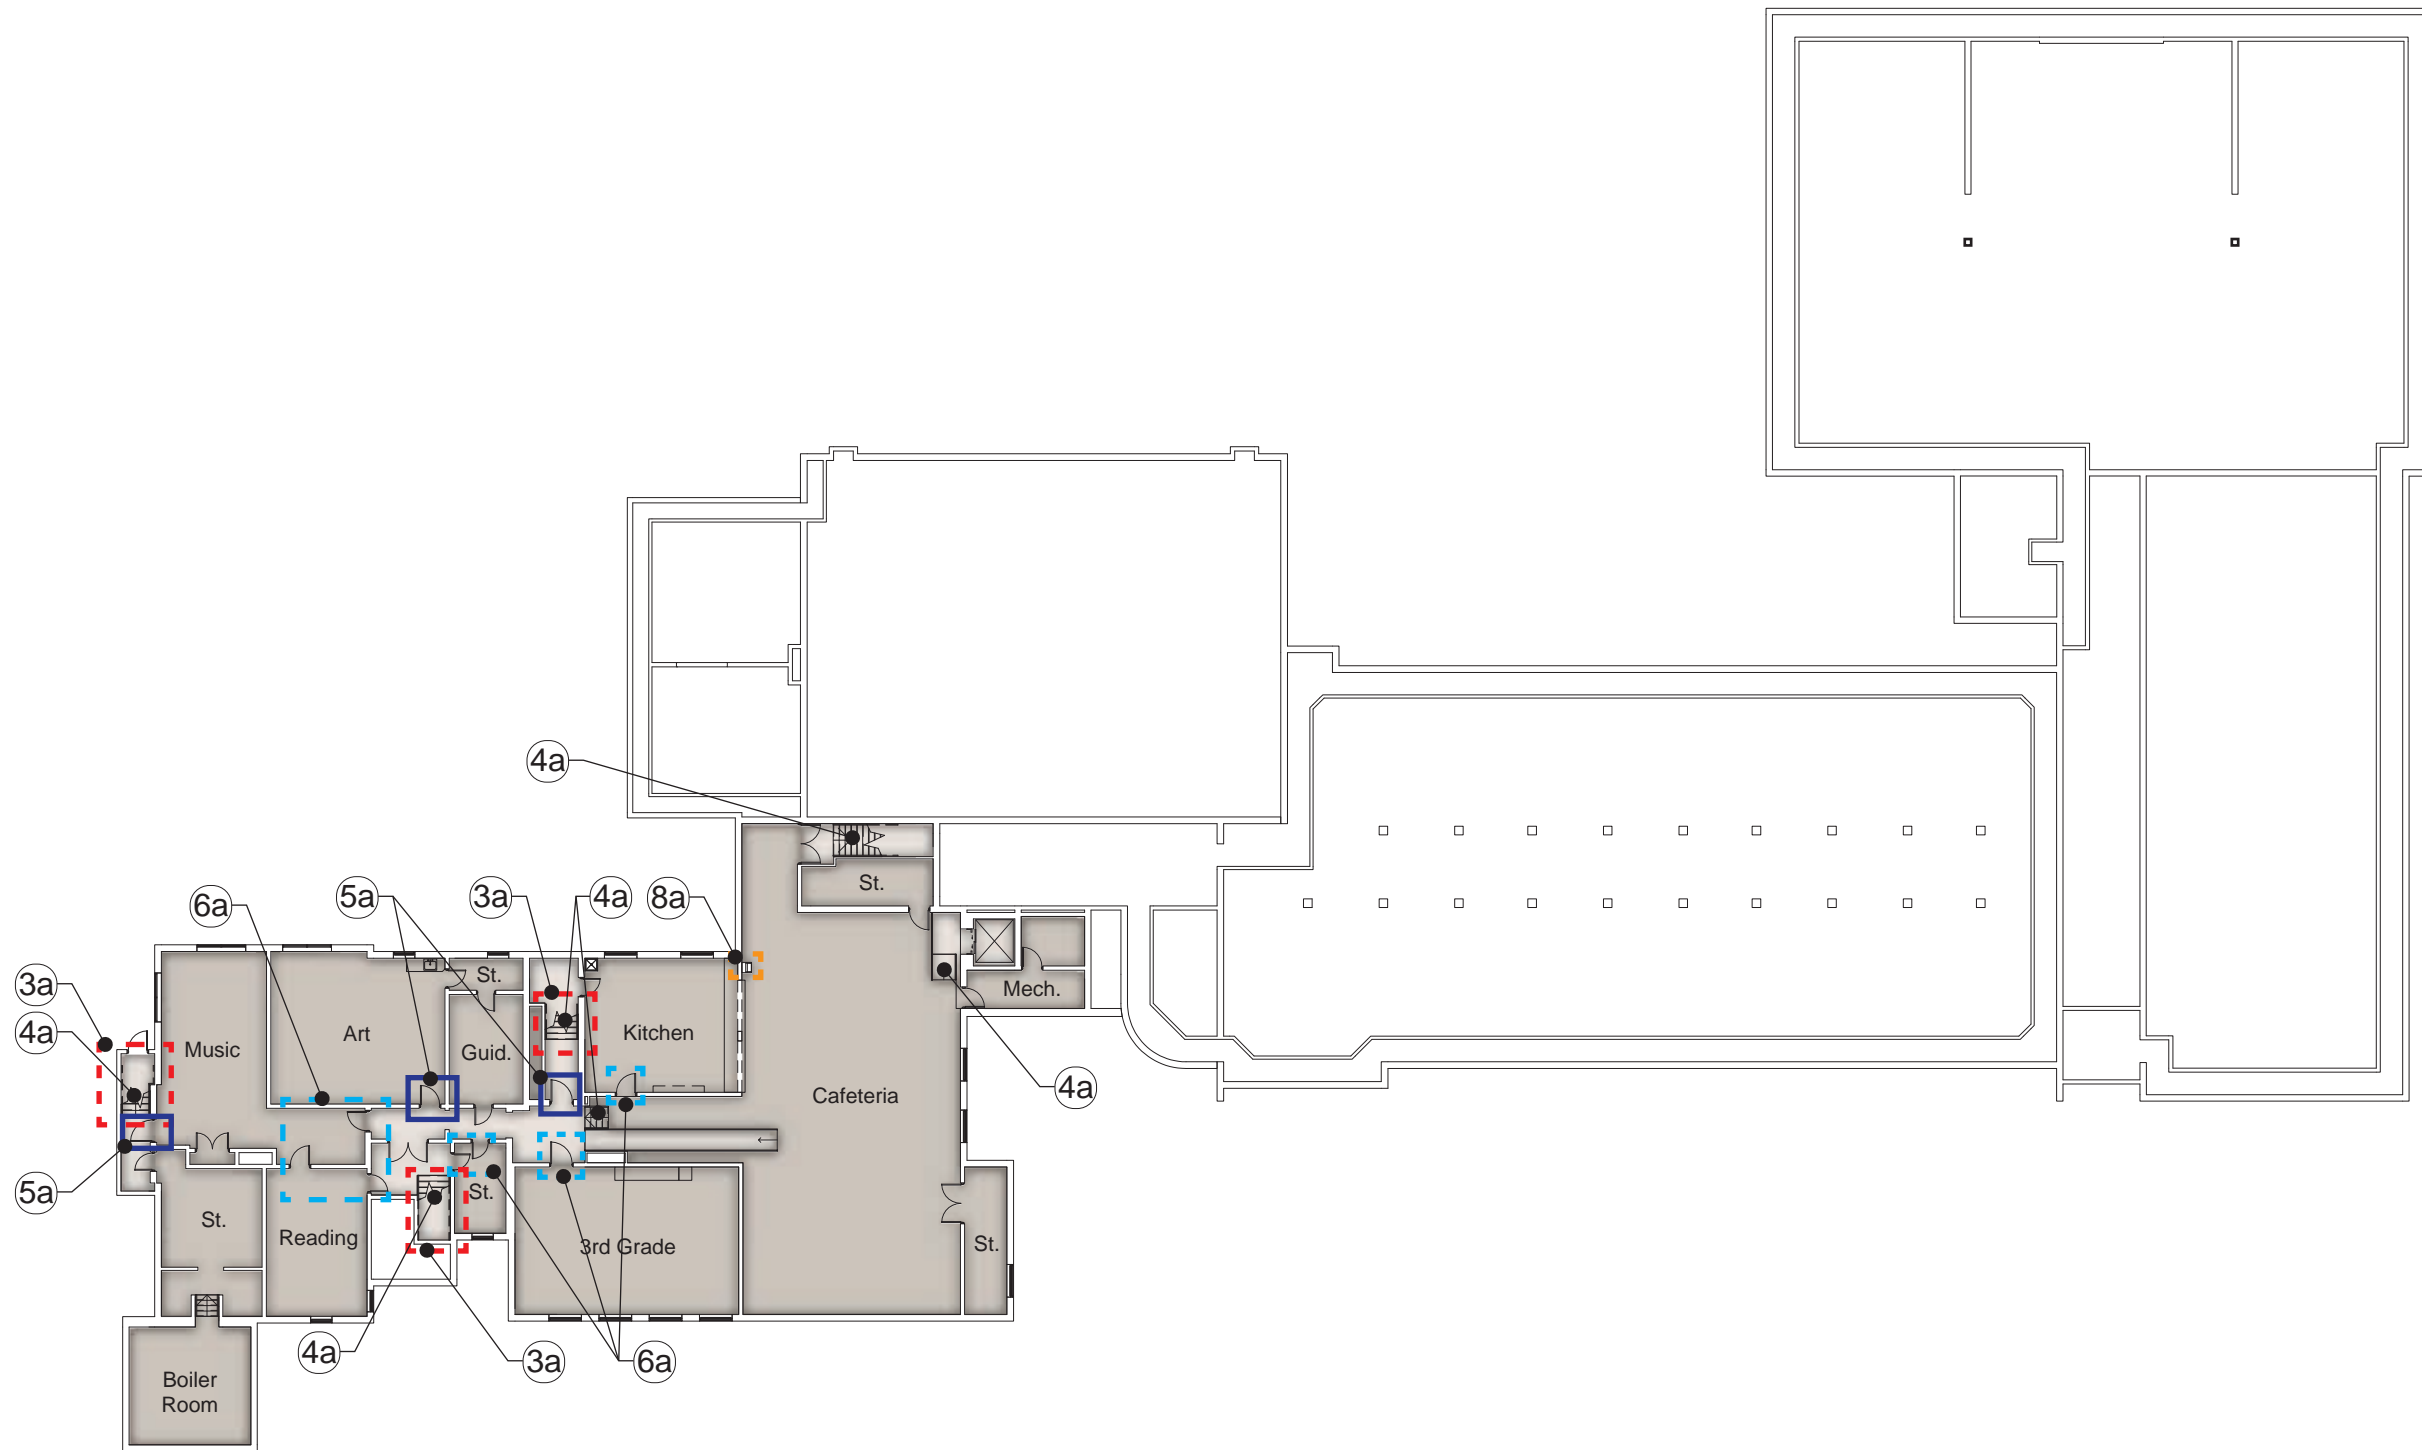
LOWER FLOOR PLAN
not to scale

9a. Counter-tops meet the above criteria for meeting accessibility standards.

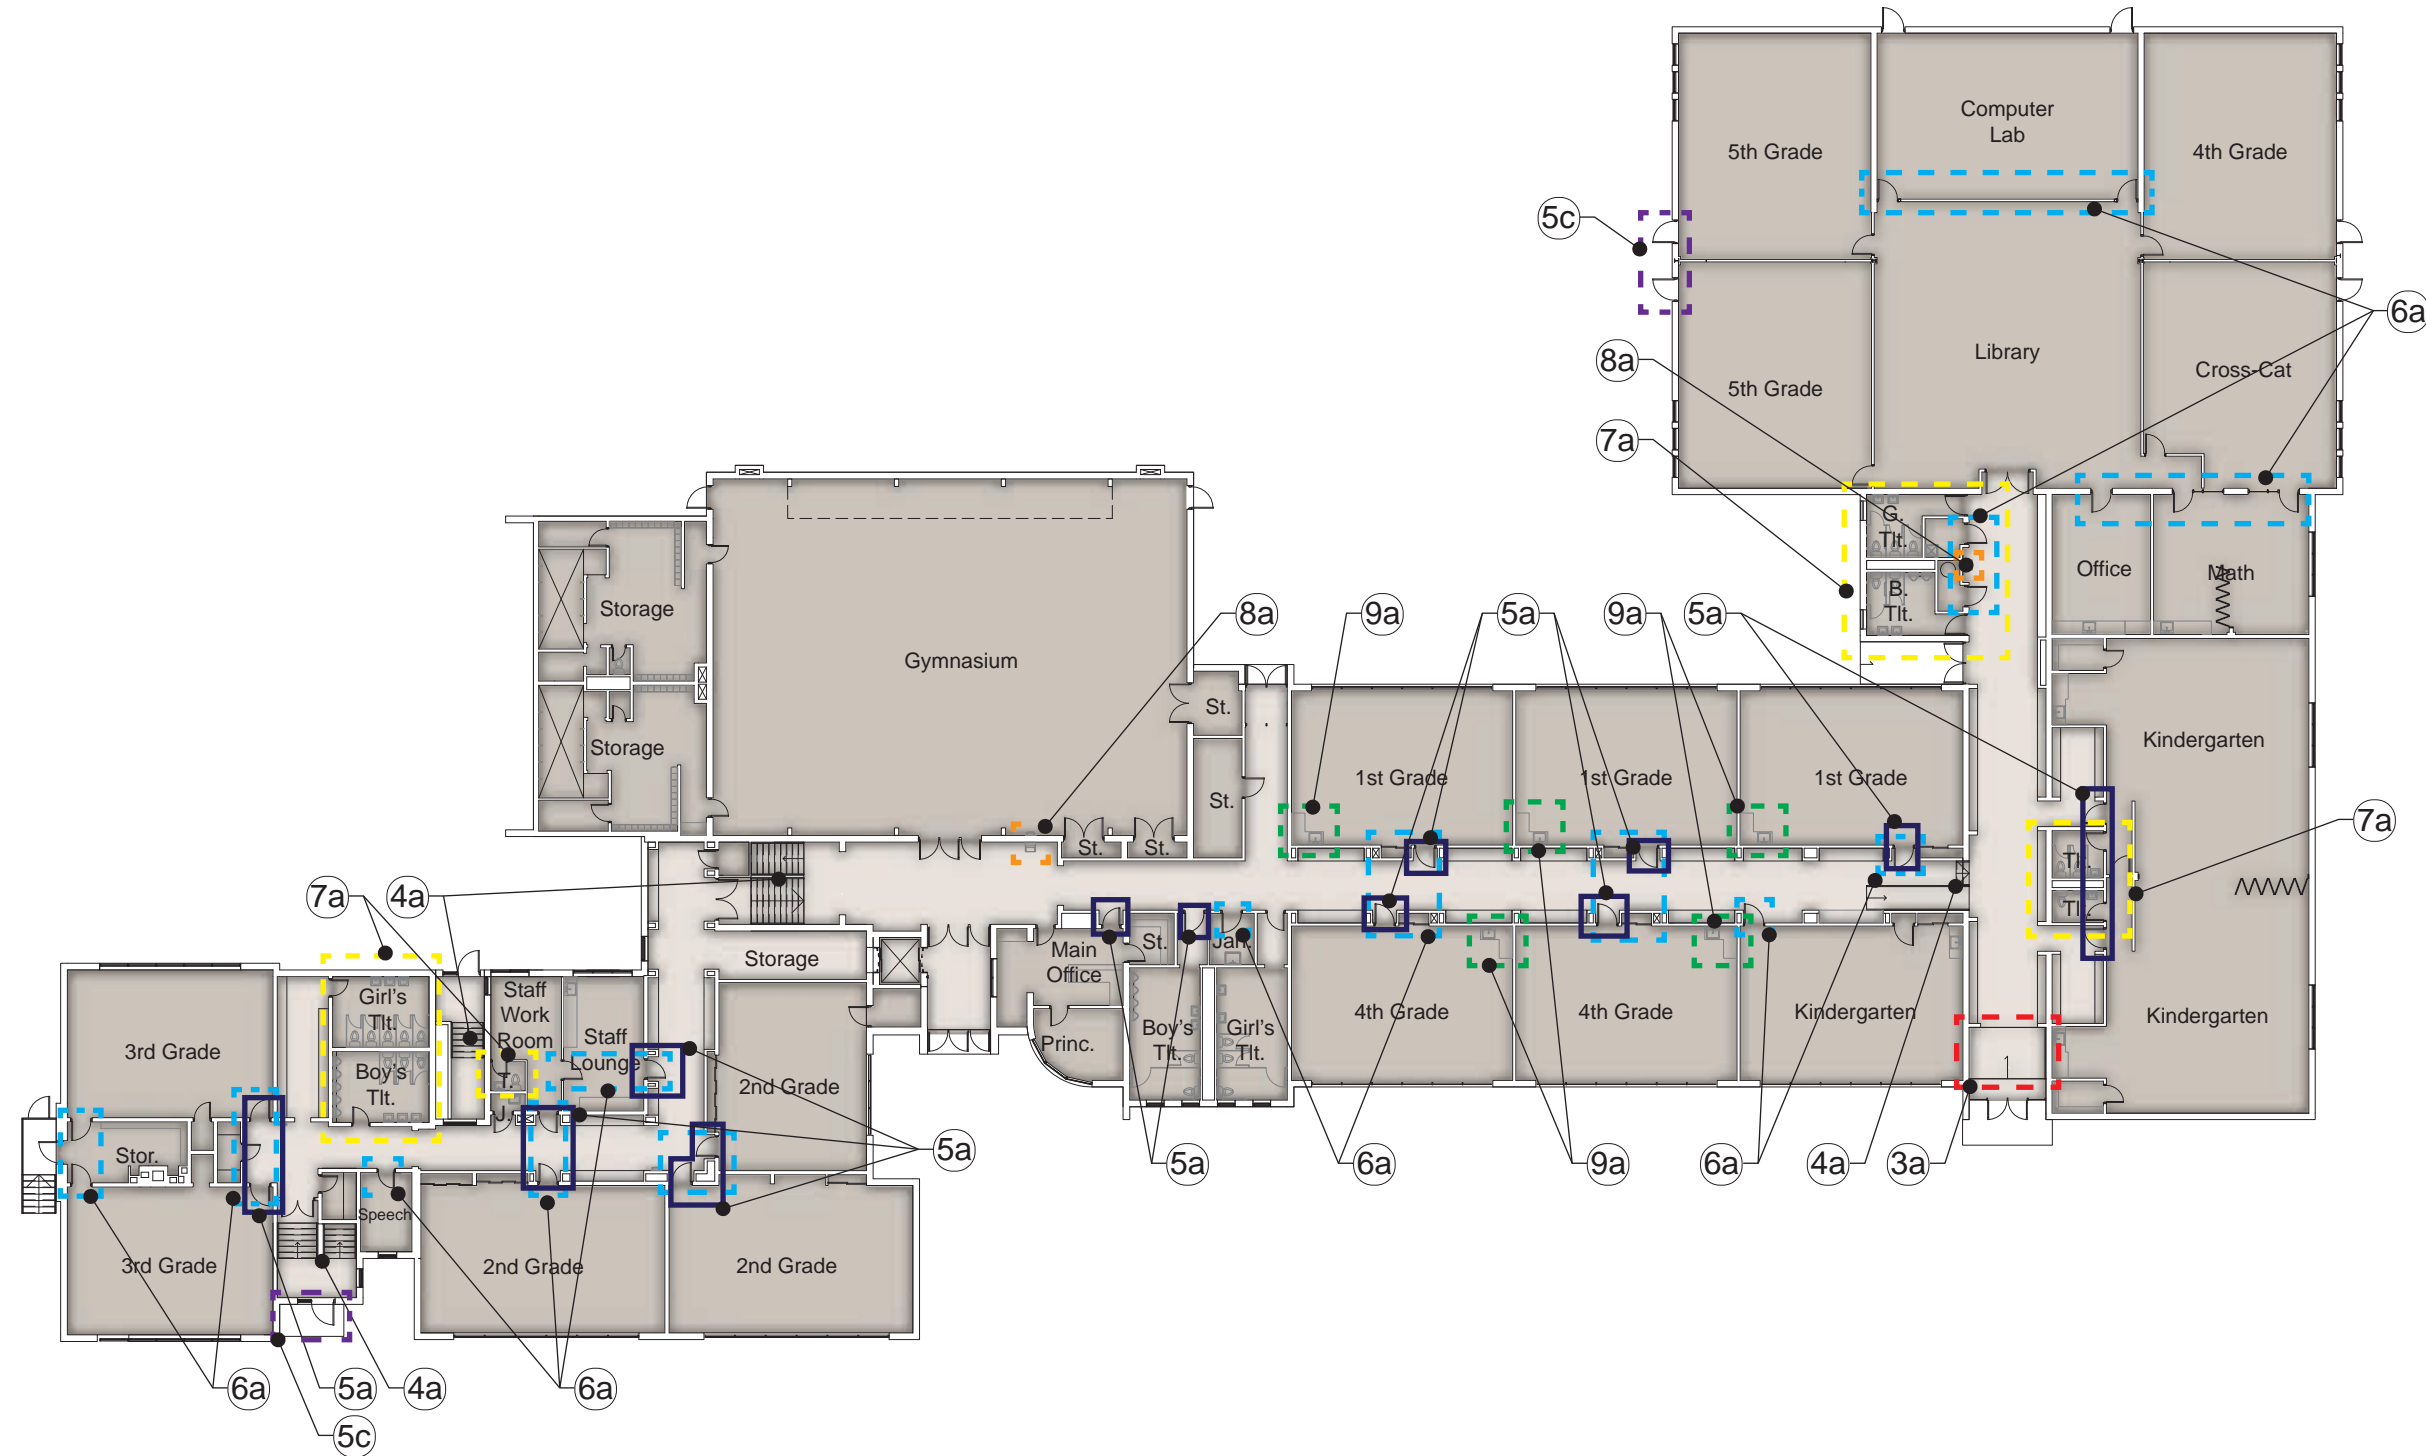
FIRST FLOOR PLAN
not to scale

9a. There are counter-tops that do not meet the above criteria for meeting accessibility standards.
