# 5 ROOSEVELT ELEMENTARY (ALLIANCE CHARTER ELEMENTARY)

Roosevelt Elementary and Alliance Charter Elementary share a building, and both schools provide a comprehensive program for Kindergarten and 1st through 5th grade students.

# ROOSEVELT ELEMENTARY: BUILDING SYSTEMS SUMMARY

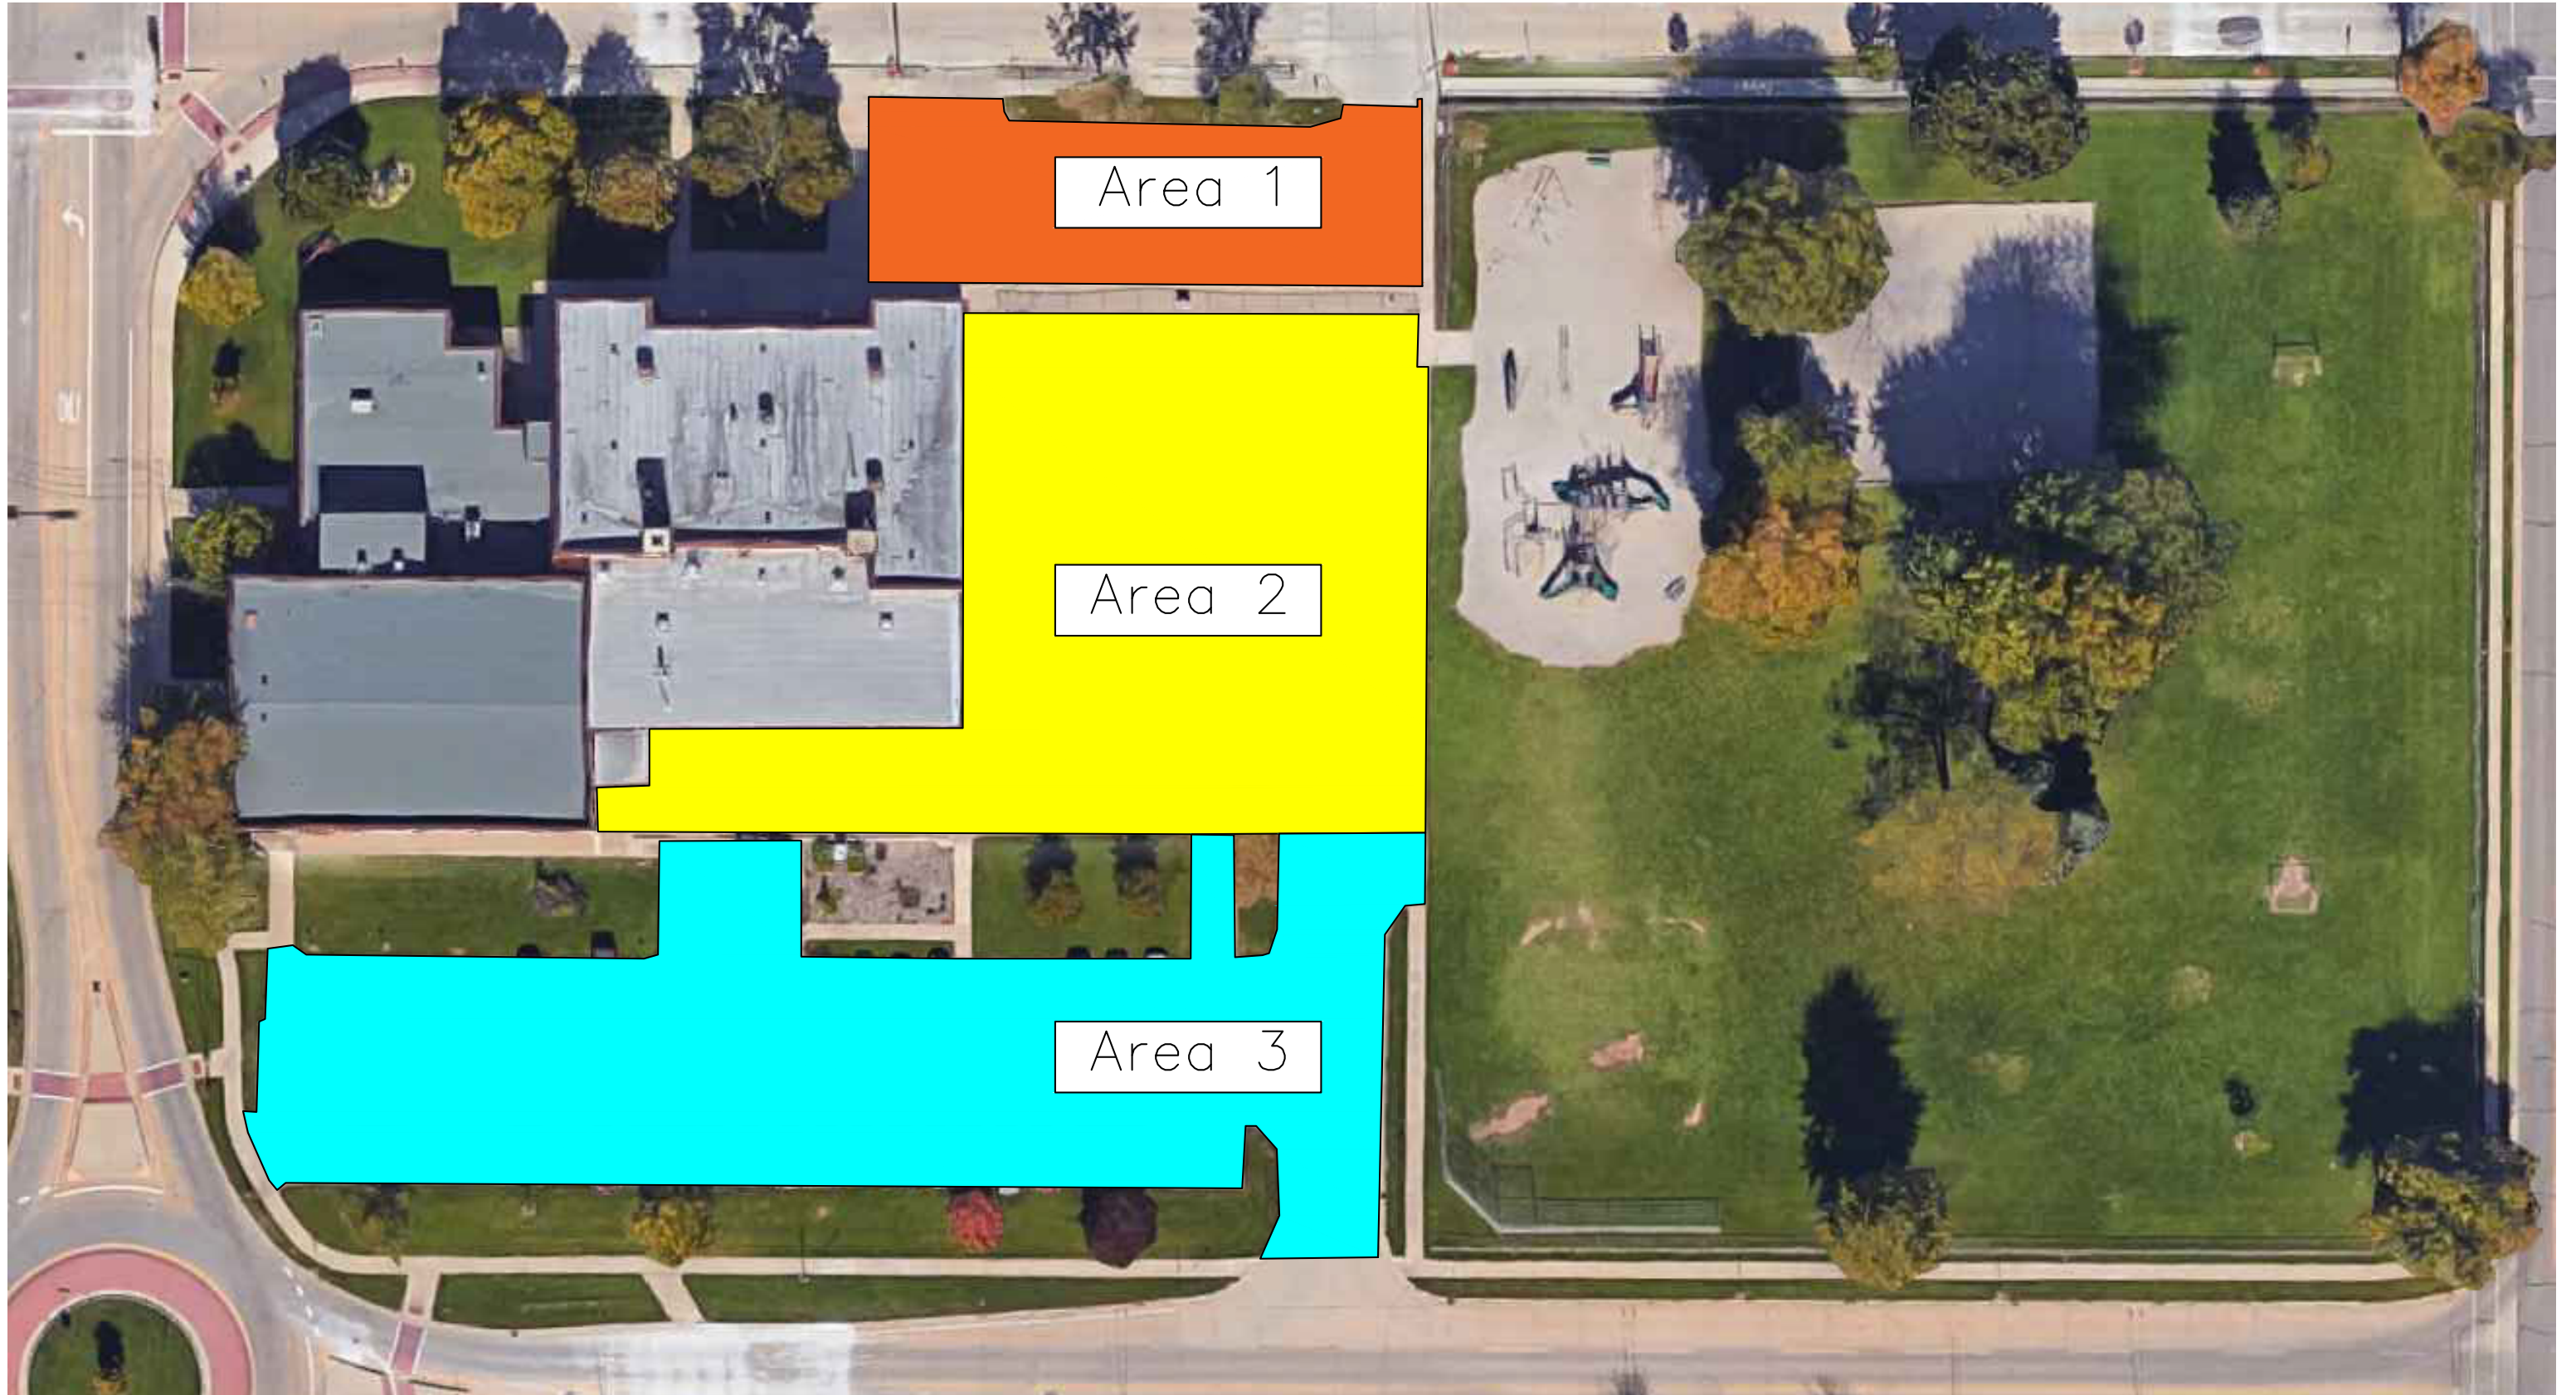
SITE PLAN  
not to scale

- Much of the playground equipment appears relatively new, but basketball hoops are dated and rusting
- No dumpster enclosure exists

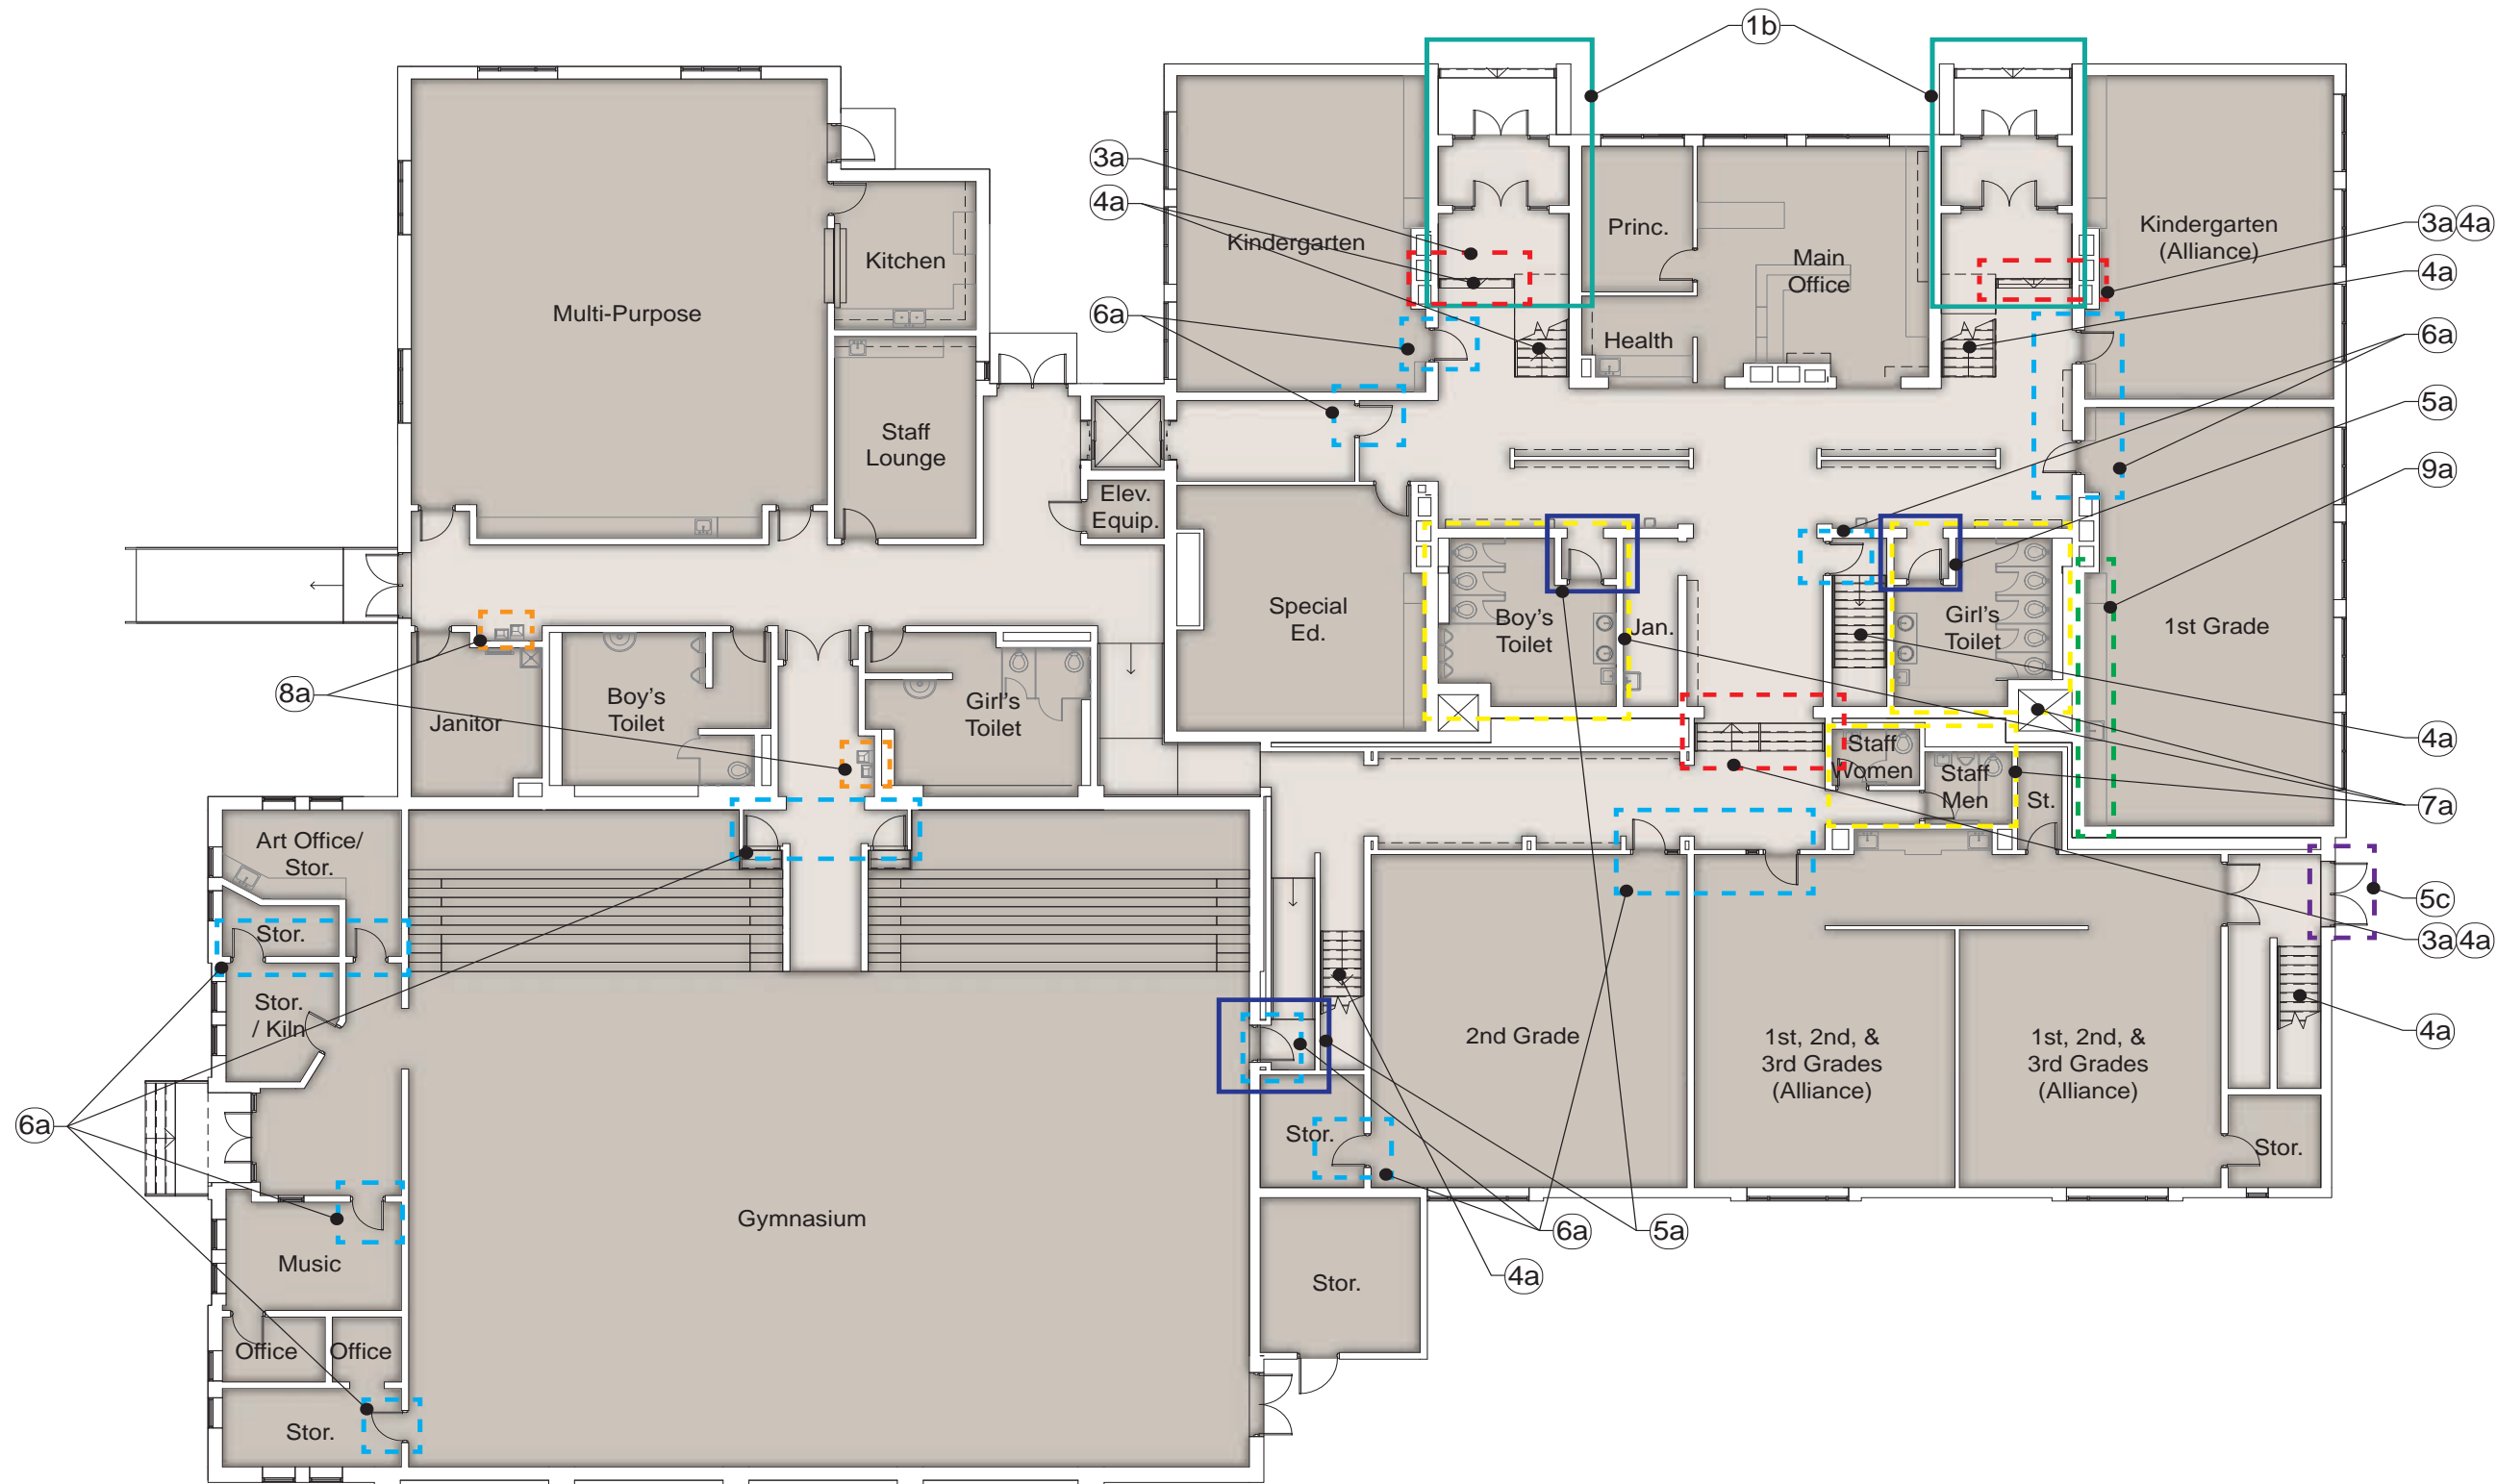
FIRST FLOOR PLAN  
not to scale

9a. there are counter-tops that do not meet the above criteria for meeting accessibility standards.

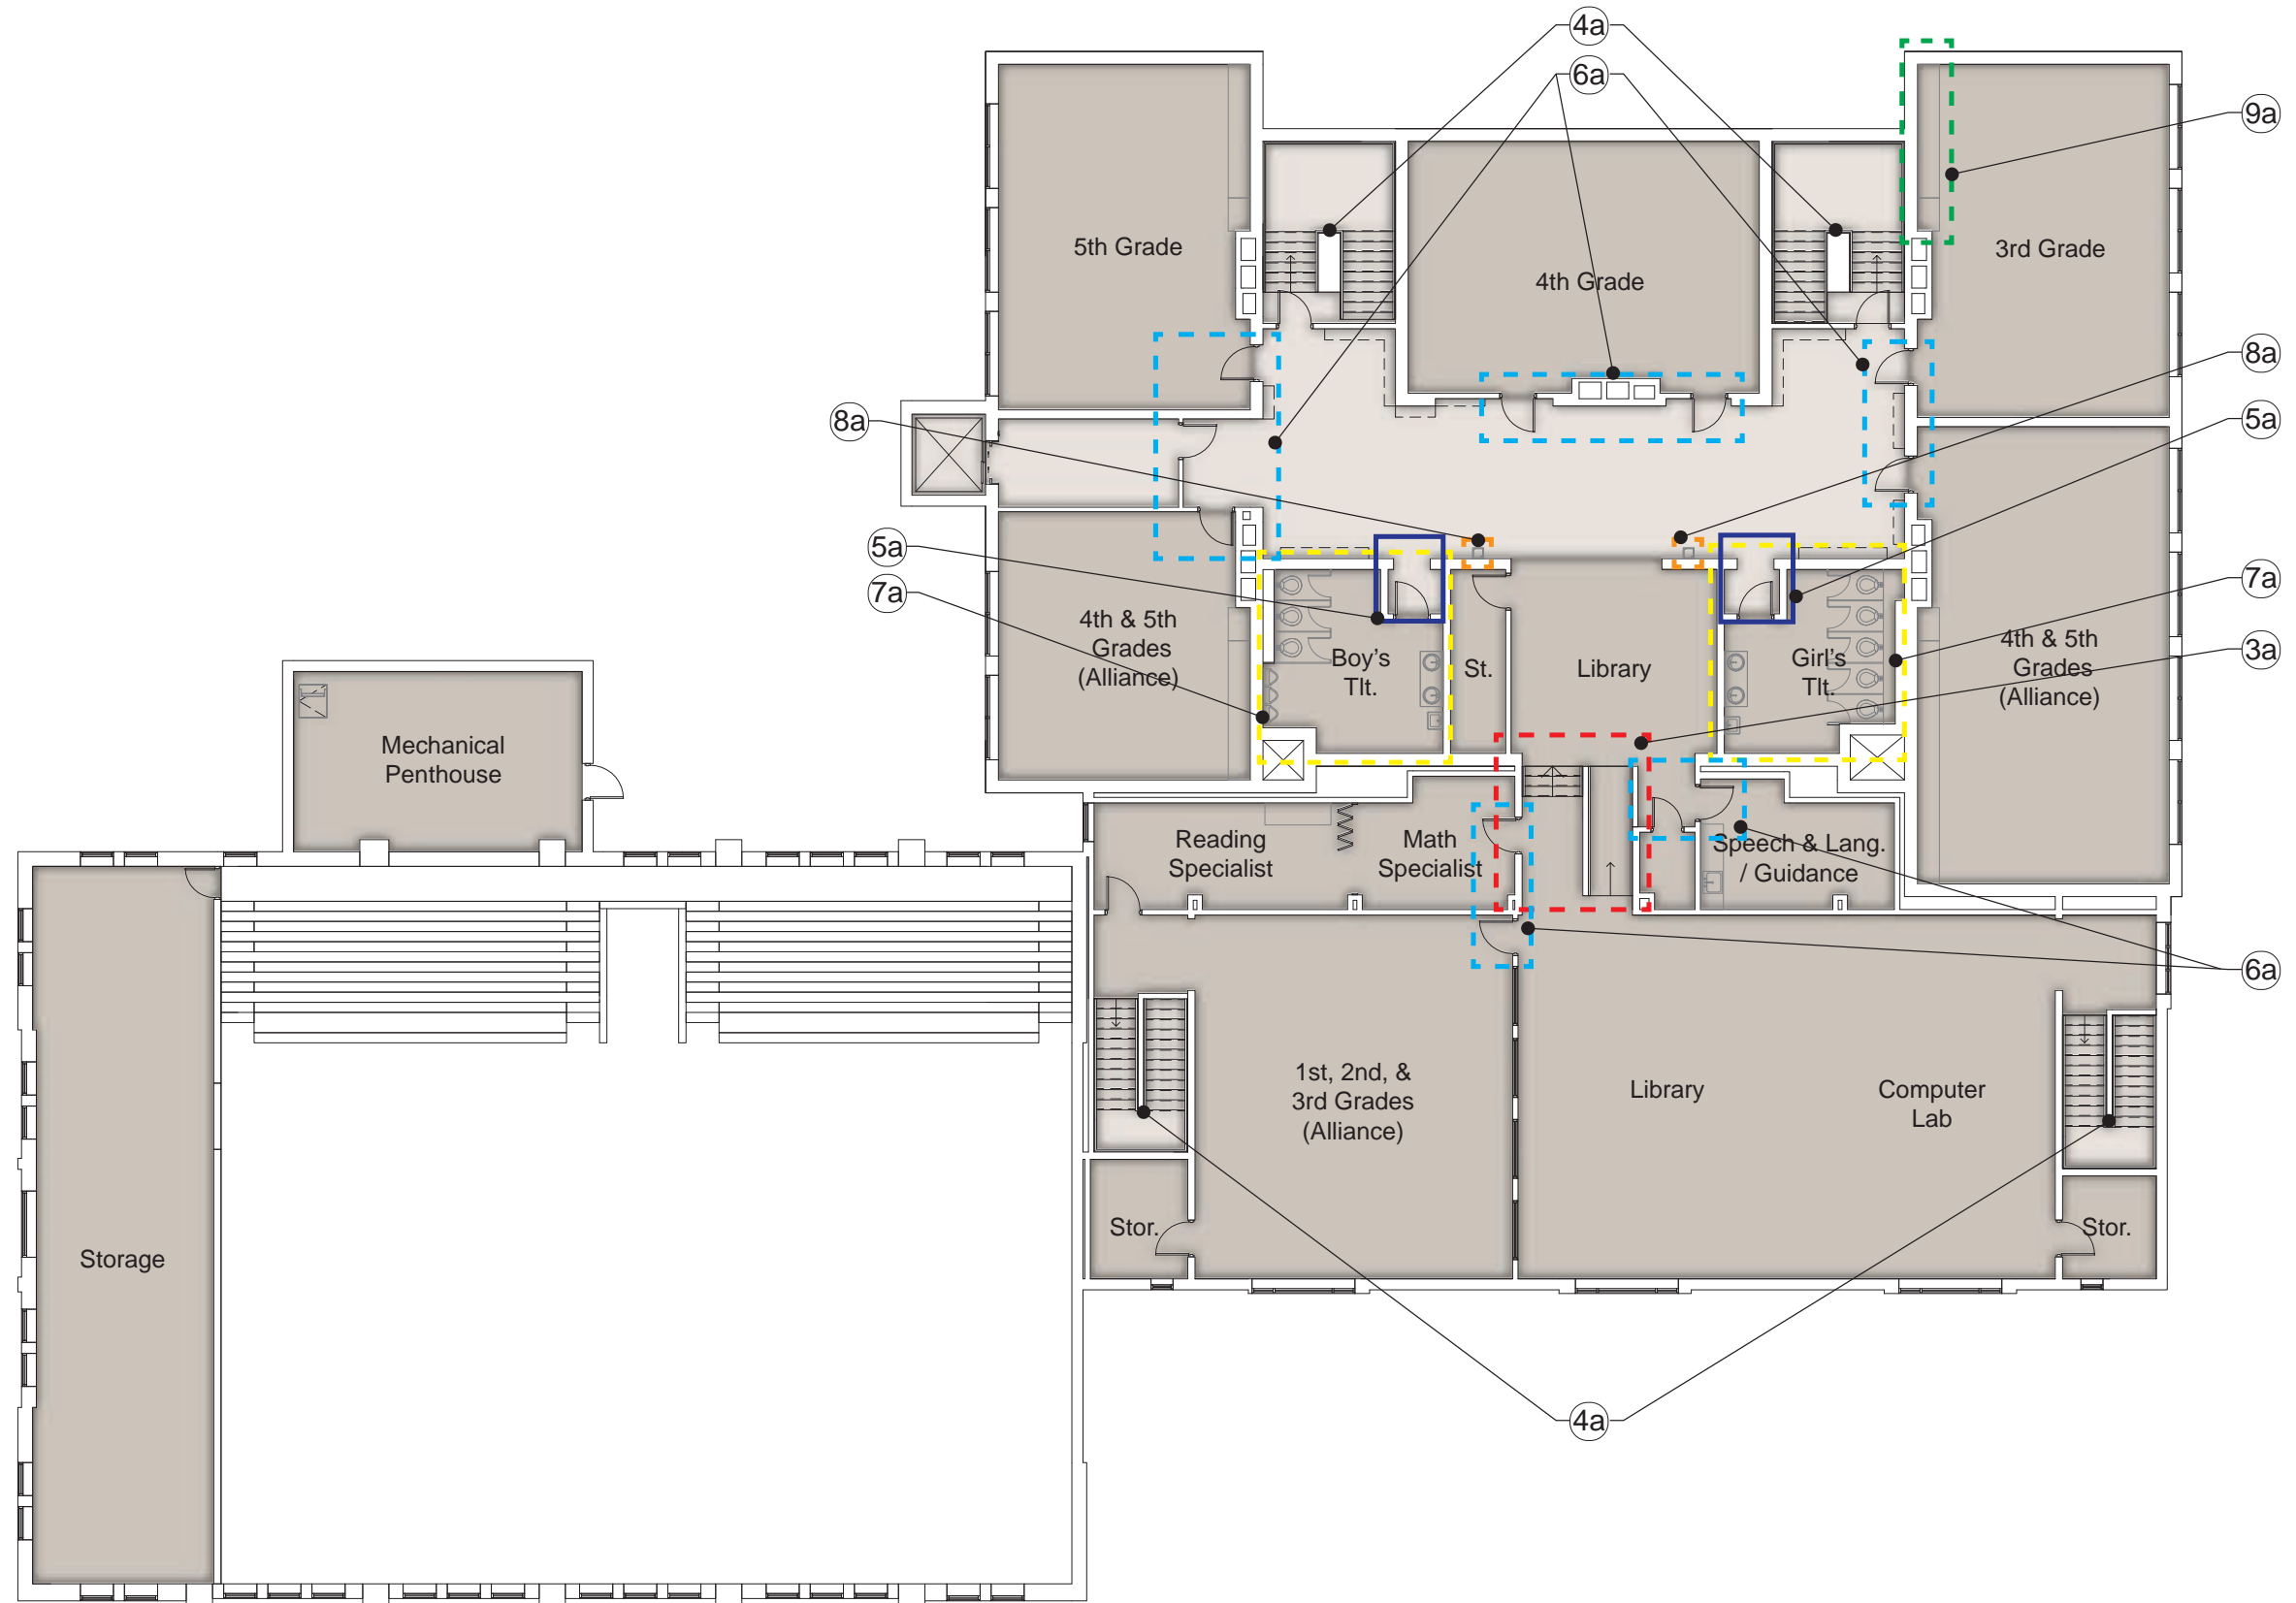
SECOND FLOOR PLAN  
*not to scale*

9a. There are counter-tops that do not meet the above criteria for meeting accessibility standards.
