12 SHATTUCK MIDDLE SCHOOL

S.F. SHATTUCK
MIDDLE
SCHOOL

SHATTUCK MIDDLE SCHOOL: BUILDING EVOLUTION

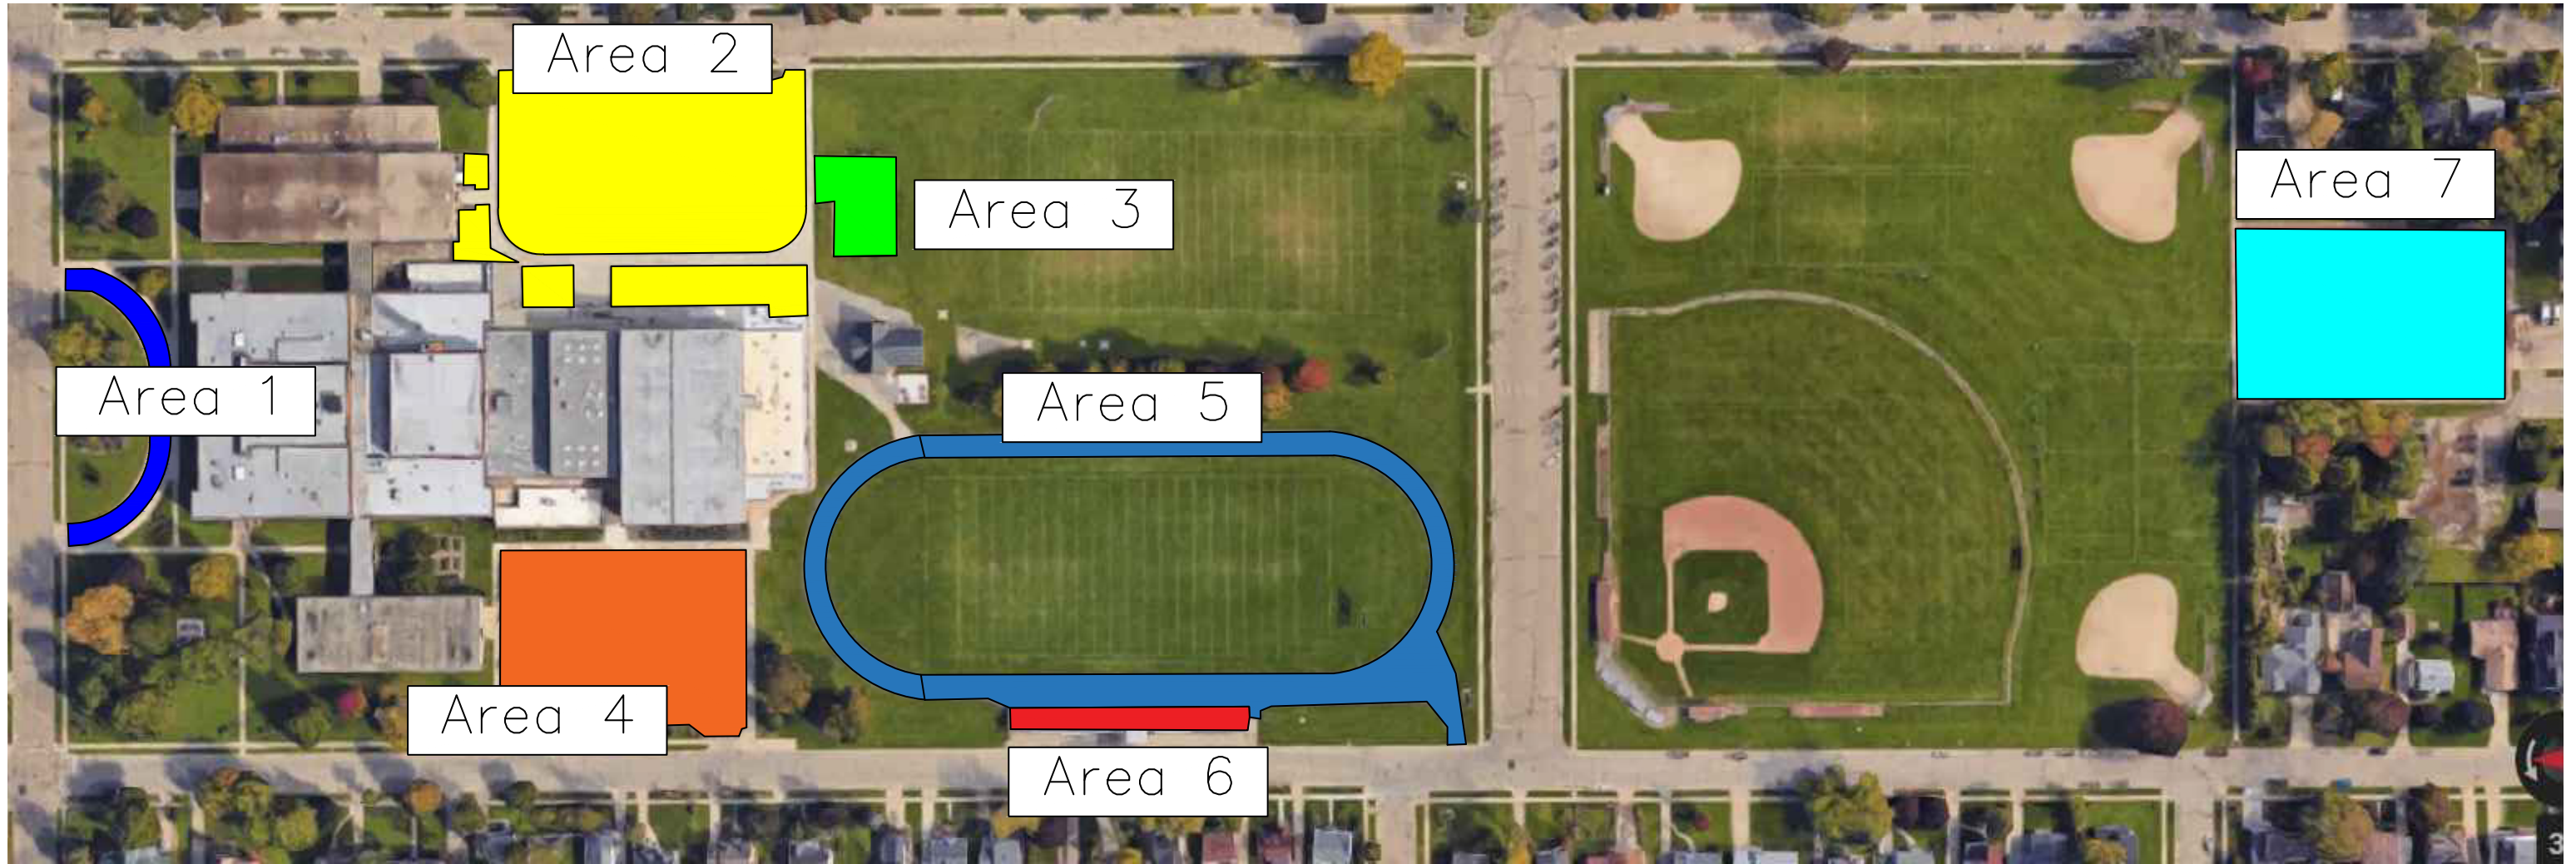
SITE PLAN
not to scale

- No dumpster enclosure exists
- The boys'/girls' locker building located on site is dated; concrete walls and floors are cracking and stained, and lockers and benches are worn and dated
- Staff reported track bleachers are dated and in poor condition

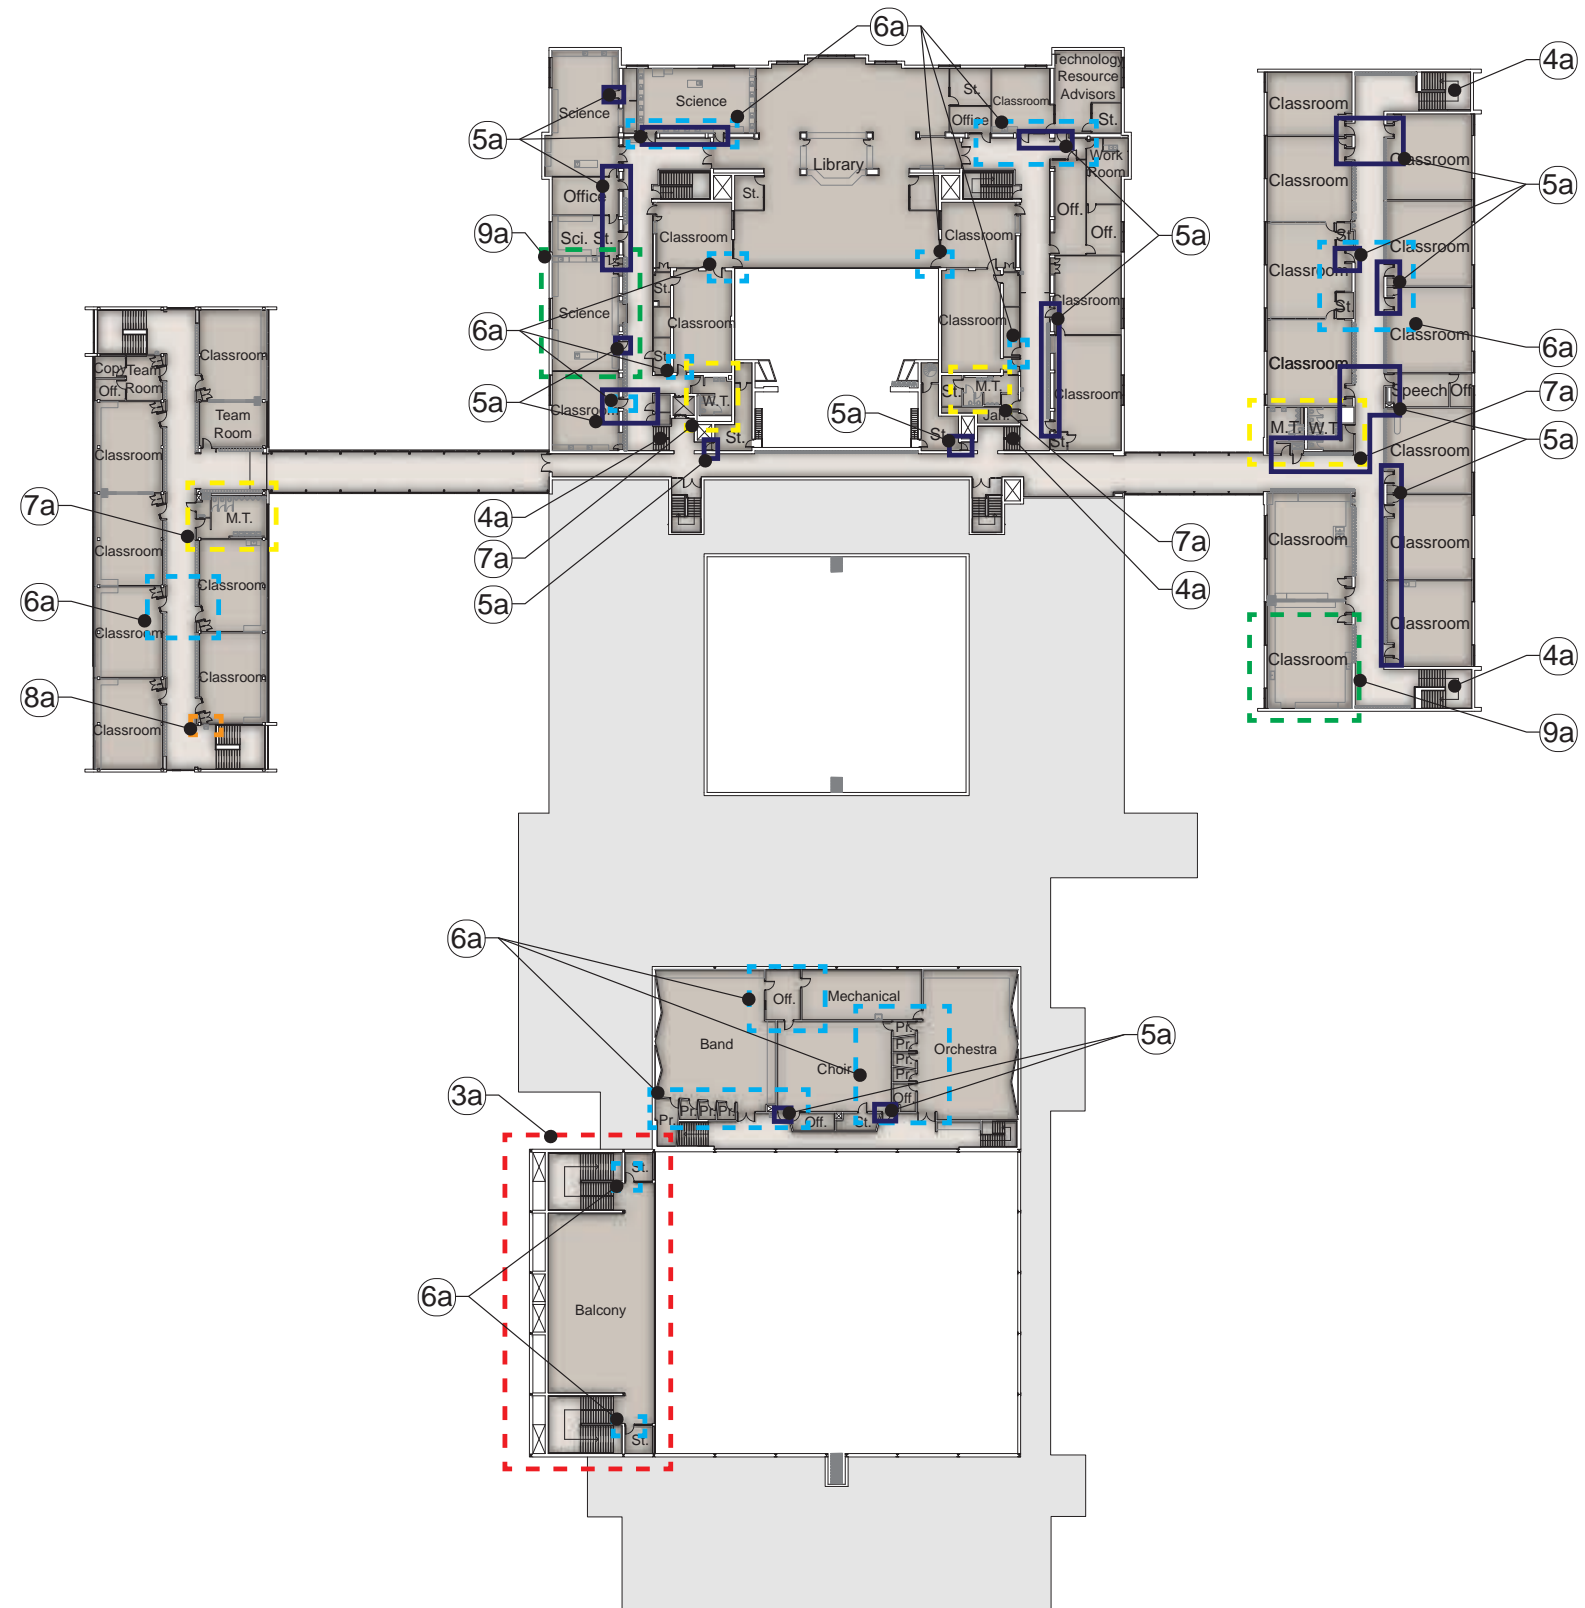
SECOND FLOOR PLAN
not to scale

9a. There are counter-tops that do not meet the above criteria for meeting accessibility standards.
