7 TAFT ELEMENTARY

TAFT ELEMENTARY: BUILDING EVOLUTION

TAFT ELEMENTARY: BUILDING SYSTEMS SUMMARY

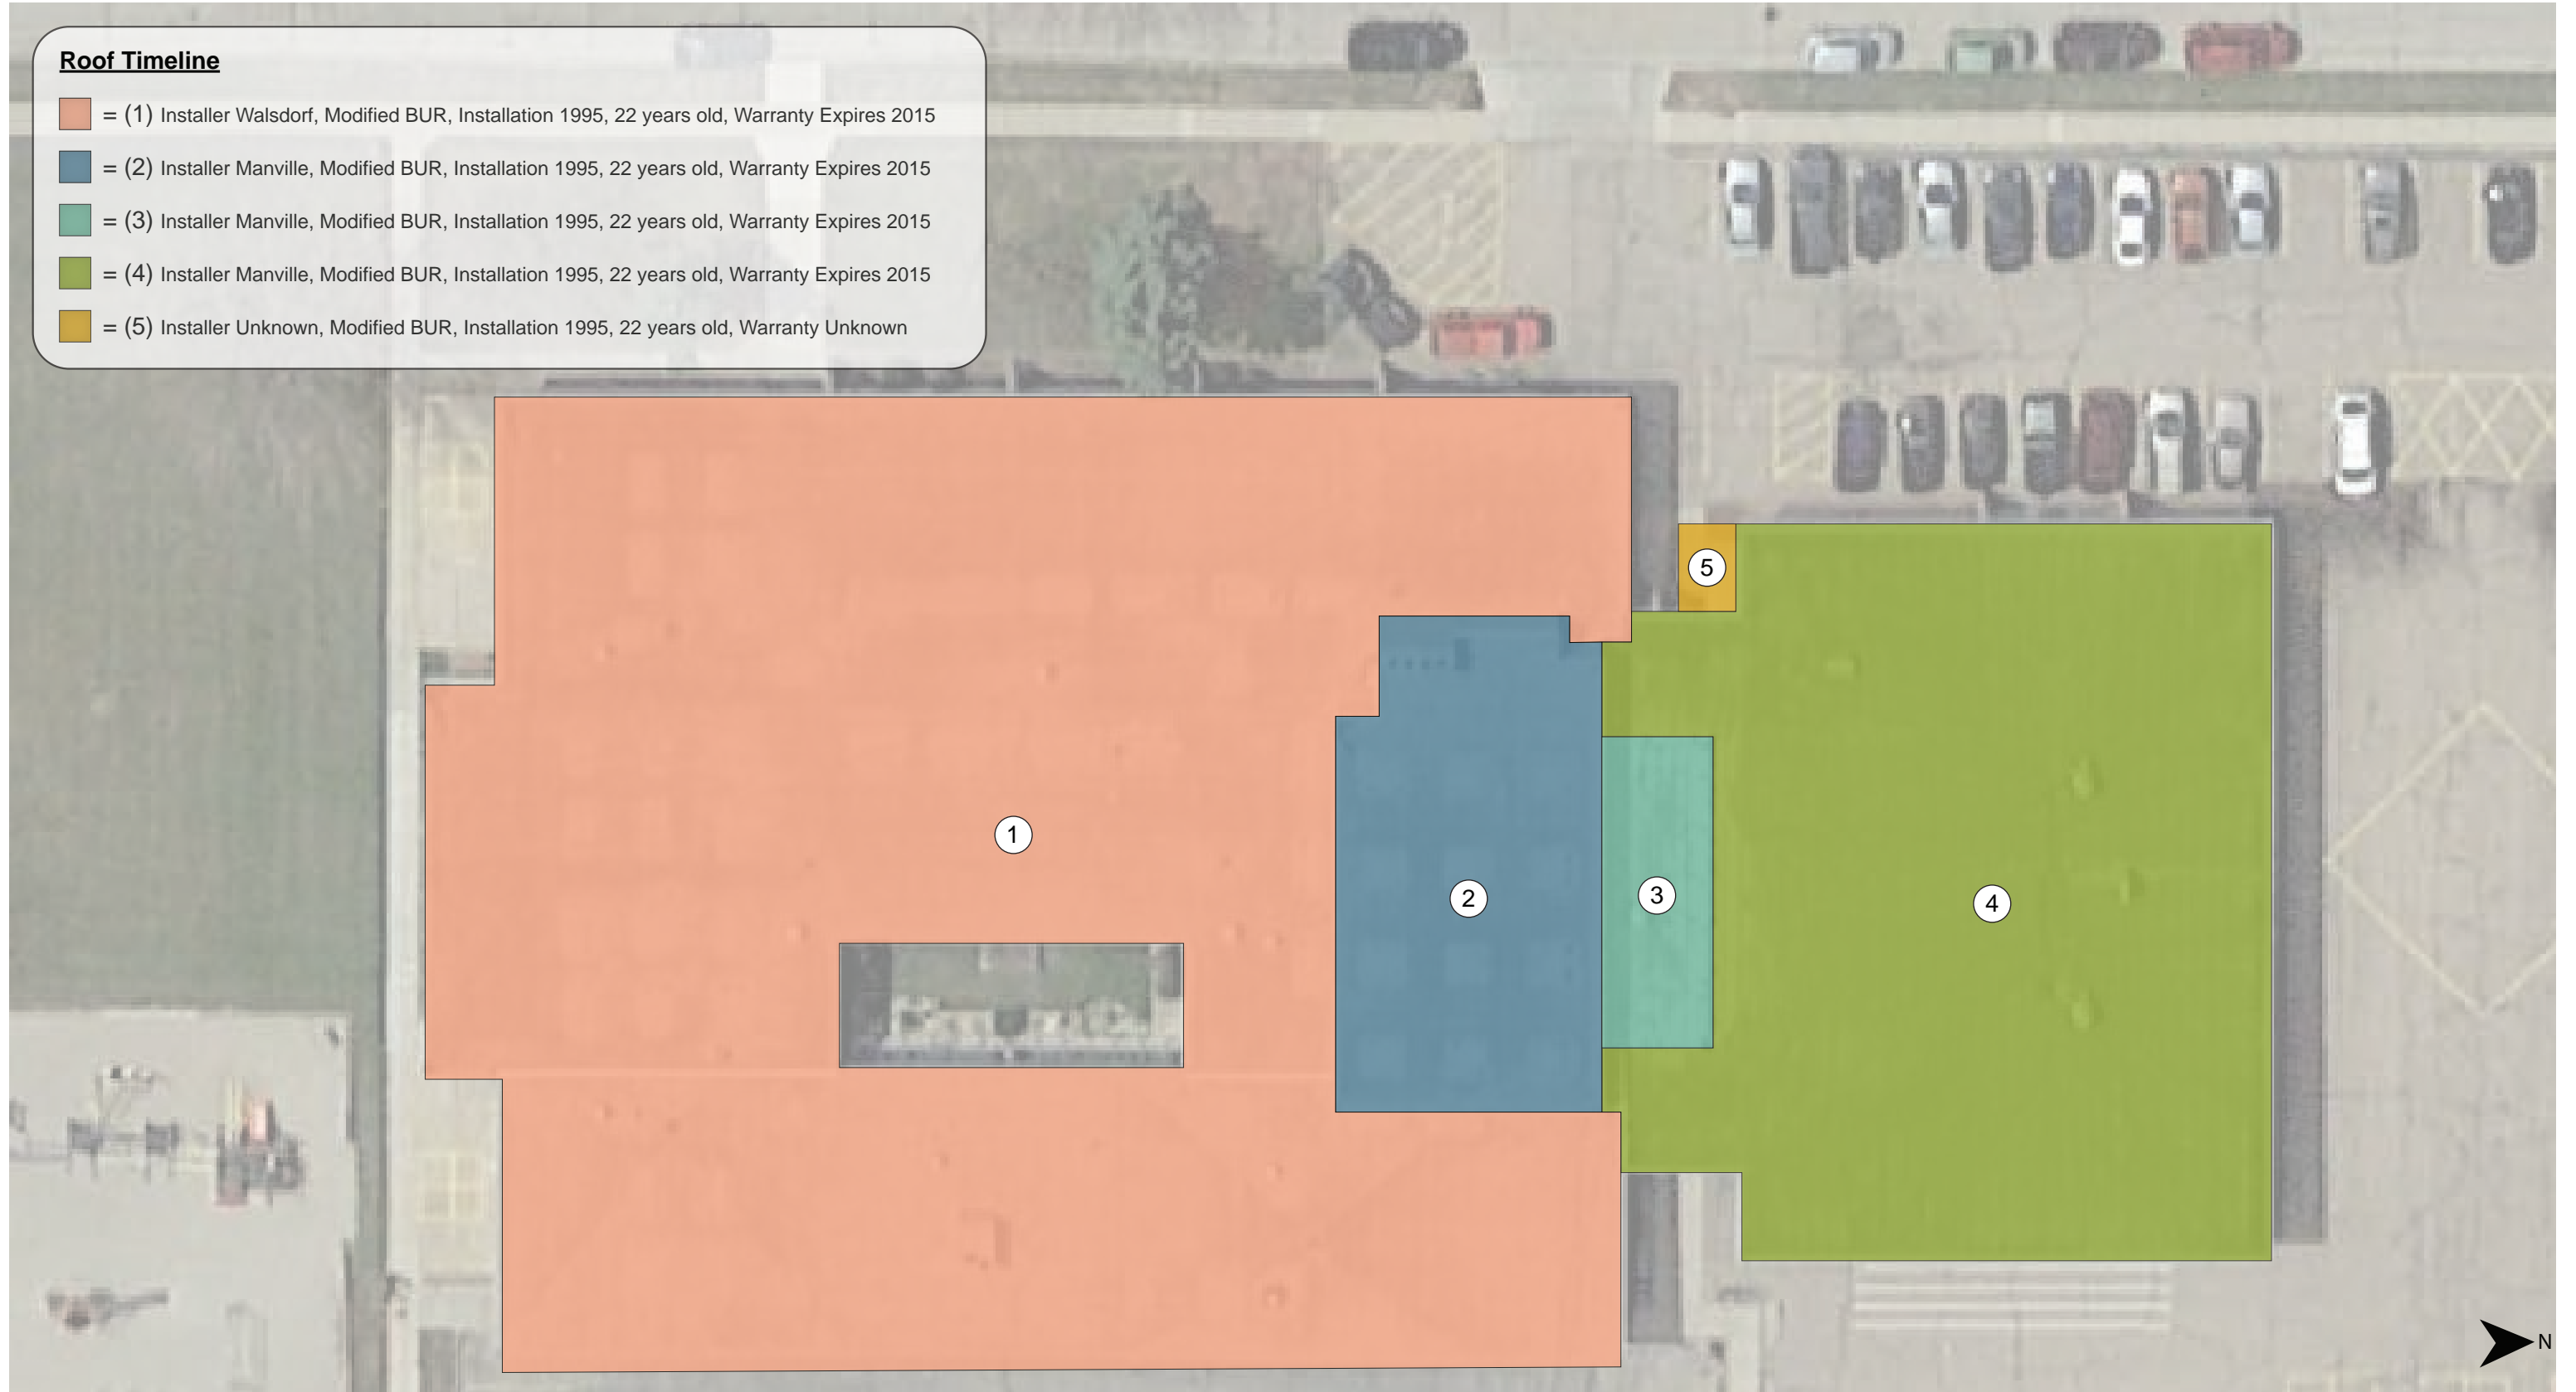
ROOF PLAN
not to scale

-   = (1) Installer Walsdorf, Modified BUR, Installation 1995, 22 years old, Warranty Expires 2015
-   = (2) Installer Manville, Modified BUR, Installation 1995, 22 years old, Warranty Expires 2015
-   = (3) Installer Manville, Modified BUR, Installation 1995, 22 years old, Warranty Expires 2015
-   = (4) Installer Manville, Modified BUR, Installation 1995, 22 years old, Warranty Expires 2015
-   = (5) Installer Unknown, Modified BUR, Installation 1995, 22 years old, Warranty Unknown

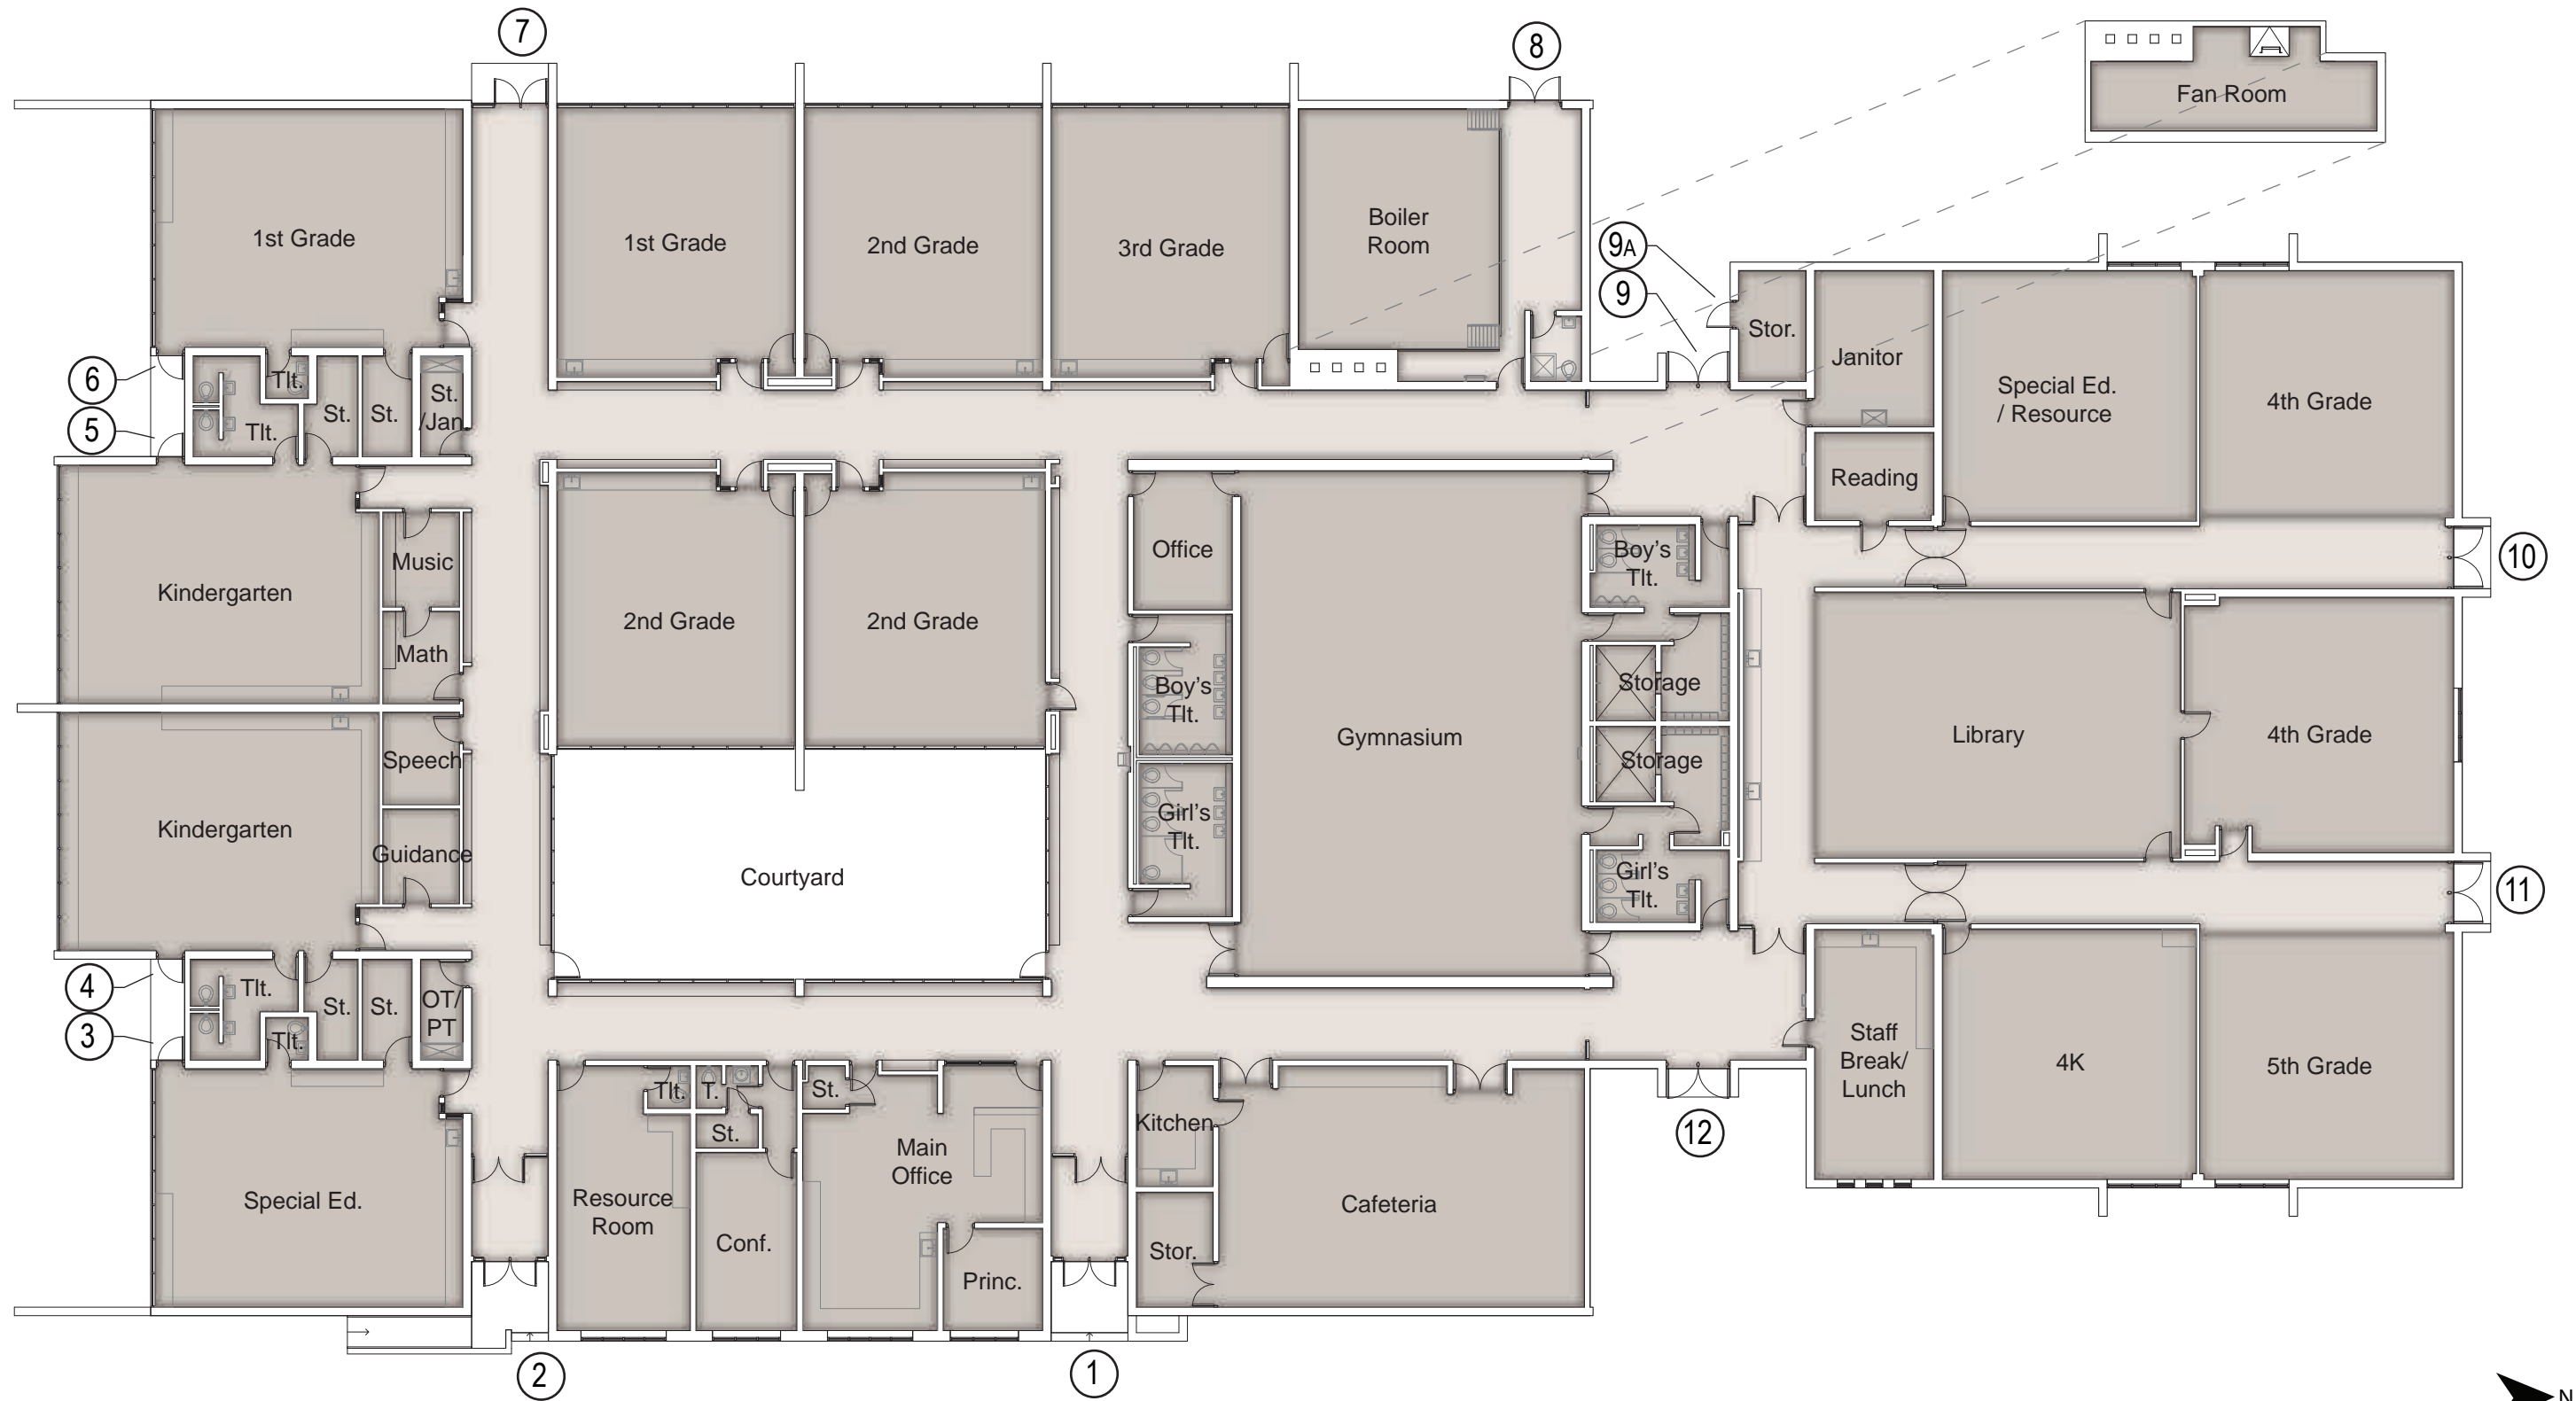
Taft Elementary: EXTERIOR DOOR ANALYSIS

- e. Many of the exterior doors are original to the building, aged, rusting, and are worn and damaged by dents and salt exposure; some of these doors have large gaps in the frame that allow for drafts
- f. Wood exterior doors are peeling and missing hardware

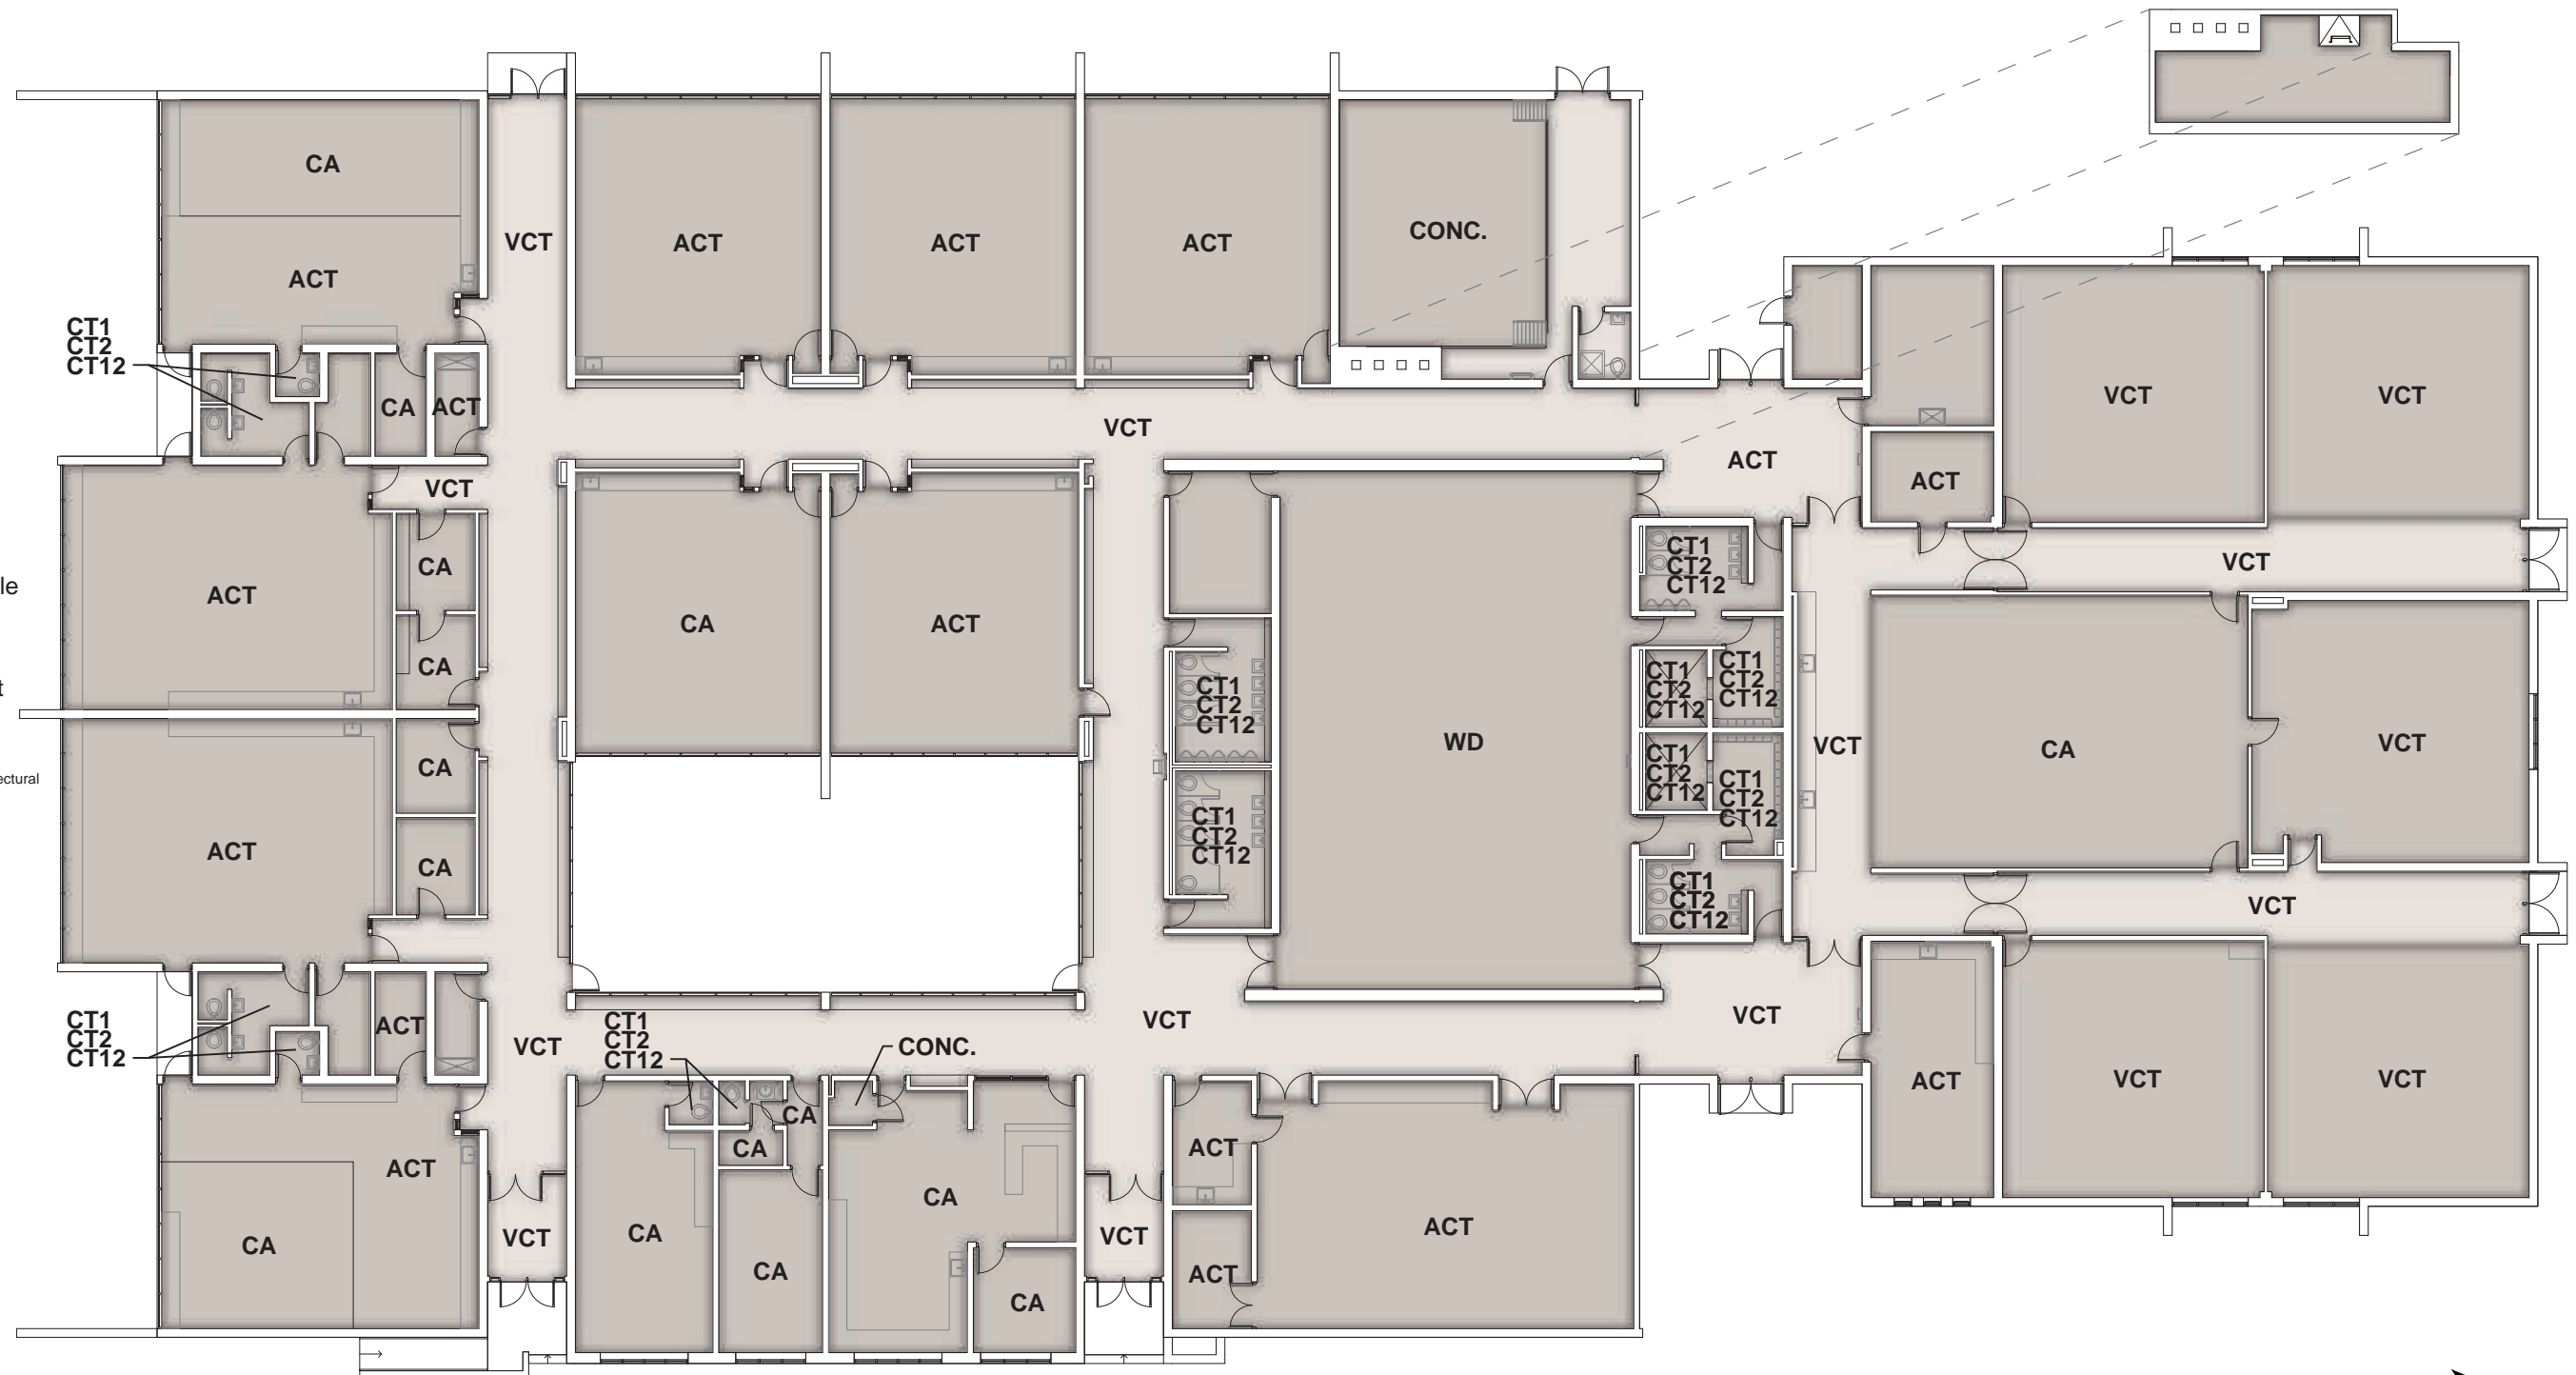
FIRST FLOOR PLAN
not to scale

- ACT - 9x9 (Asbestos)
- ACT1 - 12x12 (Asbestos)
- ACT2 - 6x6 (Asbestos)
- CA - Carpet Broadloom
- CAT - Carpet Tile
- CT1 - 1x1 Ceramic Tile
- CT2 - 2x2 Ceramic Tile
- CT12 - 1x2 Ceramic Tile
- CTH - Hex Ceramic Tile
- CONC. - Concrete
- PT - 8x8 Paver Tile
- PT1 - 6x6 Paver Tile
- PT2 - 3x3 Paver Tile
- PT3 - 3x6 Paver Tile
- RT - Rubber Tile
- RTT - Rubber Tile Tread
- SS - Seamless Synthetic
- SV - Sheet Vinyl
- TER - Terrazzo Tile
- TER1 - 12x12 Terrazzo Tile
- VCT - 12x12
- WD - Wood
- WDP - 4x4 Wood Parquet
- WM - Walk-off Mat
