8 TULLAR ELEMENTARY

TULLAR ELEMENTARY: BUILDING SYSTEMS SUMMARY

TULLAR ELEMENTARY: ENGINEER REPORT - PLUMBING

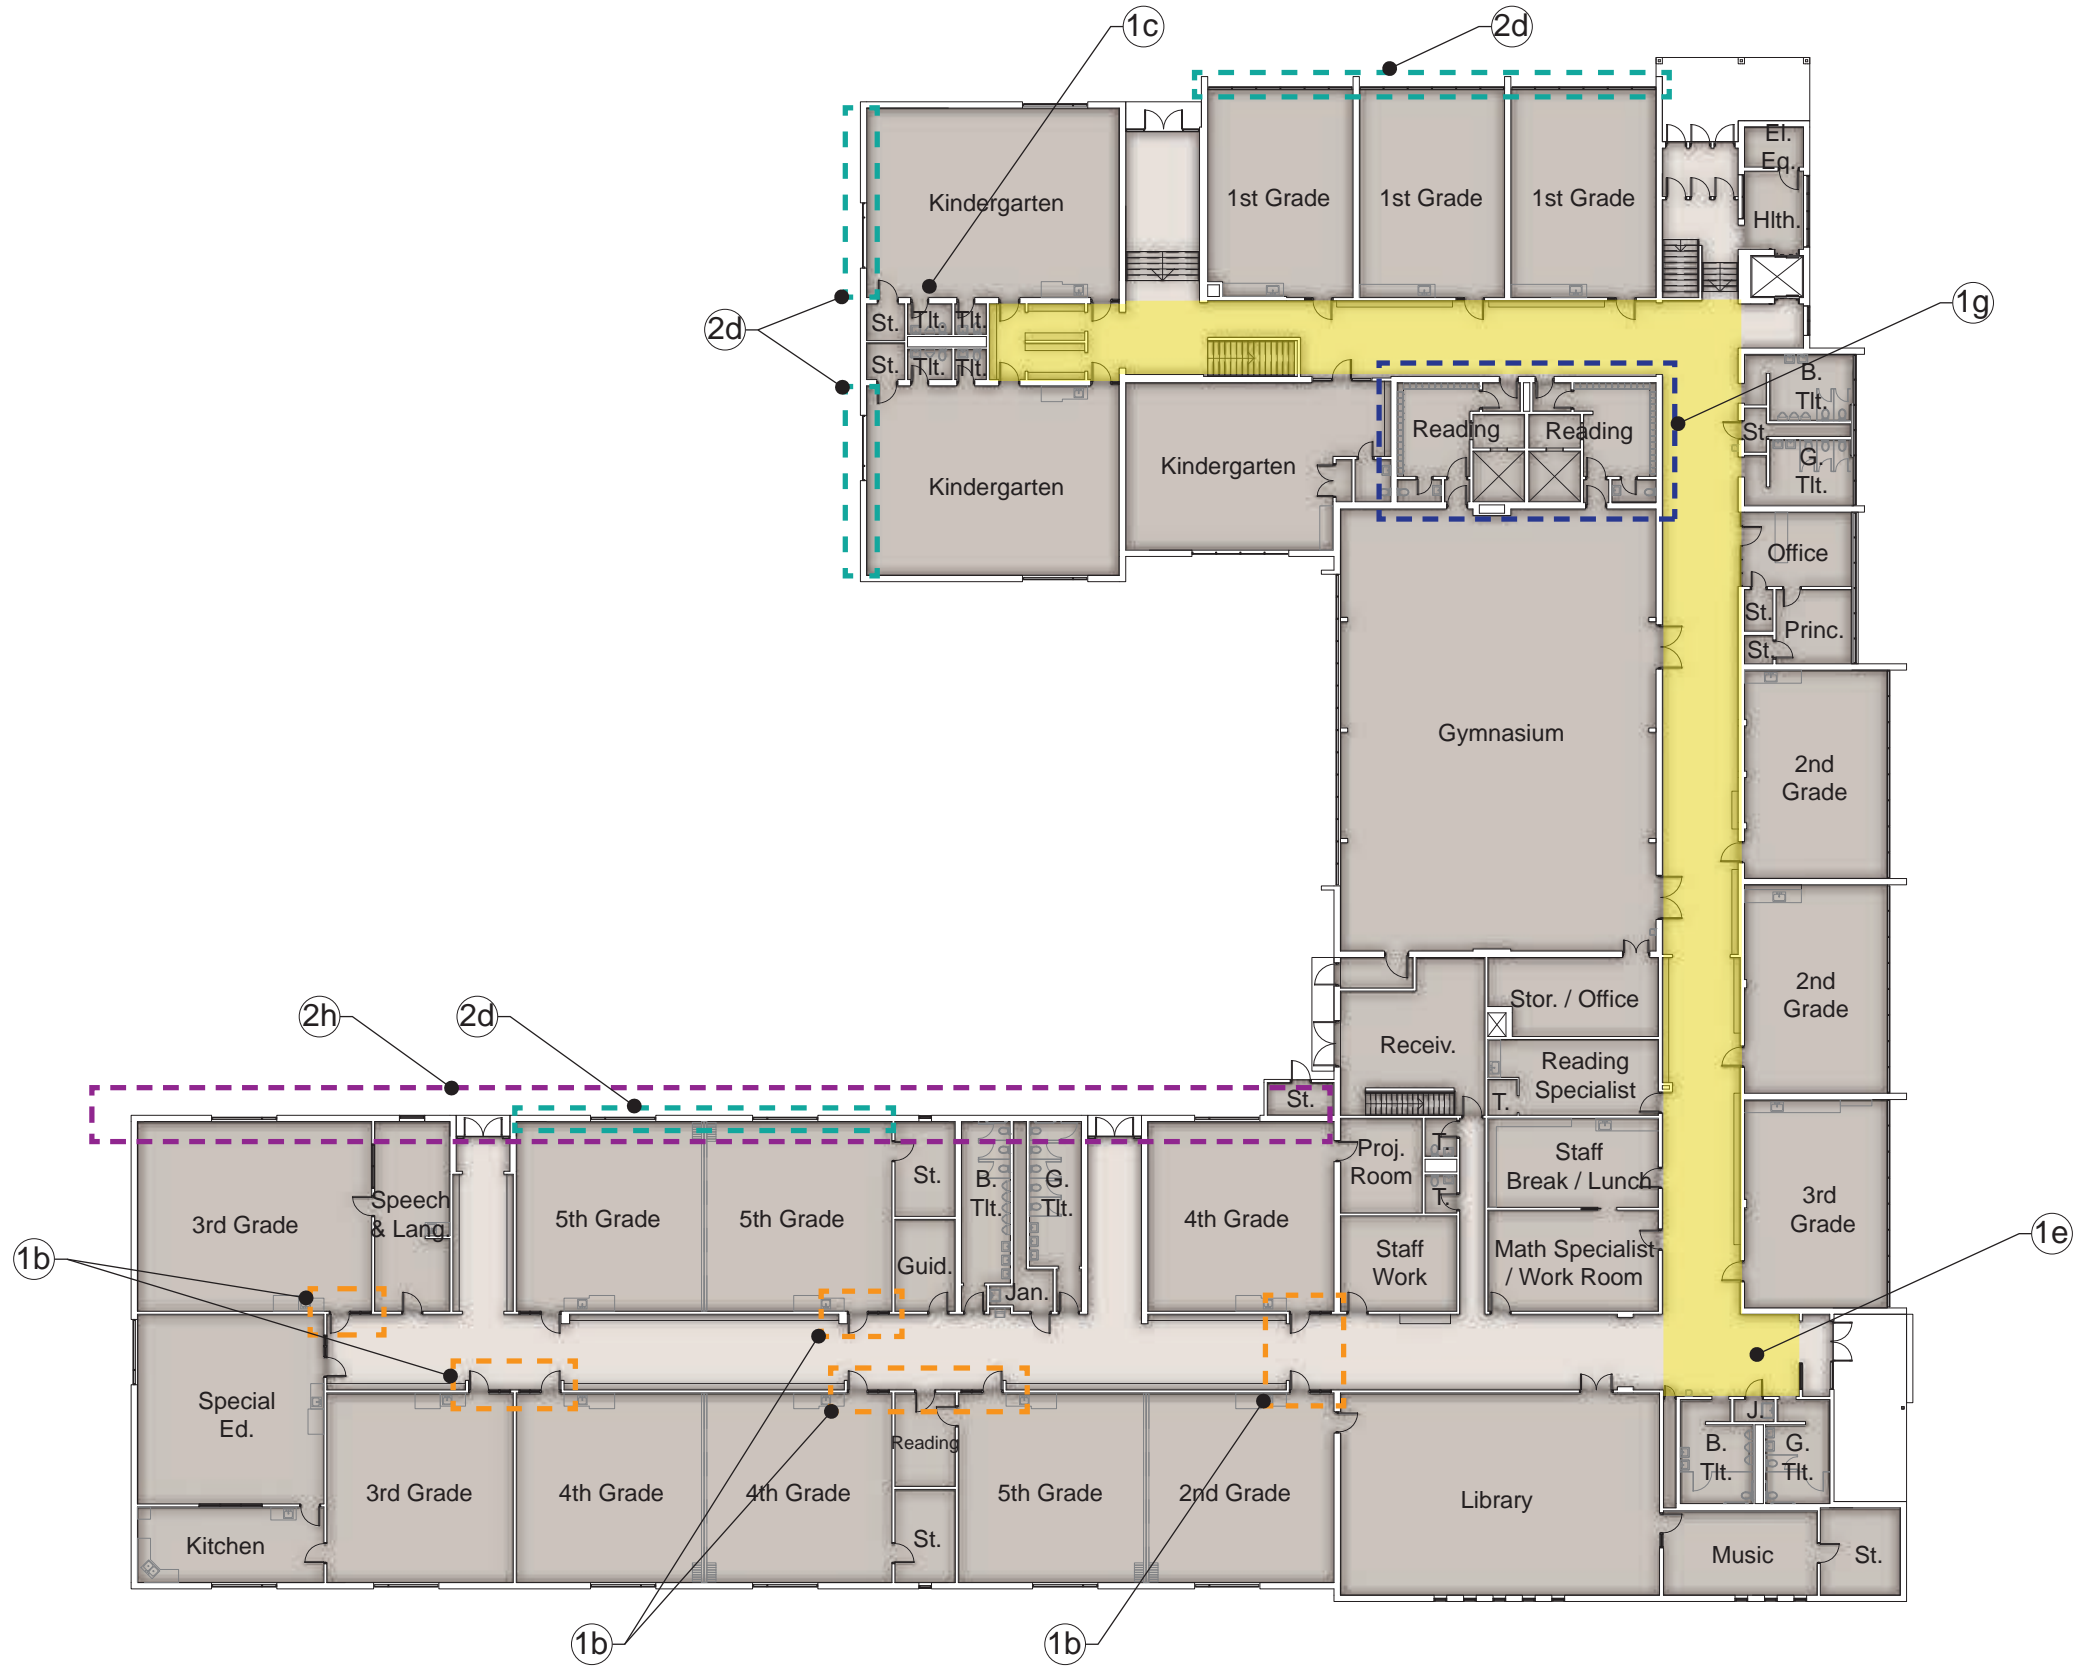
FIRST FLOOR PLAN
not to scale

- a. Some walls are cracking and have paint peeling, but staff reported there are no known current concerns

- c. Pipe coming in from the ceiling in one Kindergarten classroom was reported by staff to often condensate and leak water into the classroom; staff believes this may be due to improper insulation at the roof drain connected to this pipe
- d. There are multiple areas of ceiling tile which appear to have been patched/filled in at one point in time; staff indicated these might be areas where skylights were removed/enclosed

- e. Much of the flooring throughout the building is dated, worn, stained, and is cracking. Tile flooring in the North and East corridors show excessive wear and cracking/heaving
- f. Vinyl base is dated, worn and peeling off in some instances

- a. Some brick is cracking/crumbling and chipped
- b. Some areas of exterior wall are stained, possibly due to water damage and especially at the areas of brick near the base of the building
- c. There are instances where water pools at the foundation wall, and the foundation wall is corroding/chipping away at these areas; staff indicated there are no known concerns with water leaking into the building at these areas

- d. Windows at the Kindergarten classrooms and classrooms along the North side of the building were indicated by staff as drafty and often leaking water and/or having condensation present at the glazing
- e. Many window screens are damaged/dented

- f. All doors except the main entrance doors are original to the building, are damaged/dented, have large gaps in the frames, and were reported by staff to often leak water and have trouble opening/closing
- g. Main (front) entrance doors were replaced decades ago as reported by staff, but are dated, damaged, and were reported by staff to be drafty and leak water

- h. Gutter downspouts appear to have been removed along the North wall of the South classroom wing, allowing water to drain to grade uncontrollably at these locations and resulting in large areas where water pools and ices over in winter
- i. Undersides of roof overhangs are worn, rotting, and stained, possibly due to water damage
- j. Roof fascia is worn and damaged/dented, especially at the corner conditions

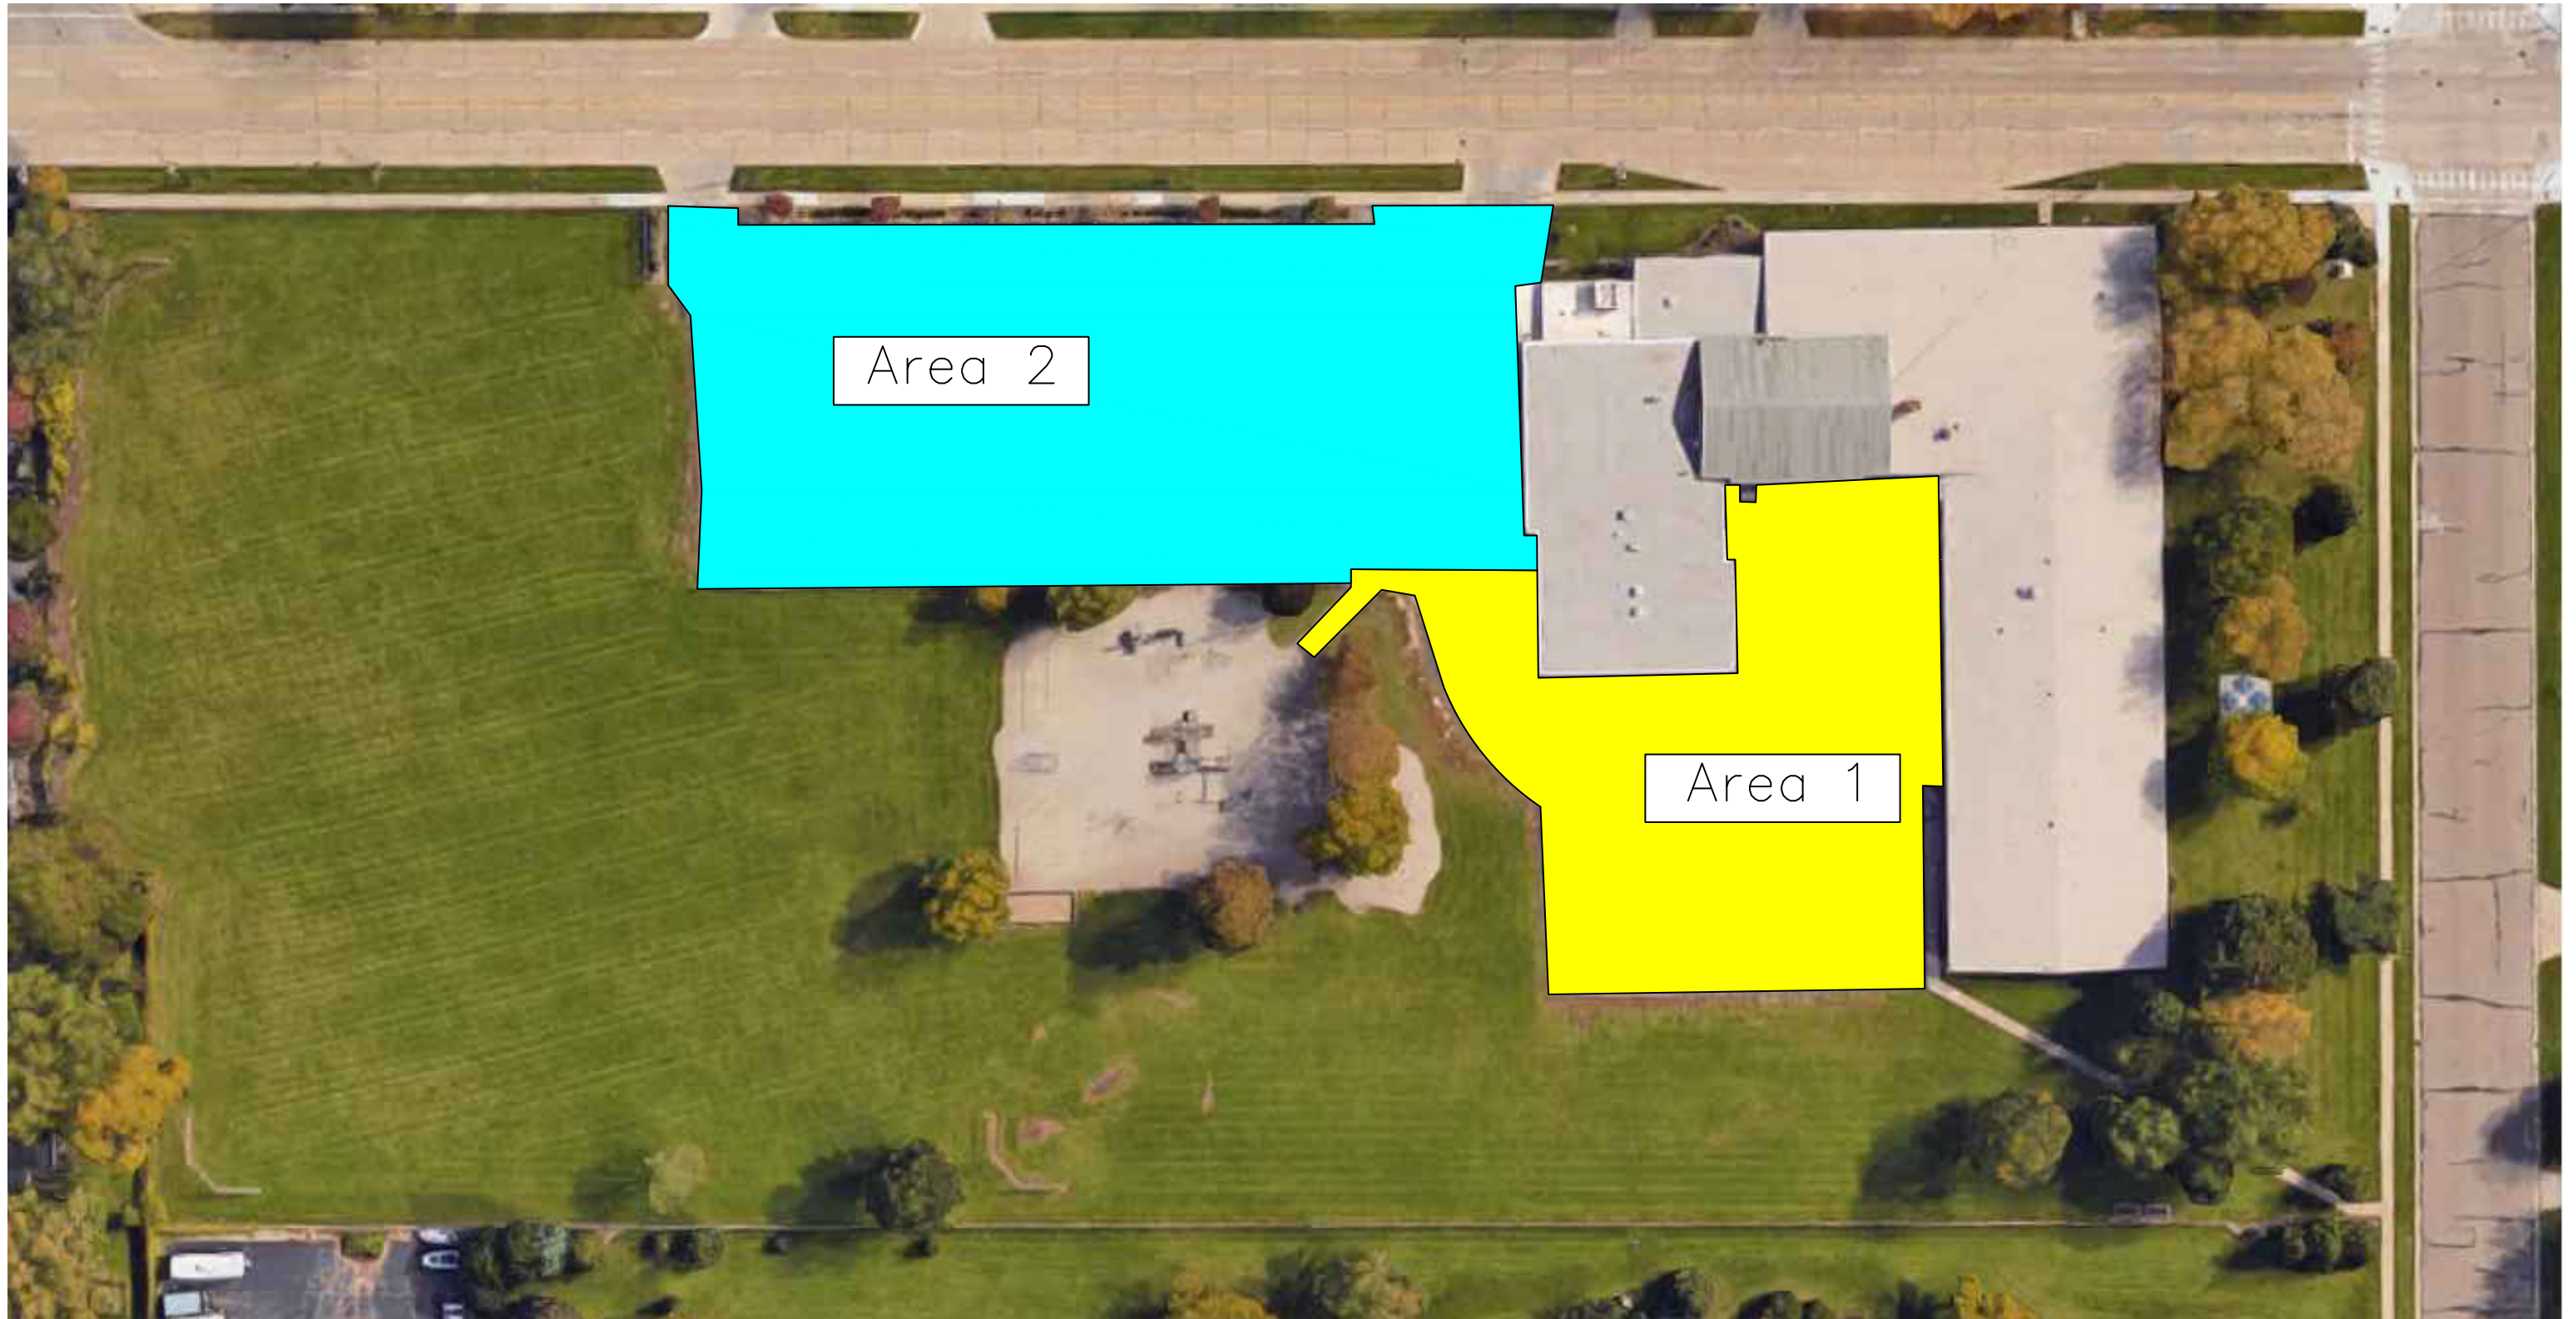
SITE PLAN
not to scale

- Playground equipment is dated and breaks often, as indicated by staff; staff reported the existing swing-set is to be removed, and new equipment with a poured-in-place playground surface may be installed
- Basketball hoops are dated and rusted
- There is no dumpster enclosure

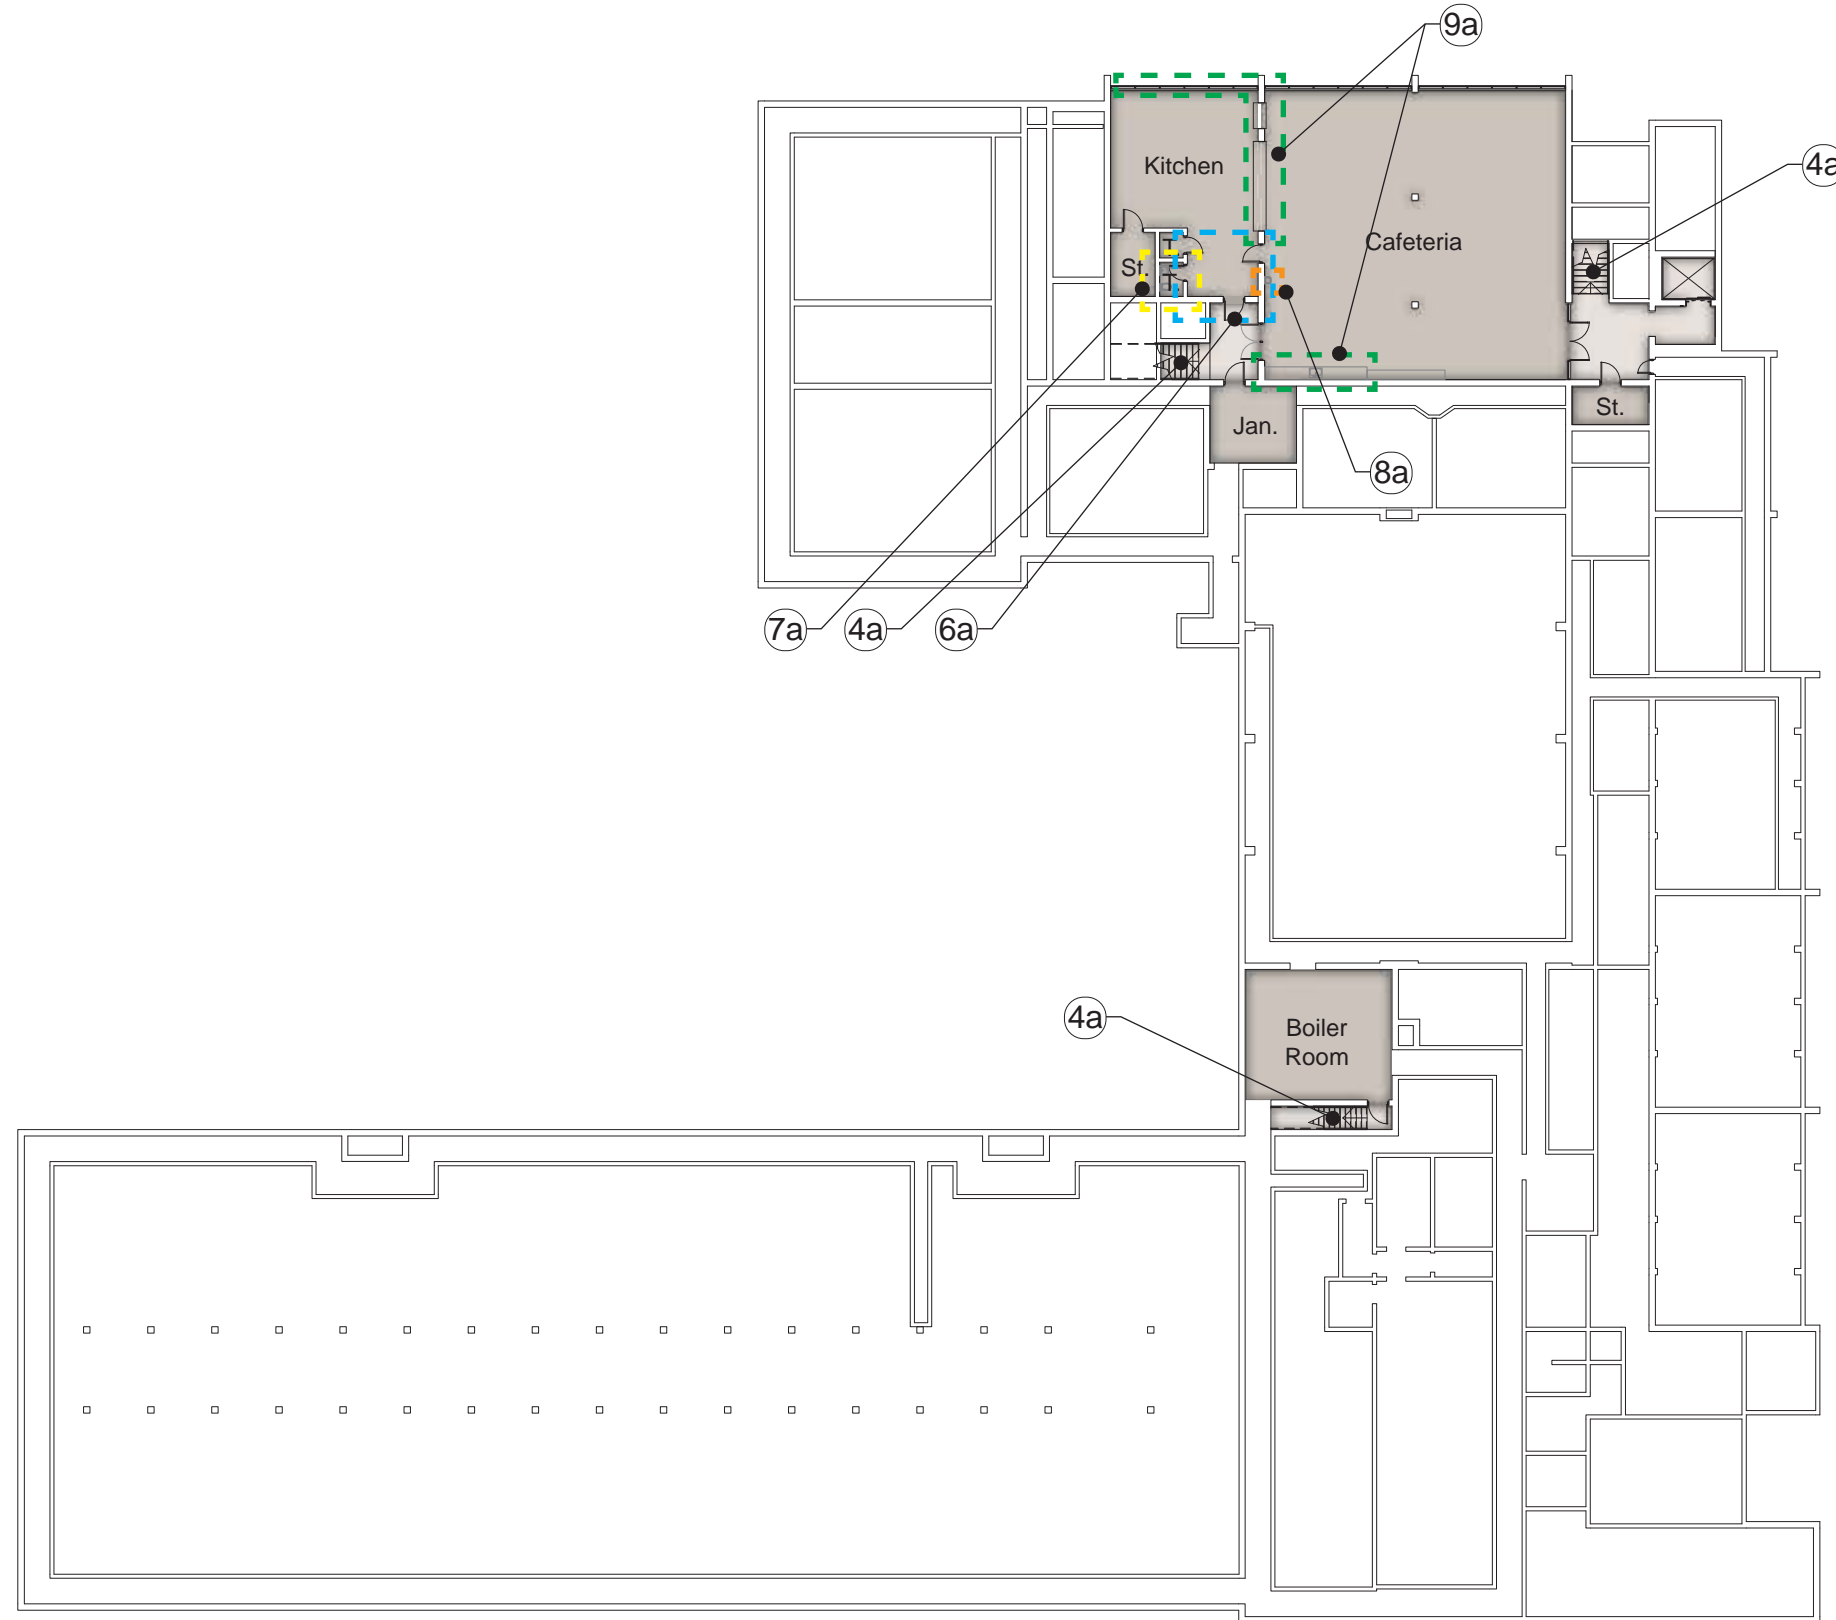
LOWER FLOOR PLAN
not to scale

9a. There are counter-tops that do not meet the above criteria for meeting accessibility standards.

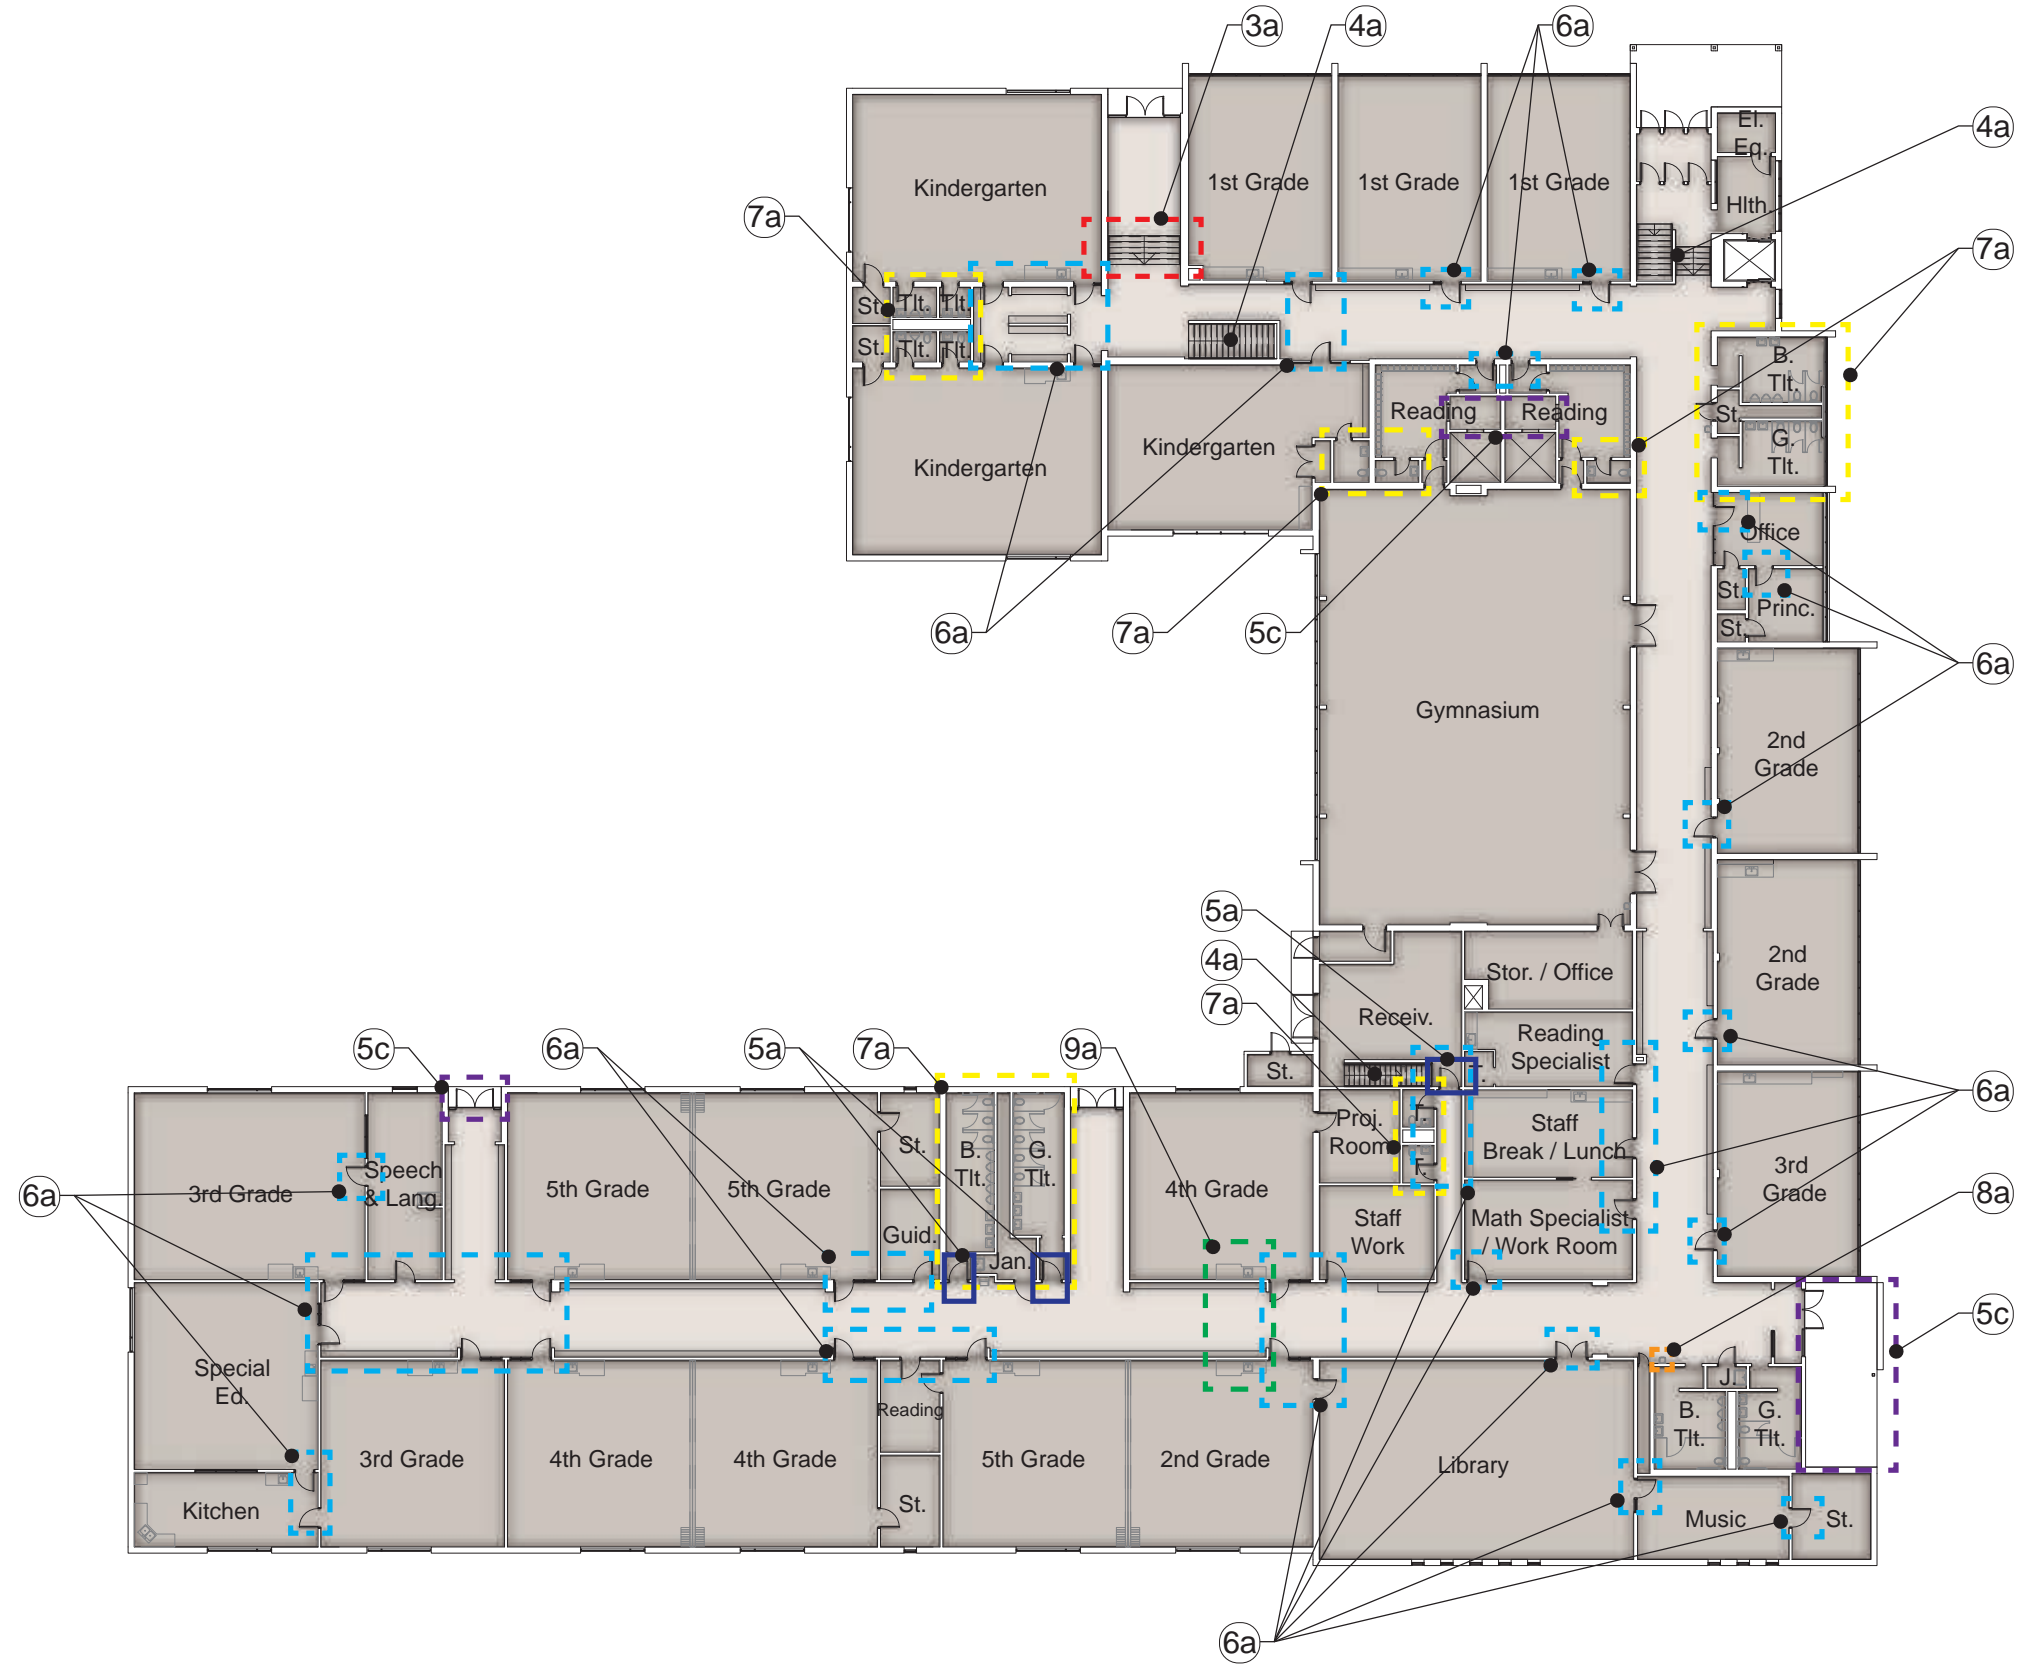
FIRST FLOOR PLAN
not to scale

9a. There are counter-tops that do not meet the above criteria for meeting accessibility standards.

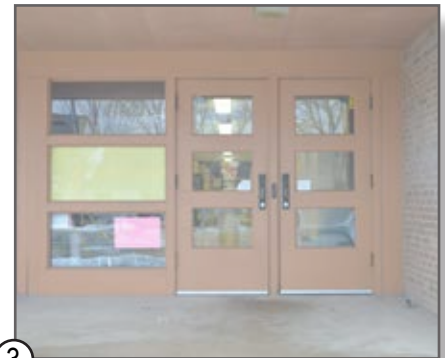
① HOLLOW METAL DOORS & HOLLOW METAL FRAME; STAFF INDICATED CONCERN
