# 10 WILSON ELEMENTARY

**WILSON ELEMENTARY: NEEDS ASSESSMENT**

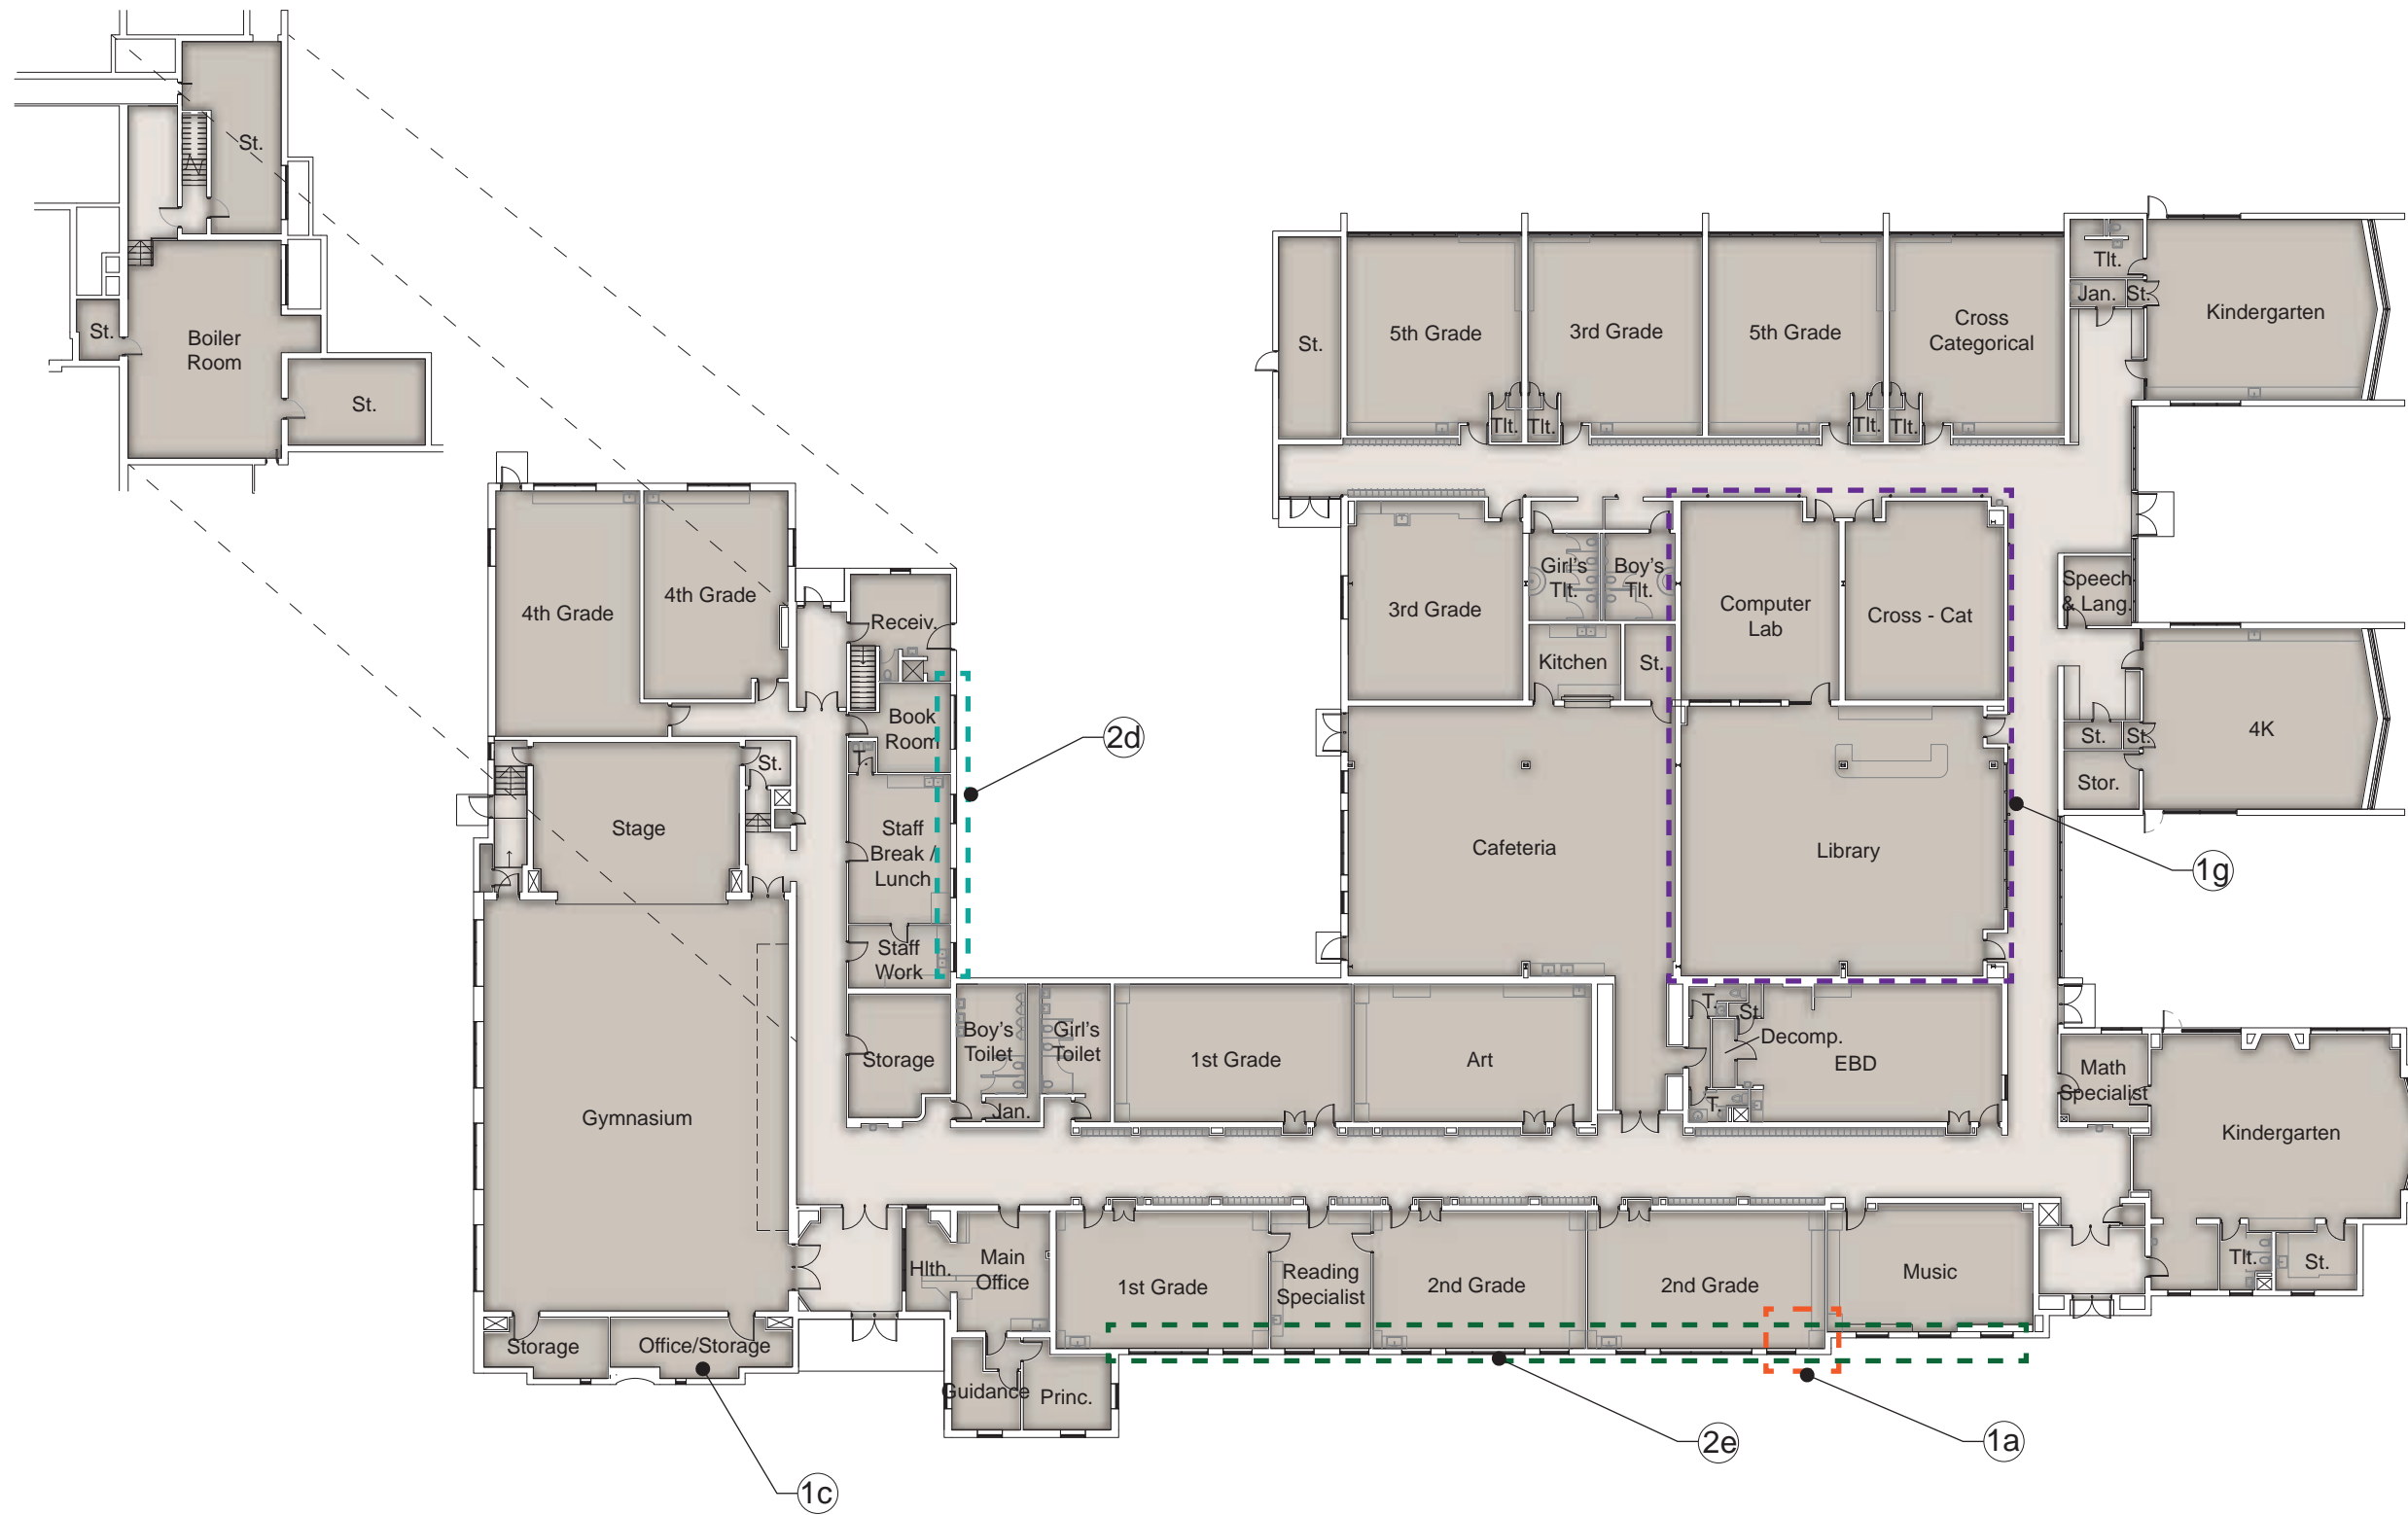
FIRST FLOOR PLAN  
not to scale

- a. Some walls are cracking and have paint peeling. Staff pointed out a particular cracked area hidden within a closet in classrooms 5; further investigation is needed to determine the cause of cracking

- c. Ceilings within the storage/office area behind the Gymnasium were reported by staff as continually leaking water into the building, and there is a significant amount of staining present
- d. There are multiple areas of ceiling tile which appear to have been patched/filled in at one point in time; staff indicated these might be areas where skylights were removed/enclosed

- e. Much of flooring is stained, worn, and cracking/heaving
- f. Staff indicated areas of potential asbestos tile throughout the building
- g. Carpeting throughout the building is worn, dated and stained, especially in the Library and Computer Room

- a. Half-wall outside the main entry doors is cracking and stained, possibly due to water damage
- b. Exterior walls are stained, possibly due to water damage; this is especially prevalent at the window sills, roof parapets, decorative door frames, and foundation wall
- c. Exterior brick is crumbling/cracking, especially at building corner conditions and near the foundation wall, and there are some areas where tuckpointing is present; staff reported tuckpointing was addressed a few years ago and has since not been a concern

- d. Wood windows are single-pane and have wood and paint peeling at the frame; staff reported that these windows are drafty and there are issues with water leaking into the building and condensation/frost build up on window panes
- e. Glass block windows are cracked and many have adjacent single-pane windows that staff reported are also drafty and leak water into the building; some glass block appears to have been replaced over time

- f. Nearly all wood frame exterior doors are worn and rotting
- g. Steel frame doors were recently replaced

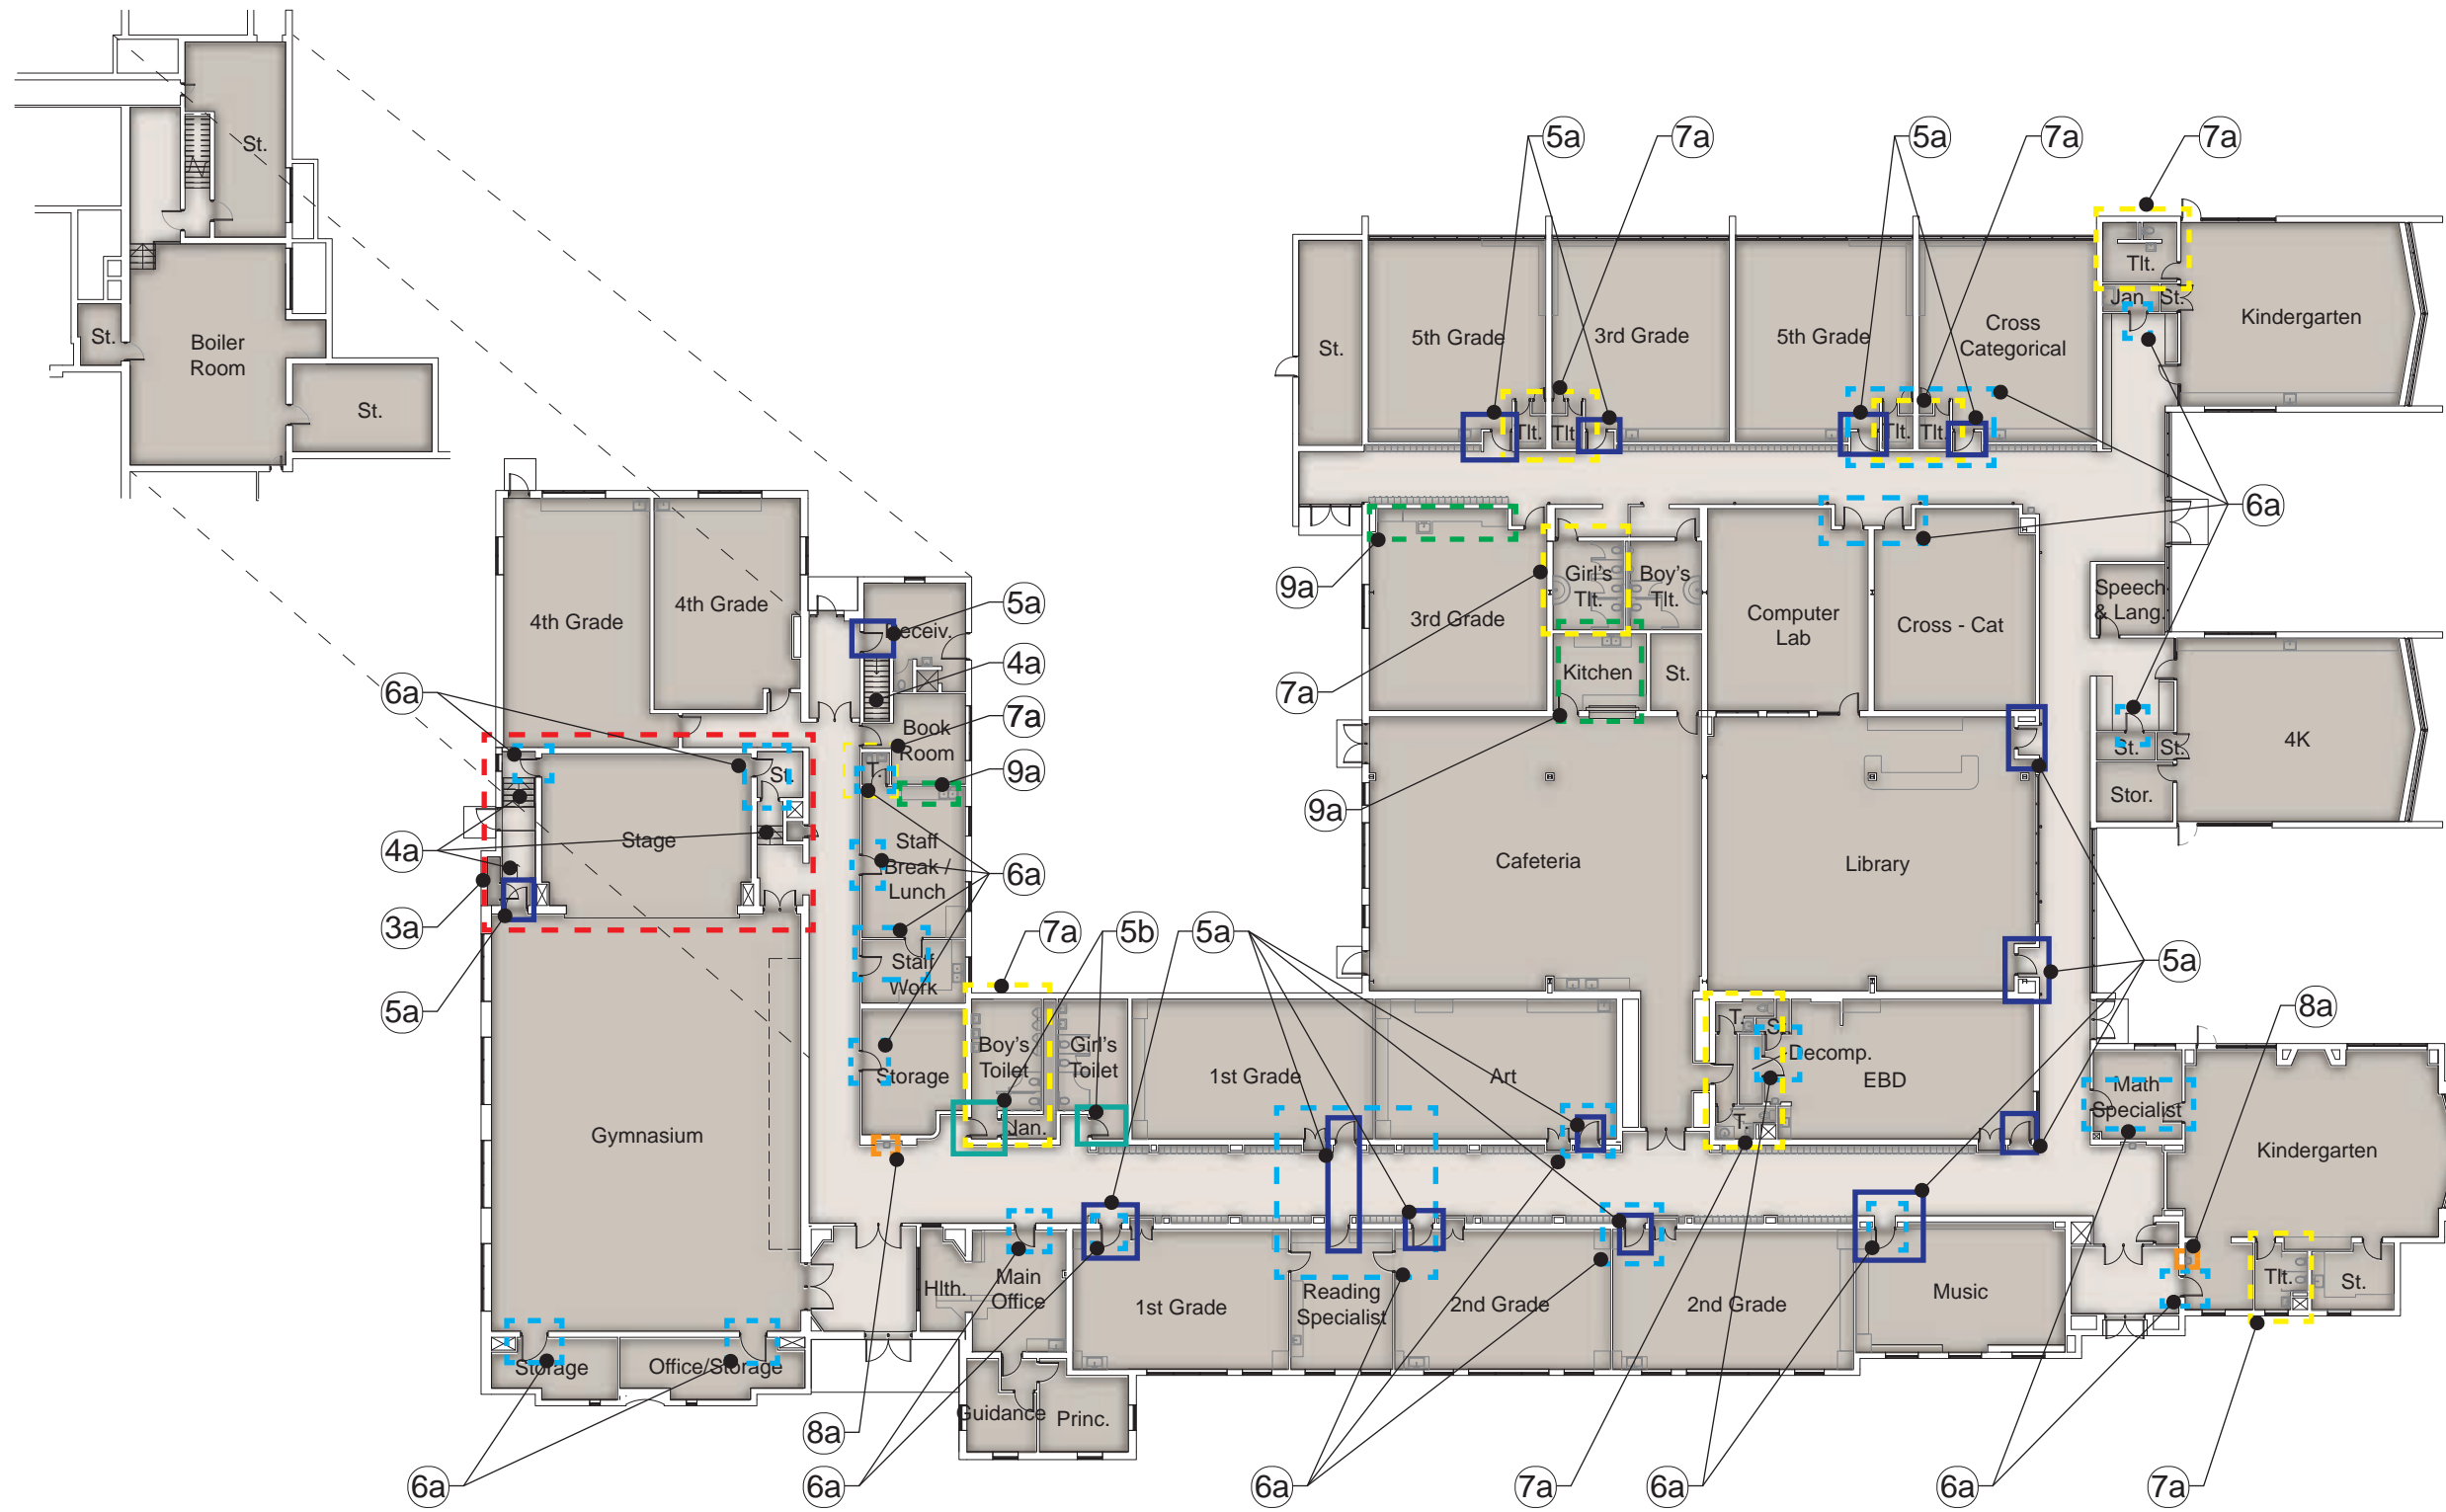
FIRST FLOOR PLAN  
not to scale

9a. There are counter-tops that do not meet the above criteria for meeting accessibility standards.

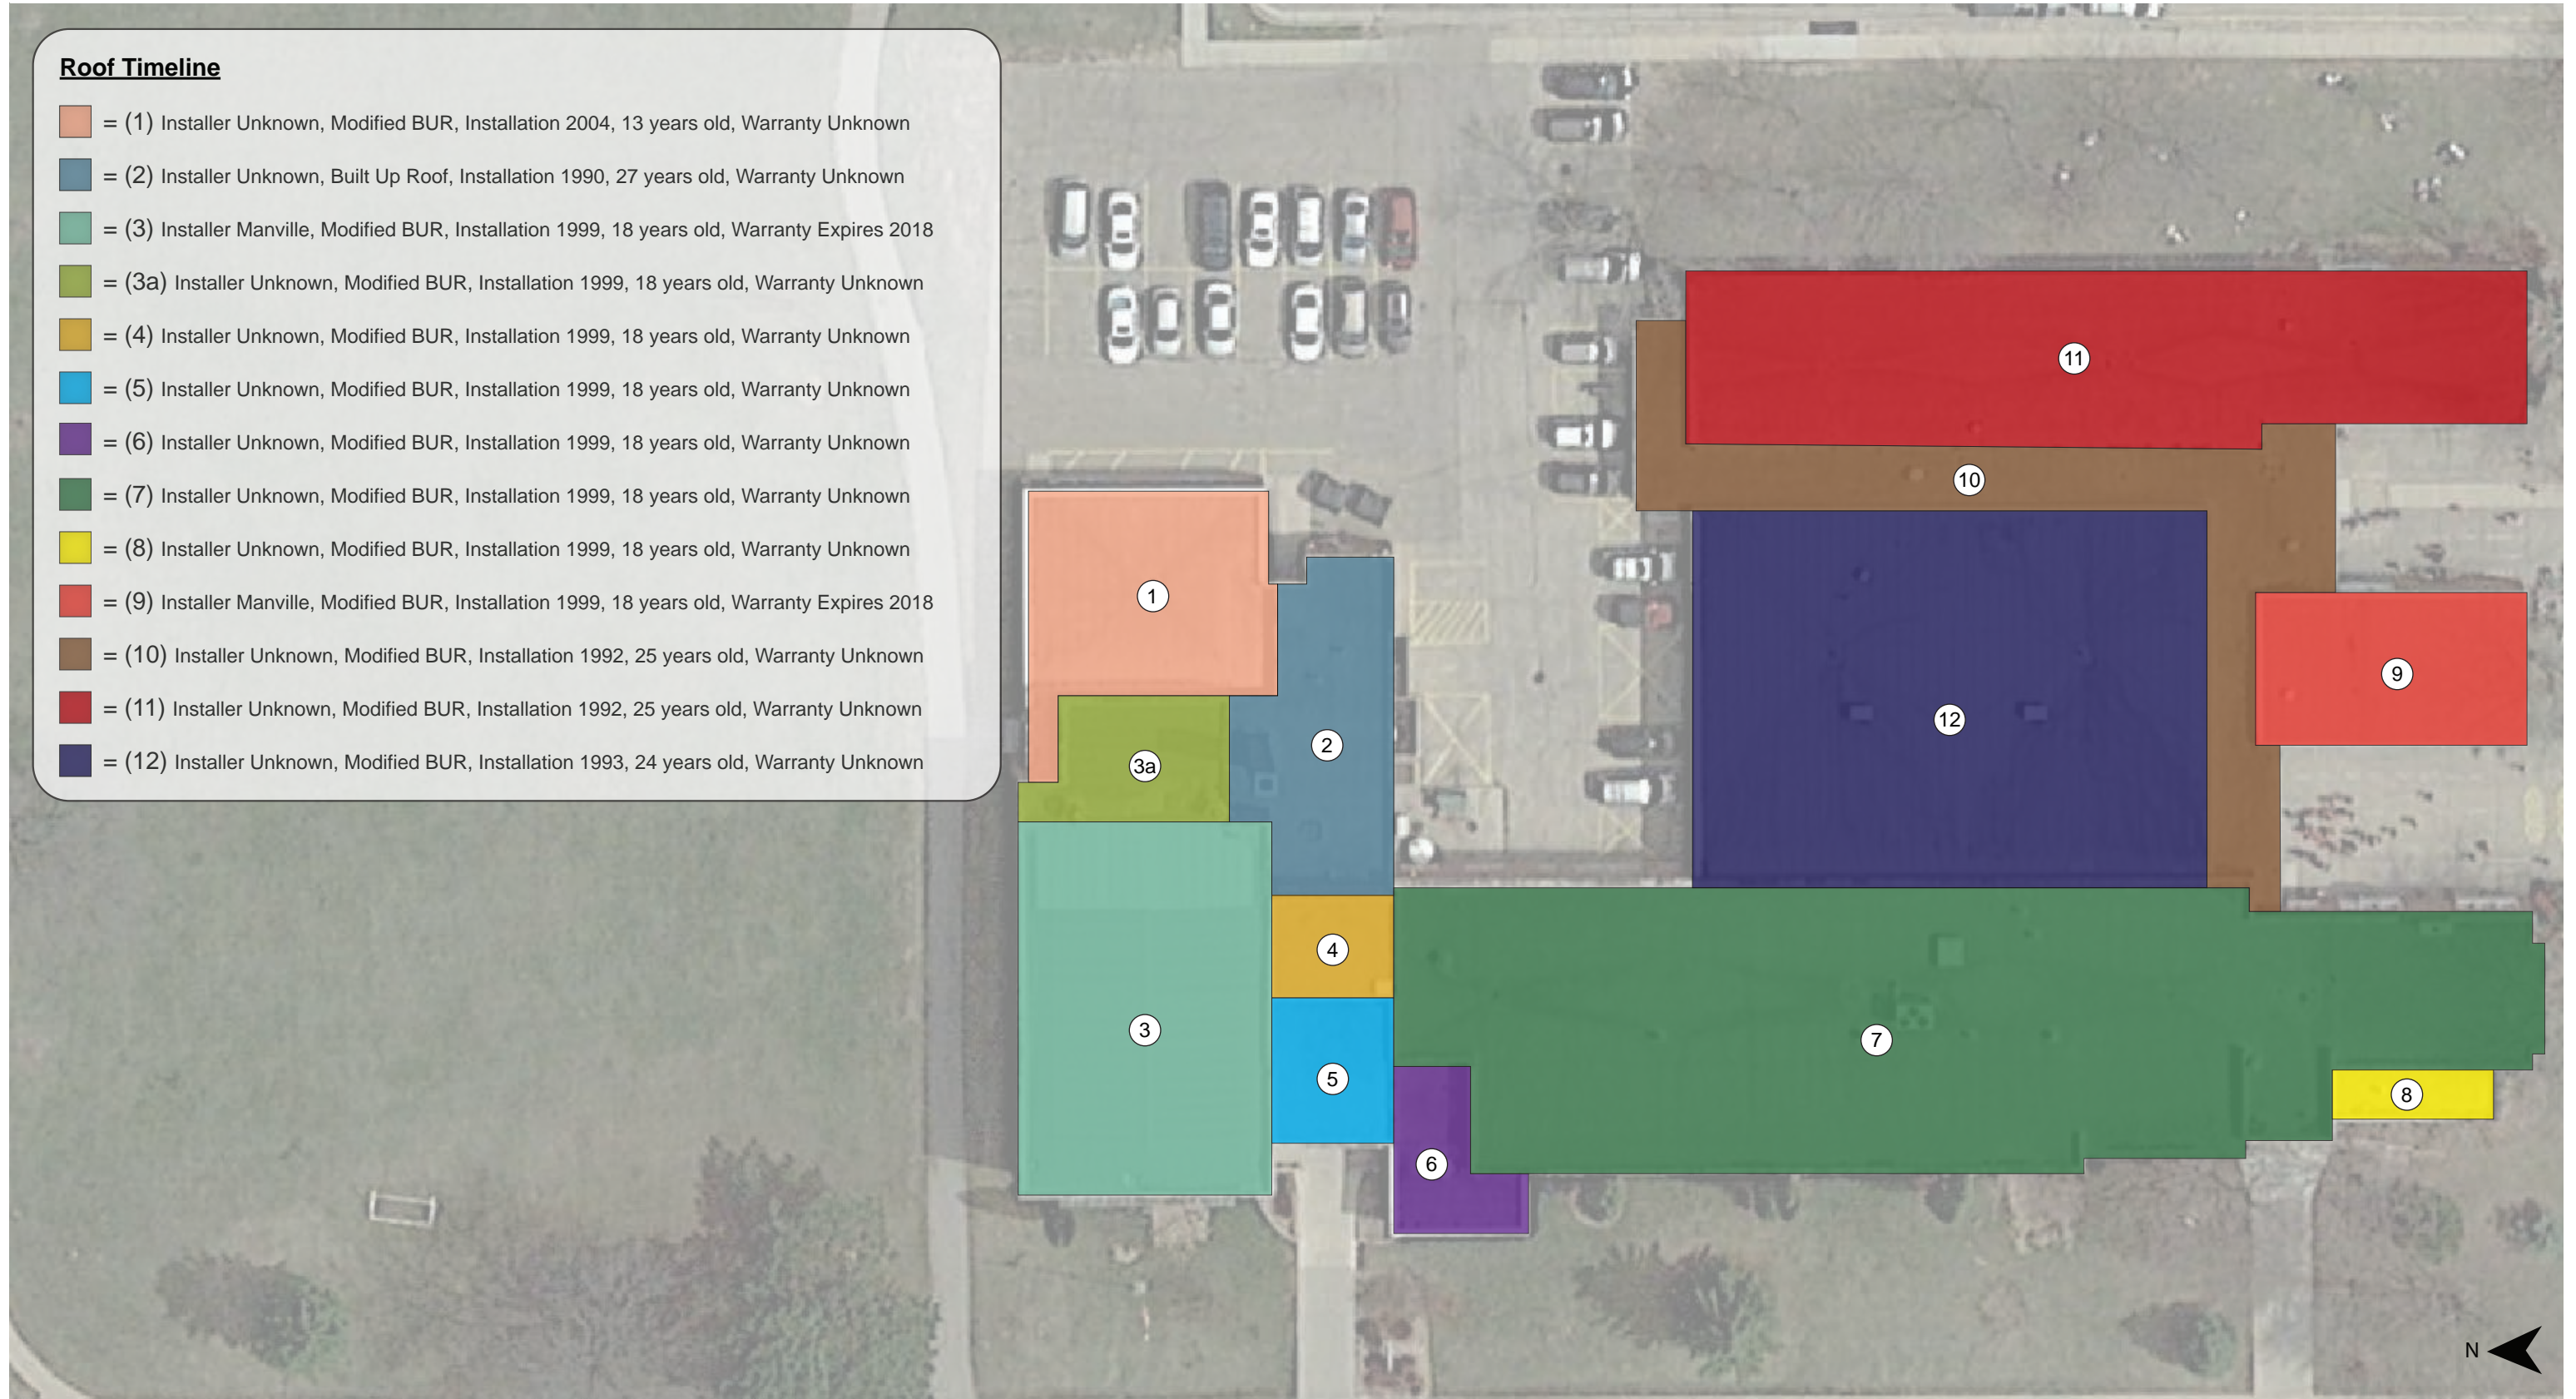
ROOF PLAN  
not to scale

- = (10) Installer Unknown, Modified BUR, Installation 1992, 25 years old, Warranty Unknown
- = (11) Installer Unknown, Modified BUR, Installation 1992, 25 years old, Warranty Unknown

- = (12) Installer Unknown, Modified BUR, Installation 1993, 24 years old, Warranty Unknown
