14 ADMINISTRATION BUILDING

The Administration building resides in the old Kimberly High School building and houses District Office Staff.

The Administration Building was originally constructed in 1907 as Kimberly High School. A garage addition was completed in 1977 and another addition in 2009, and now serves as the Neenah Joint School District Office.

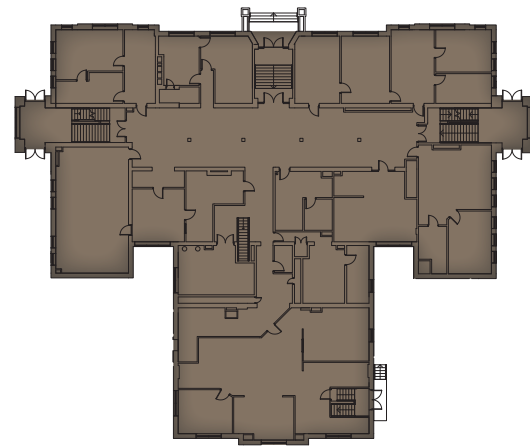
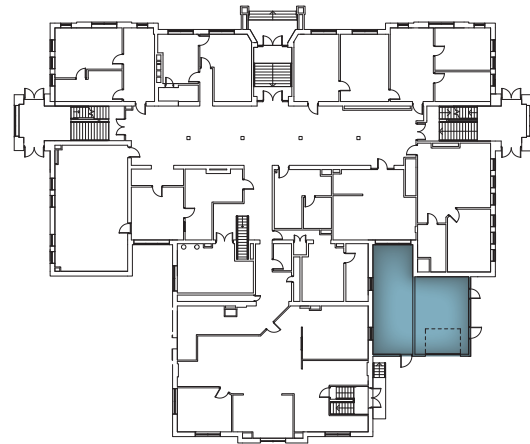
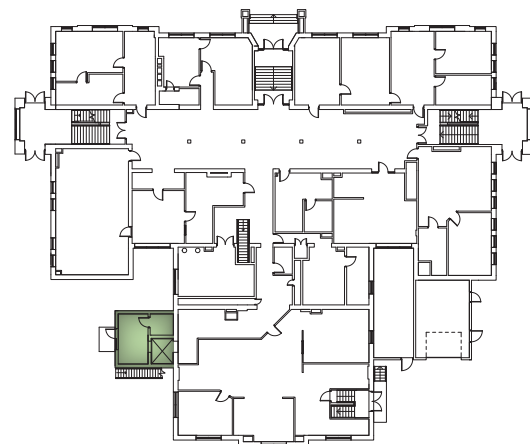
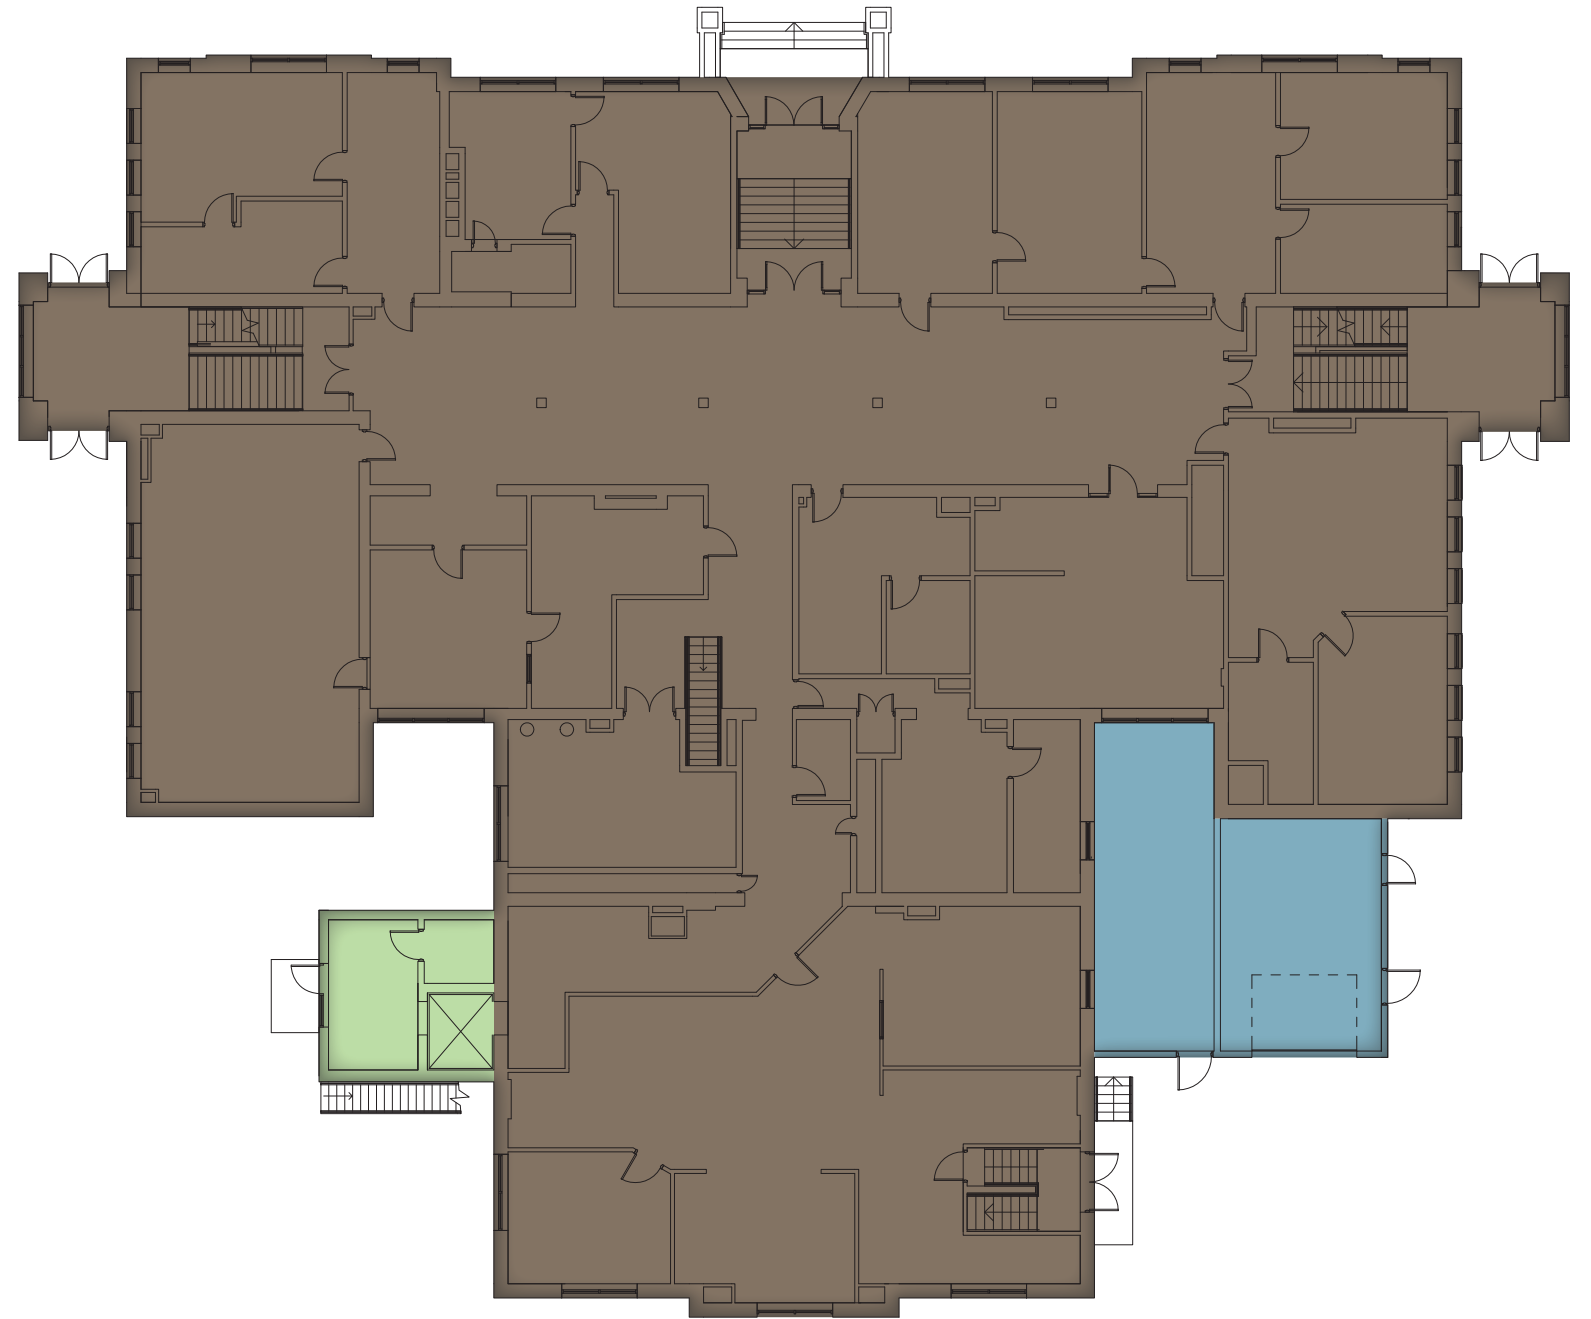
ADMINISTRATION BUILDING: BUILDING EVOLUTION

The following building evolution diagram outlines the additions made to the original building over time due primarily to student enrollment growth.

1907

1977

2009

= 1907 - Original
-

= 1977 - Garage/Storage Addition
-

= 2009 - Entrance Addition

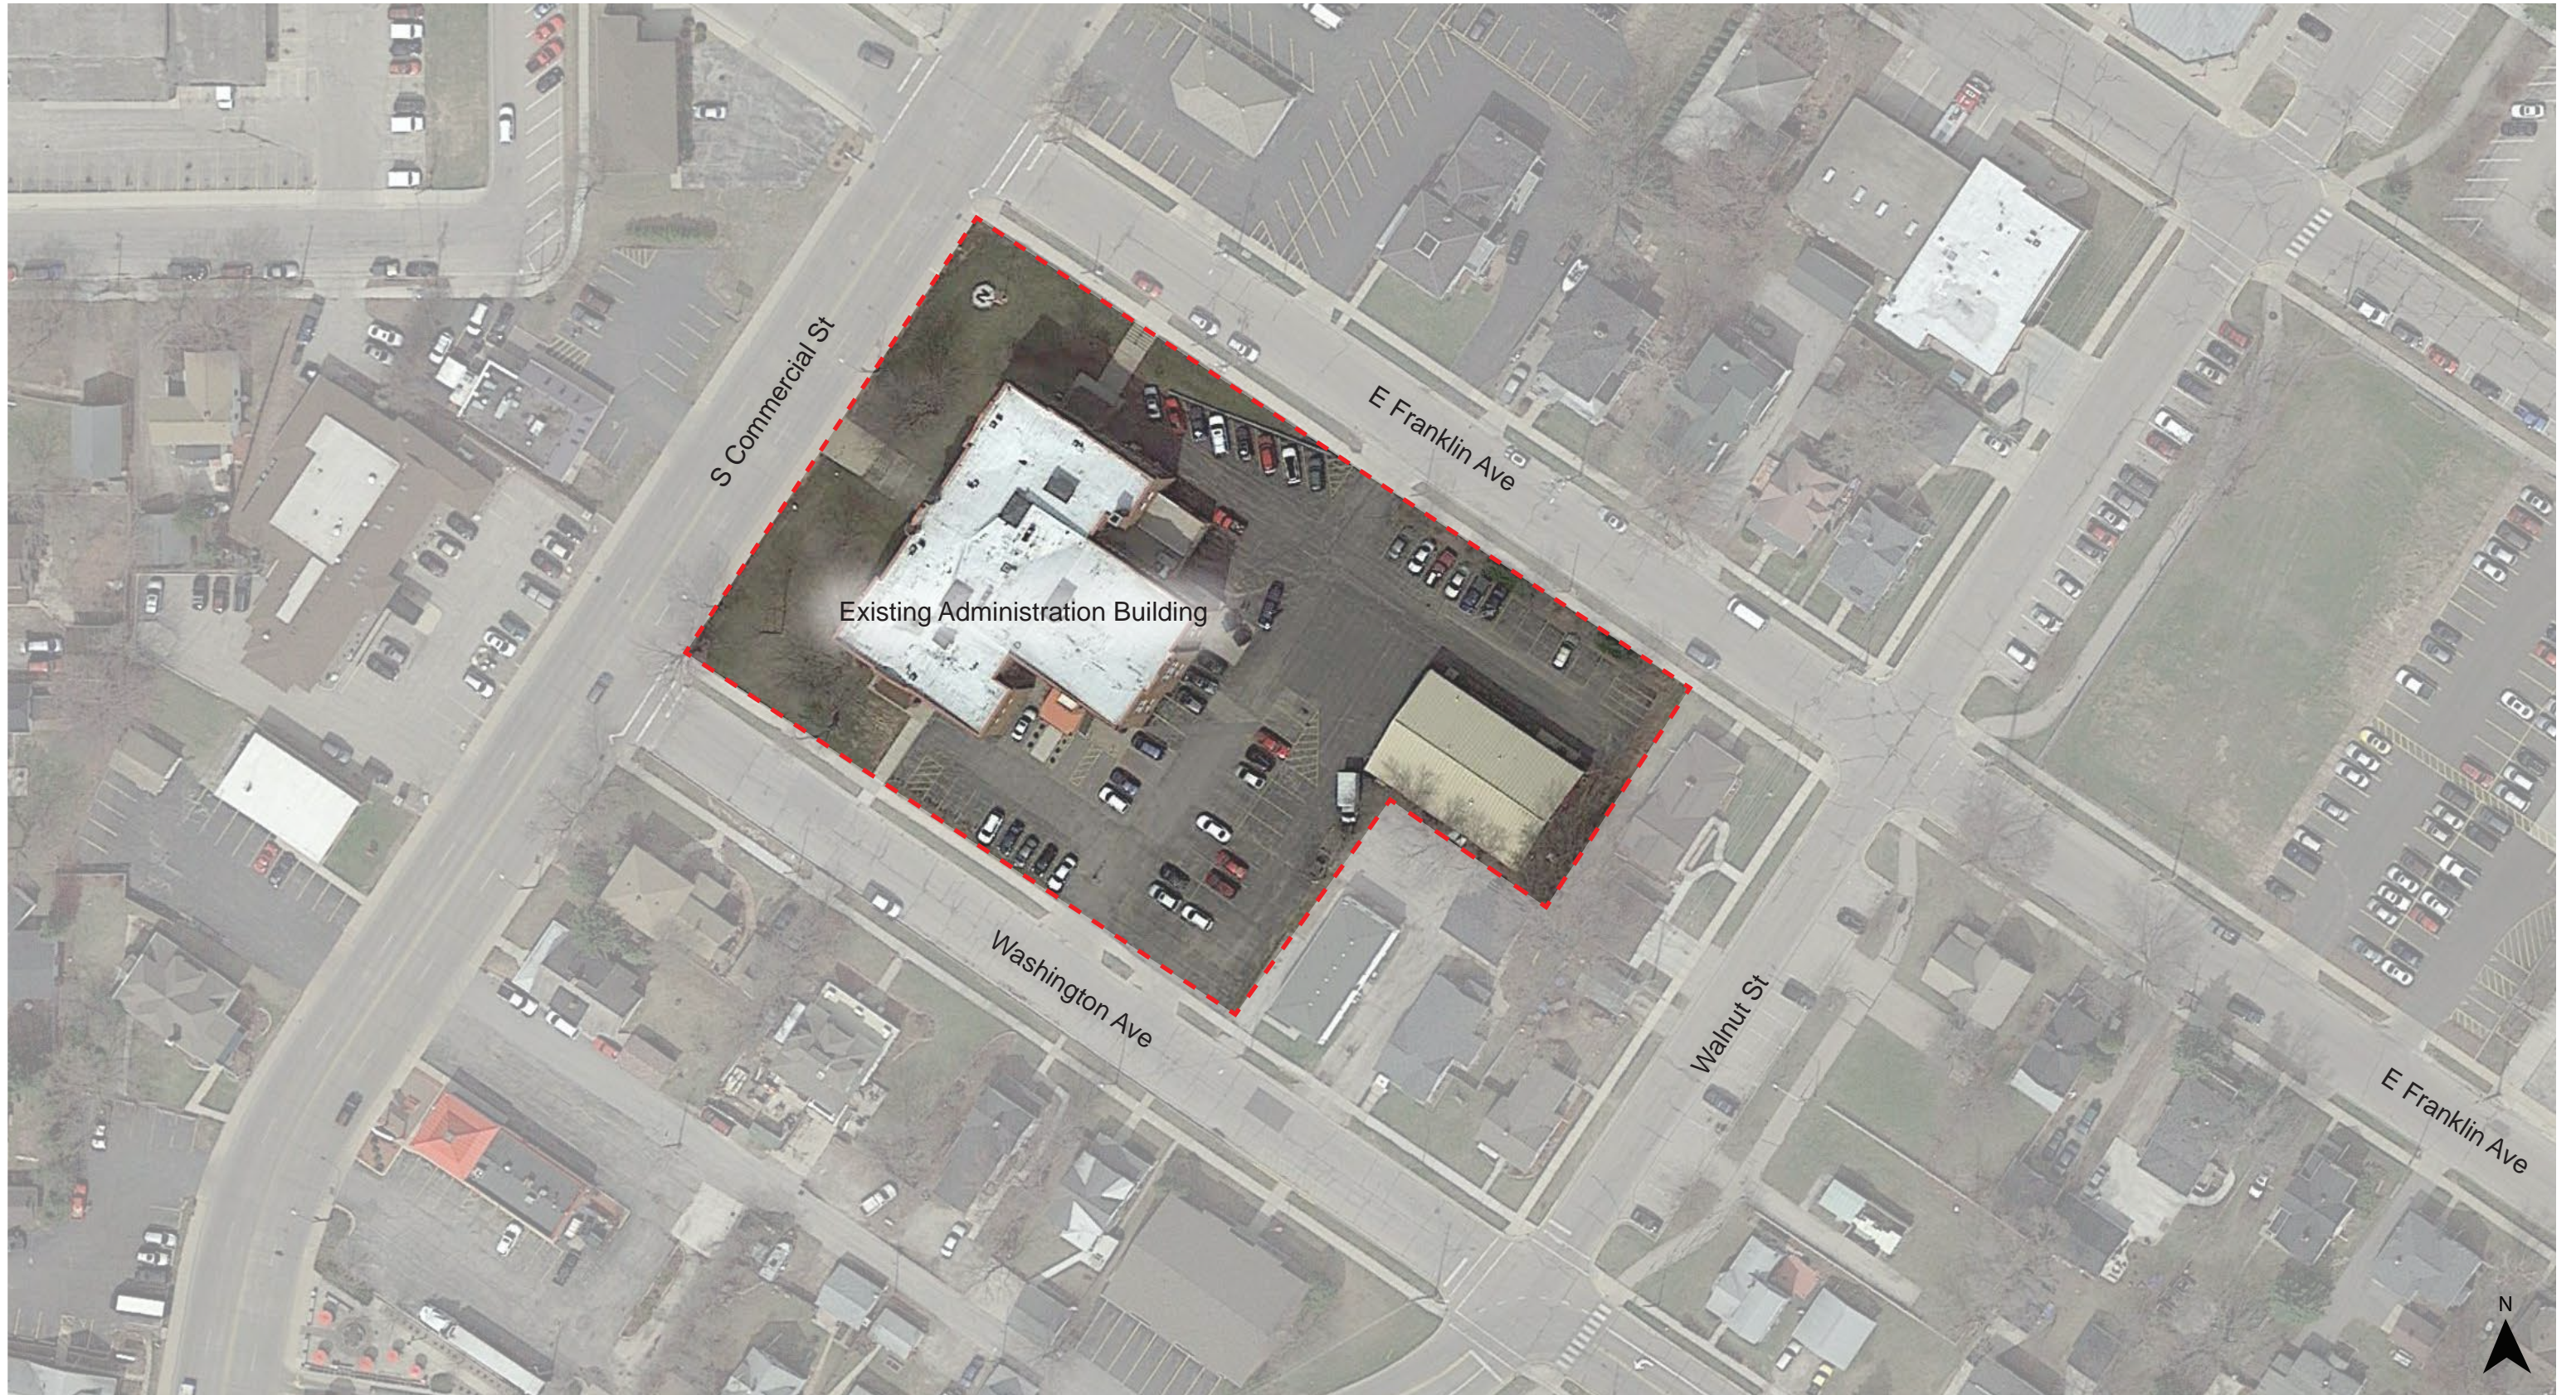
SITE PLAN
not to scale

BUILDING AREA: 46,535 sq. ft.
SITE SIZE: 1.90 ACRES; 85% IMPERVIOUS SURFACE
PARKING: 60 STALLS (4 HANDICAP, 56 REGULAR)

ADMINISTRATION BUILDING: EXISTING SITE PLAN

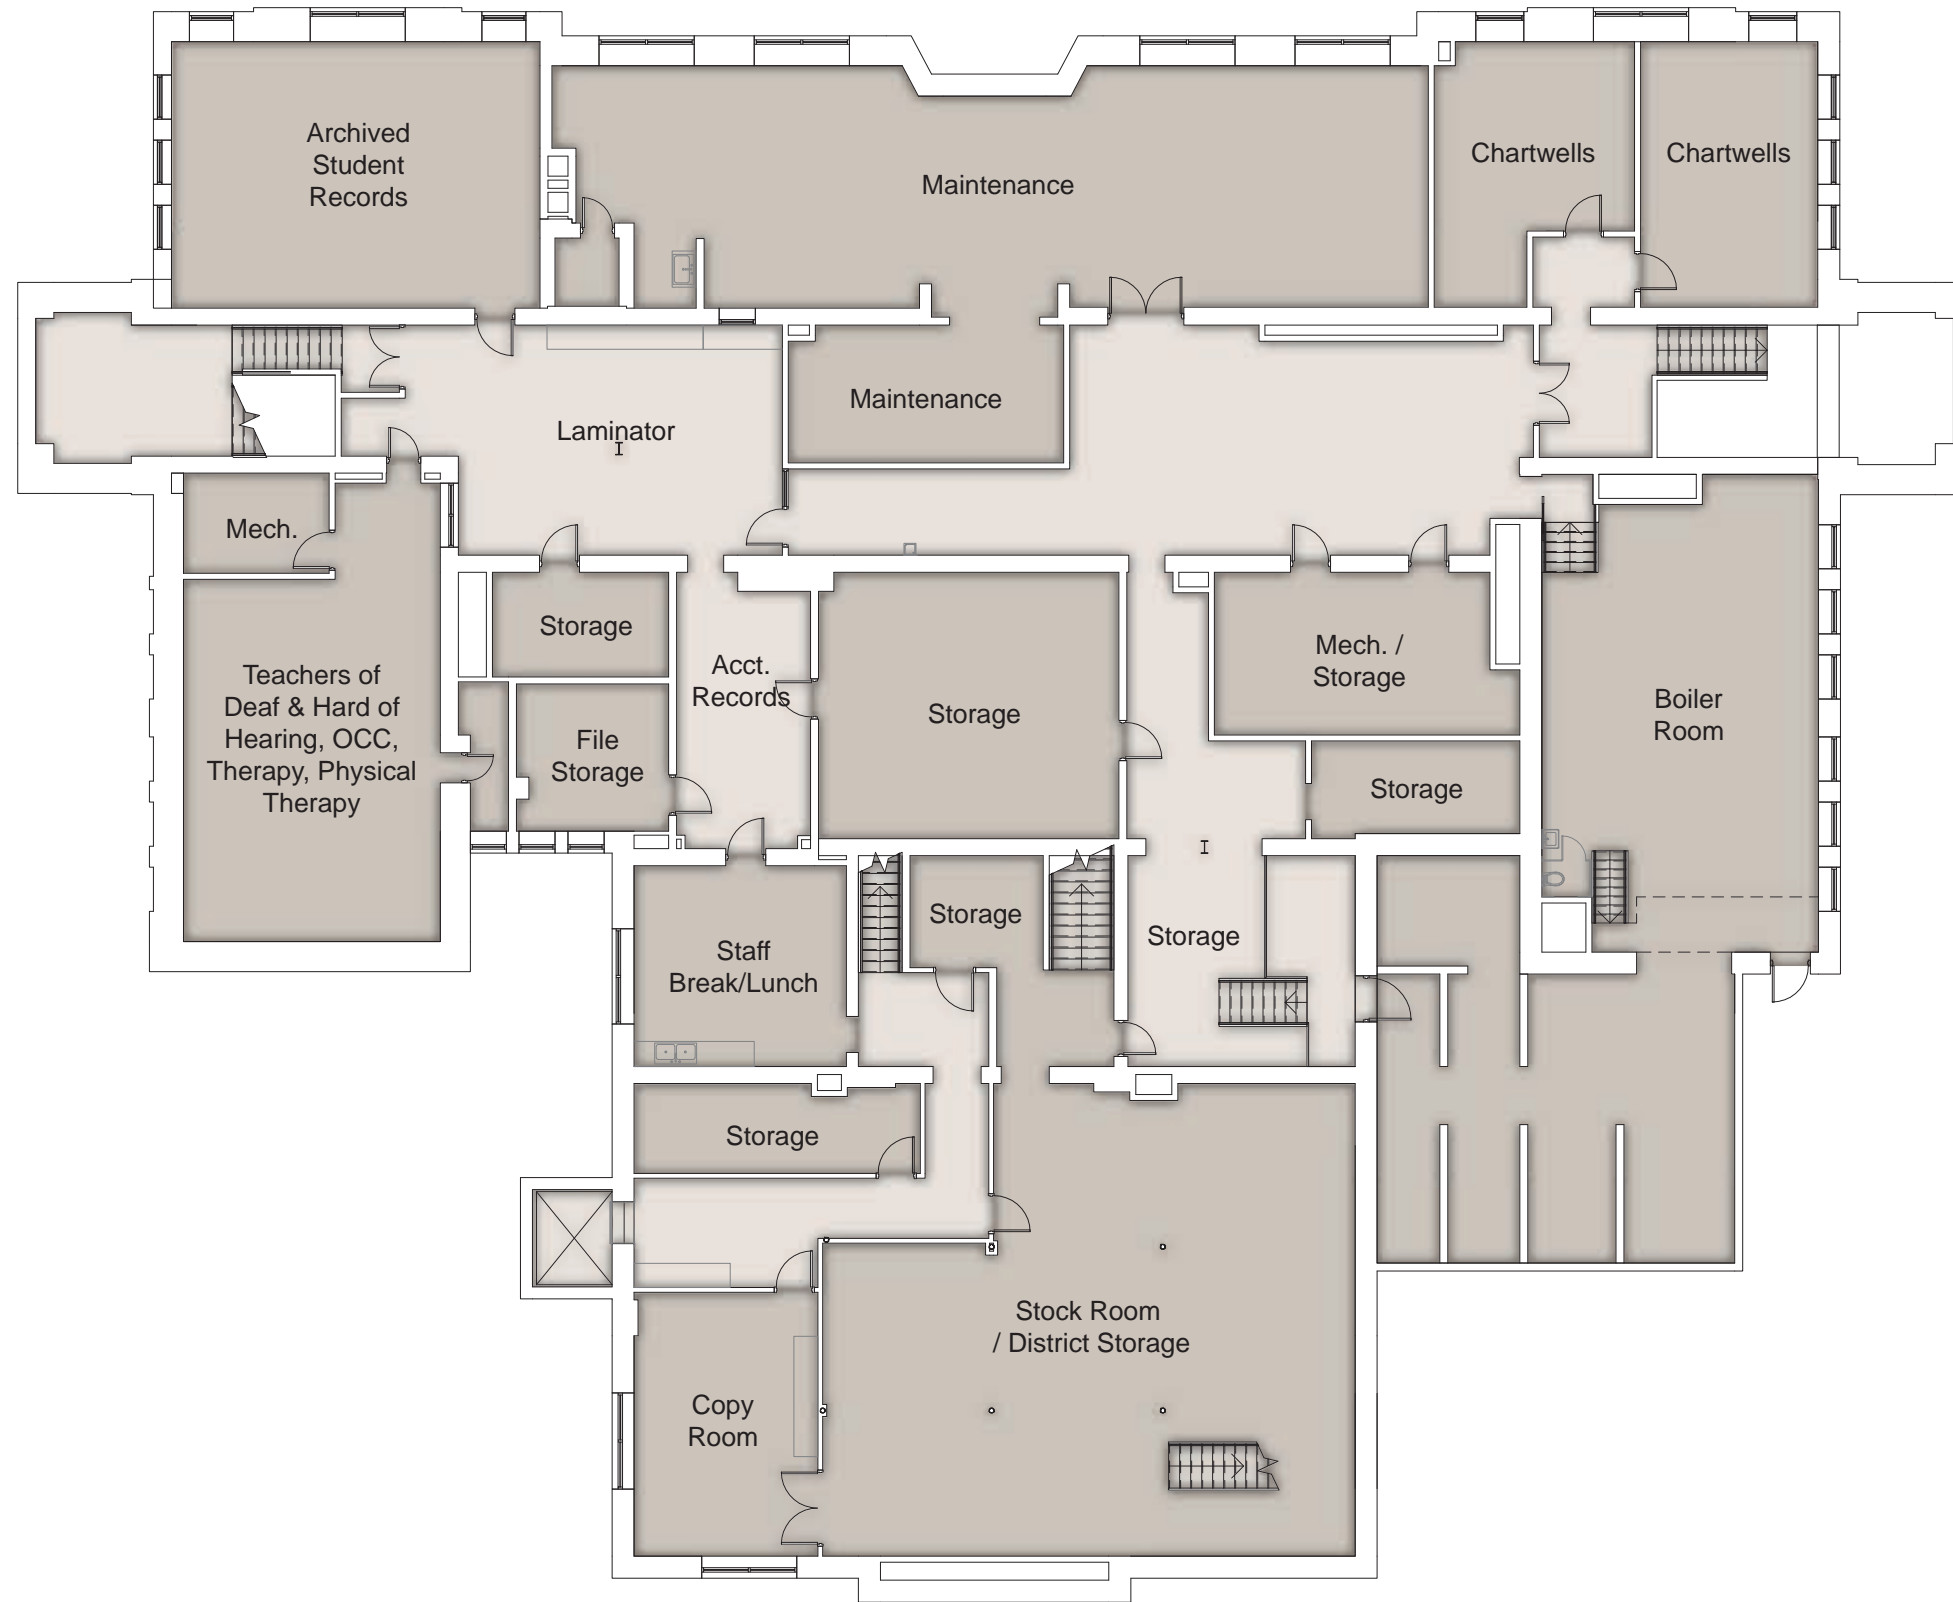
LOWER FLOOR PLAN
not to scale

ADMINISTRATION BUILDING: EXISTING FLOOR PLAN

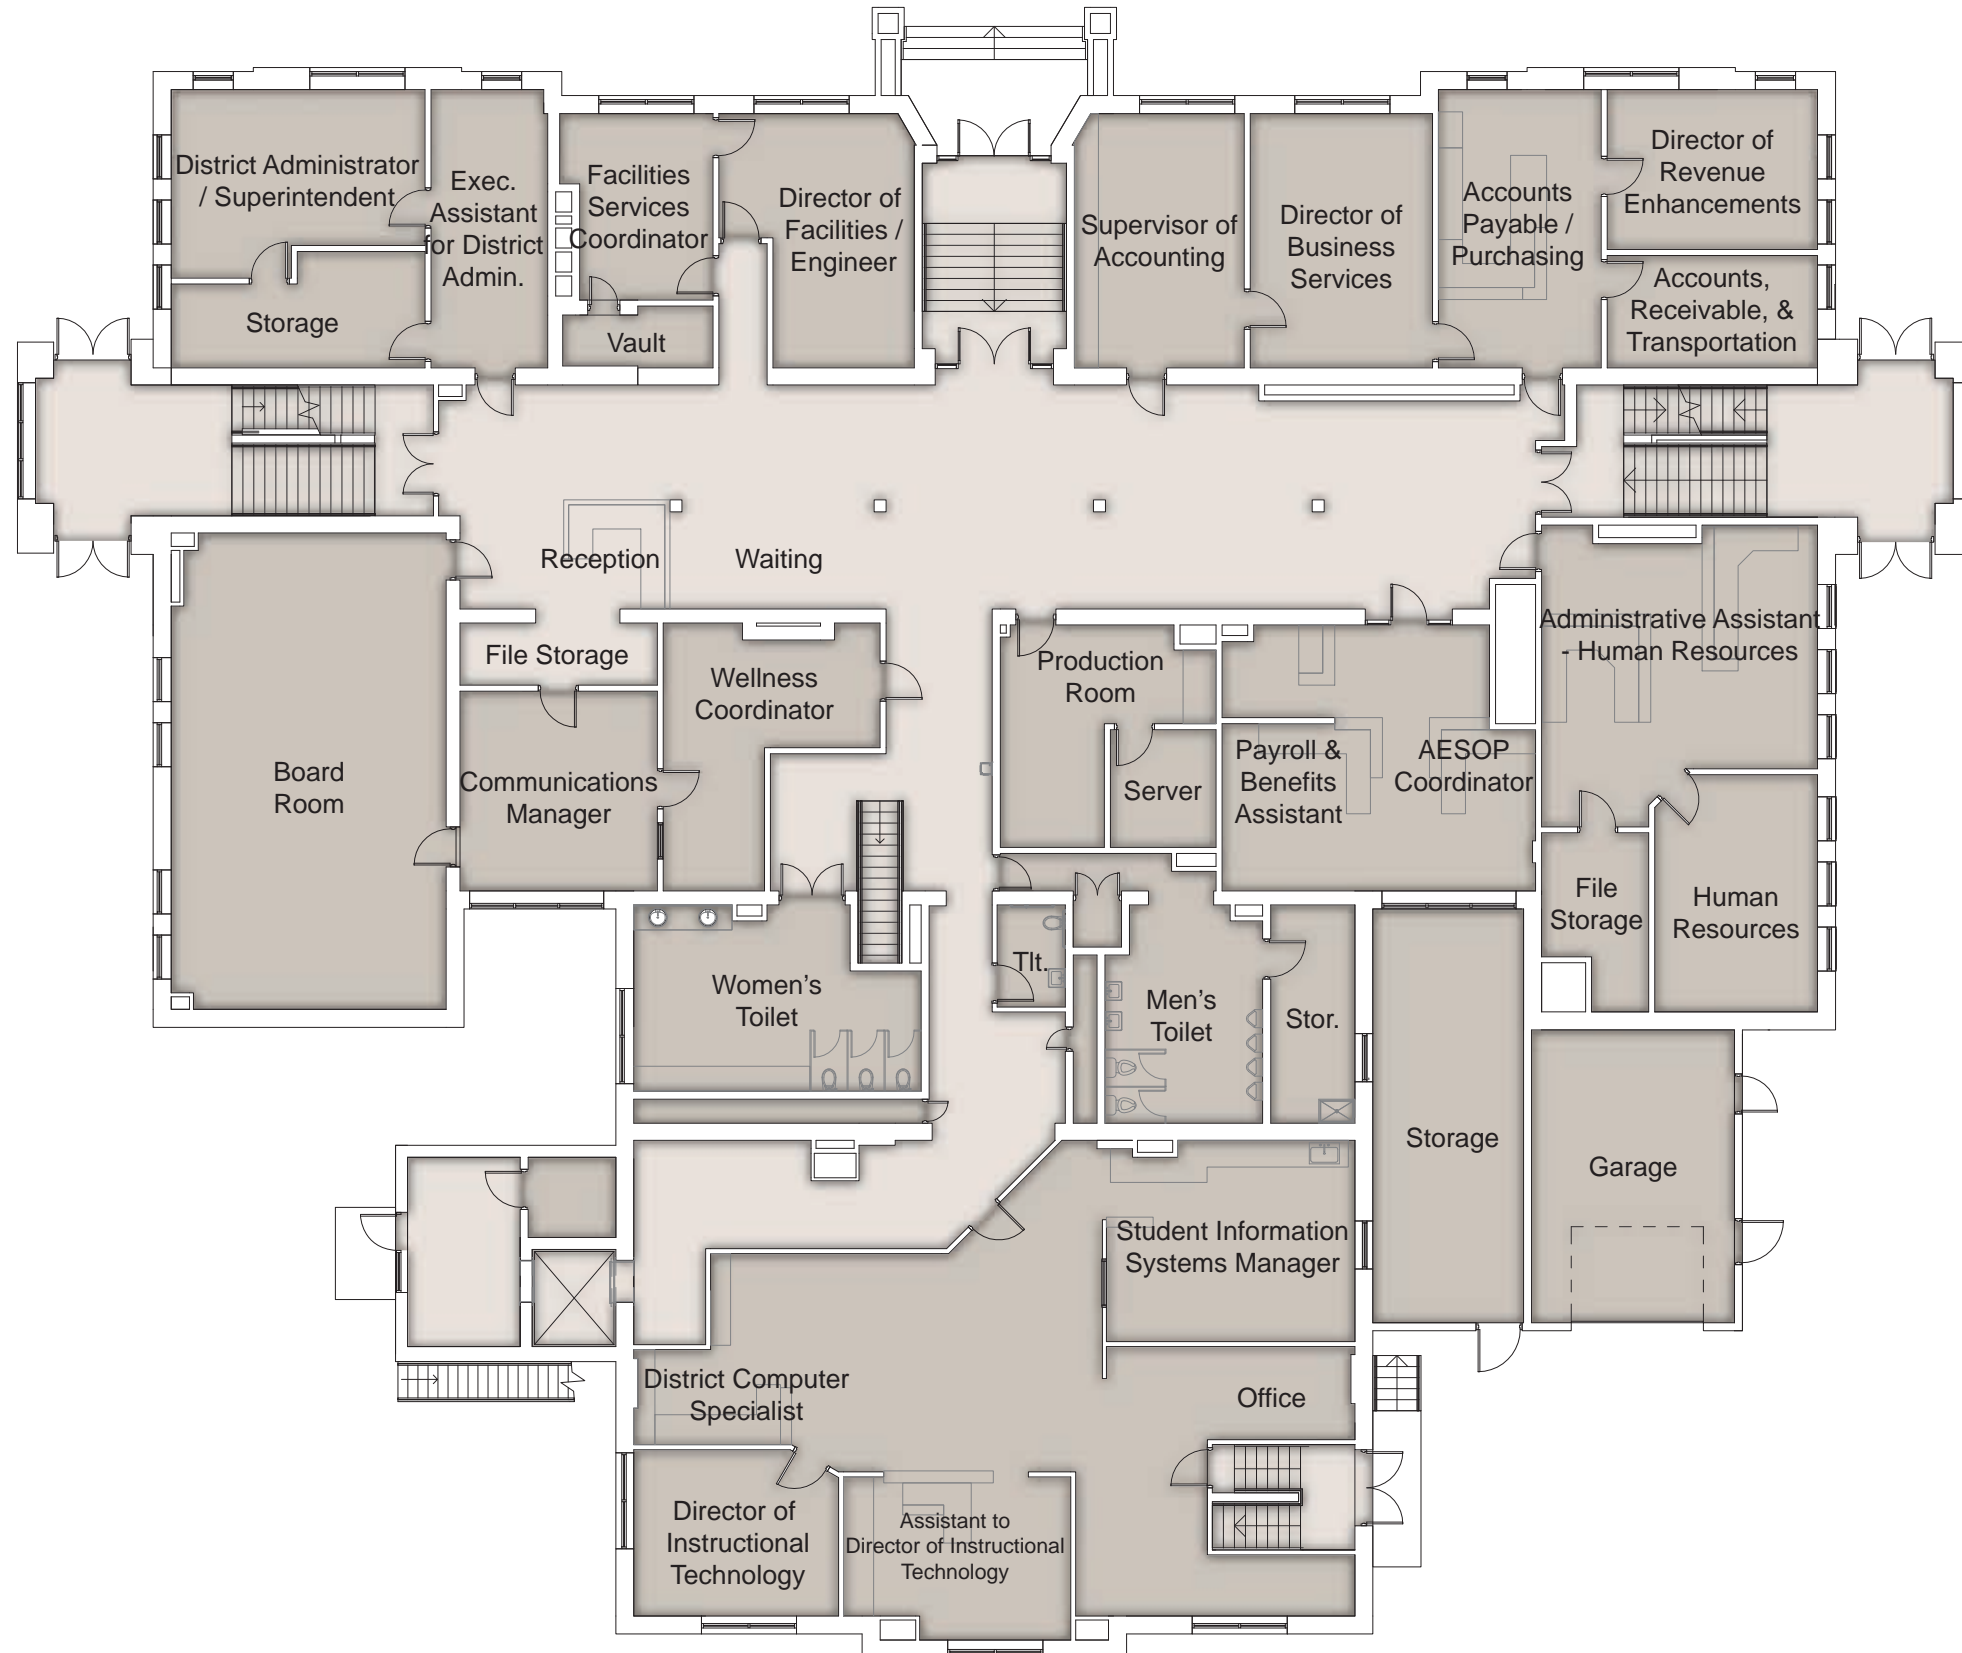
FIRST FLOOR PLAN
not to scale

ADMINISTRATION BUILDING: EXISTING FLOOR PLAN

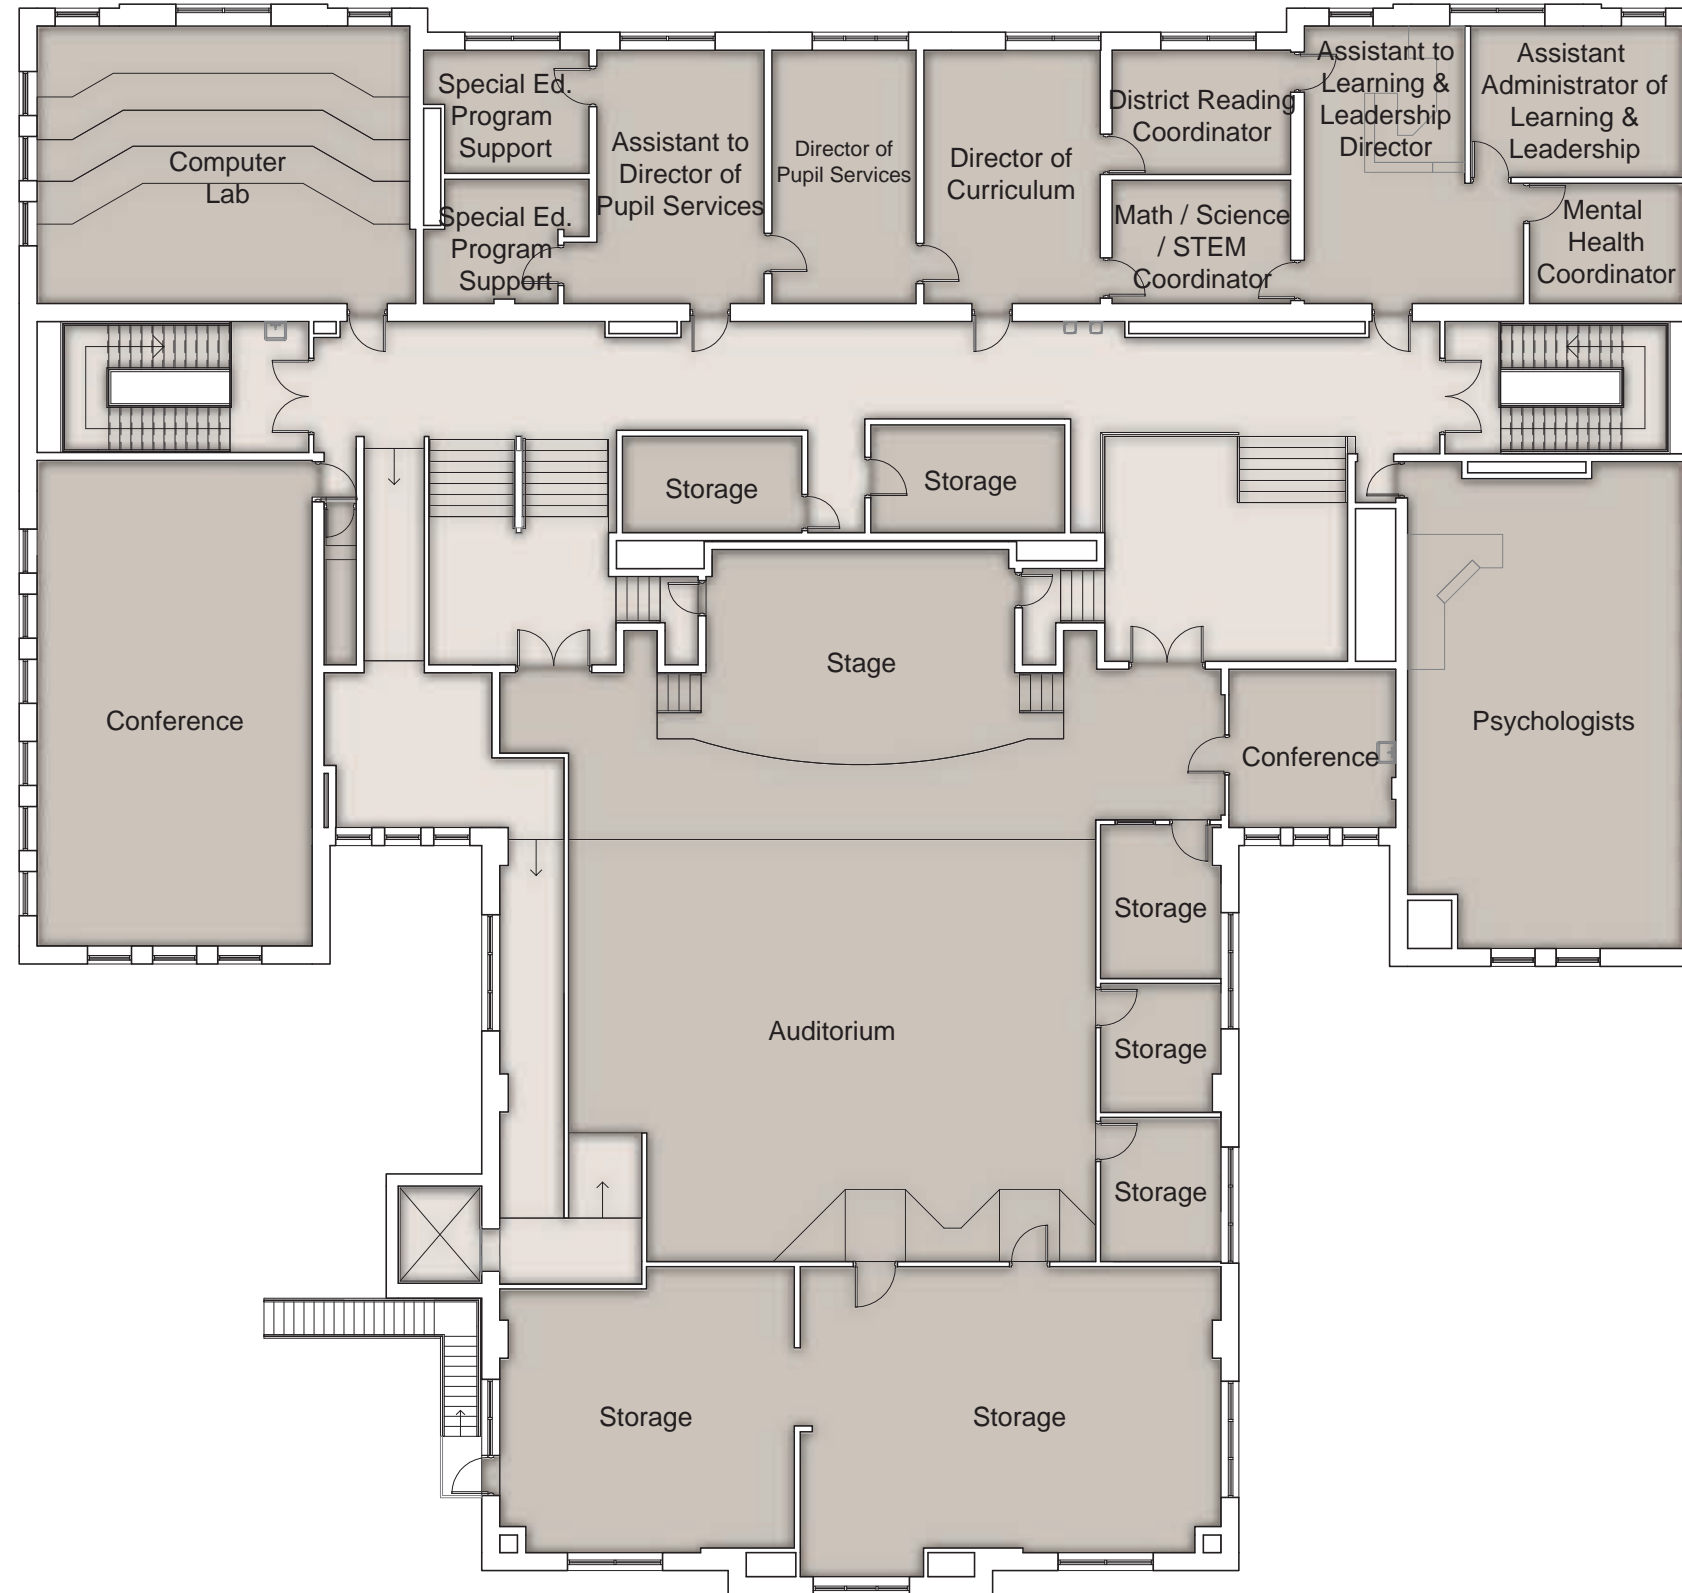
SECOND FLOOR PLAN
not to scale

ADMINISTRATION BUILDING: EXISTING FLOOR PLAN

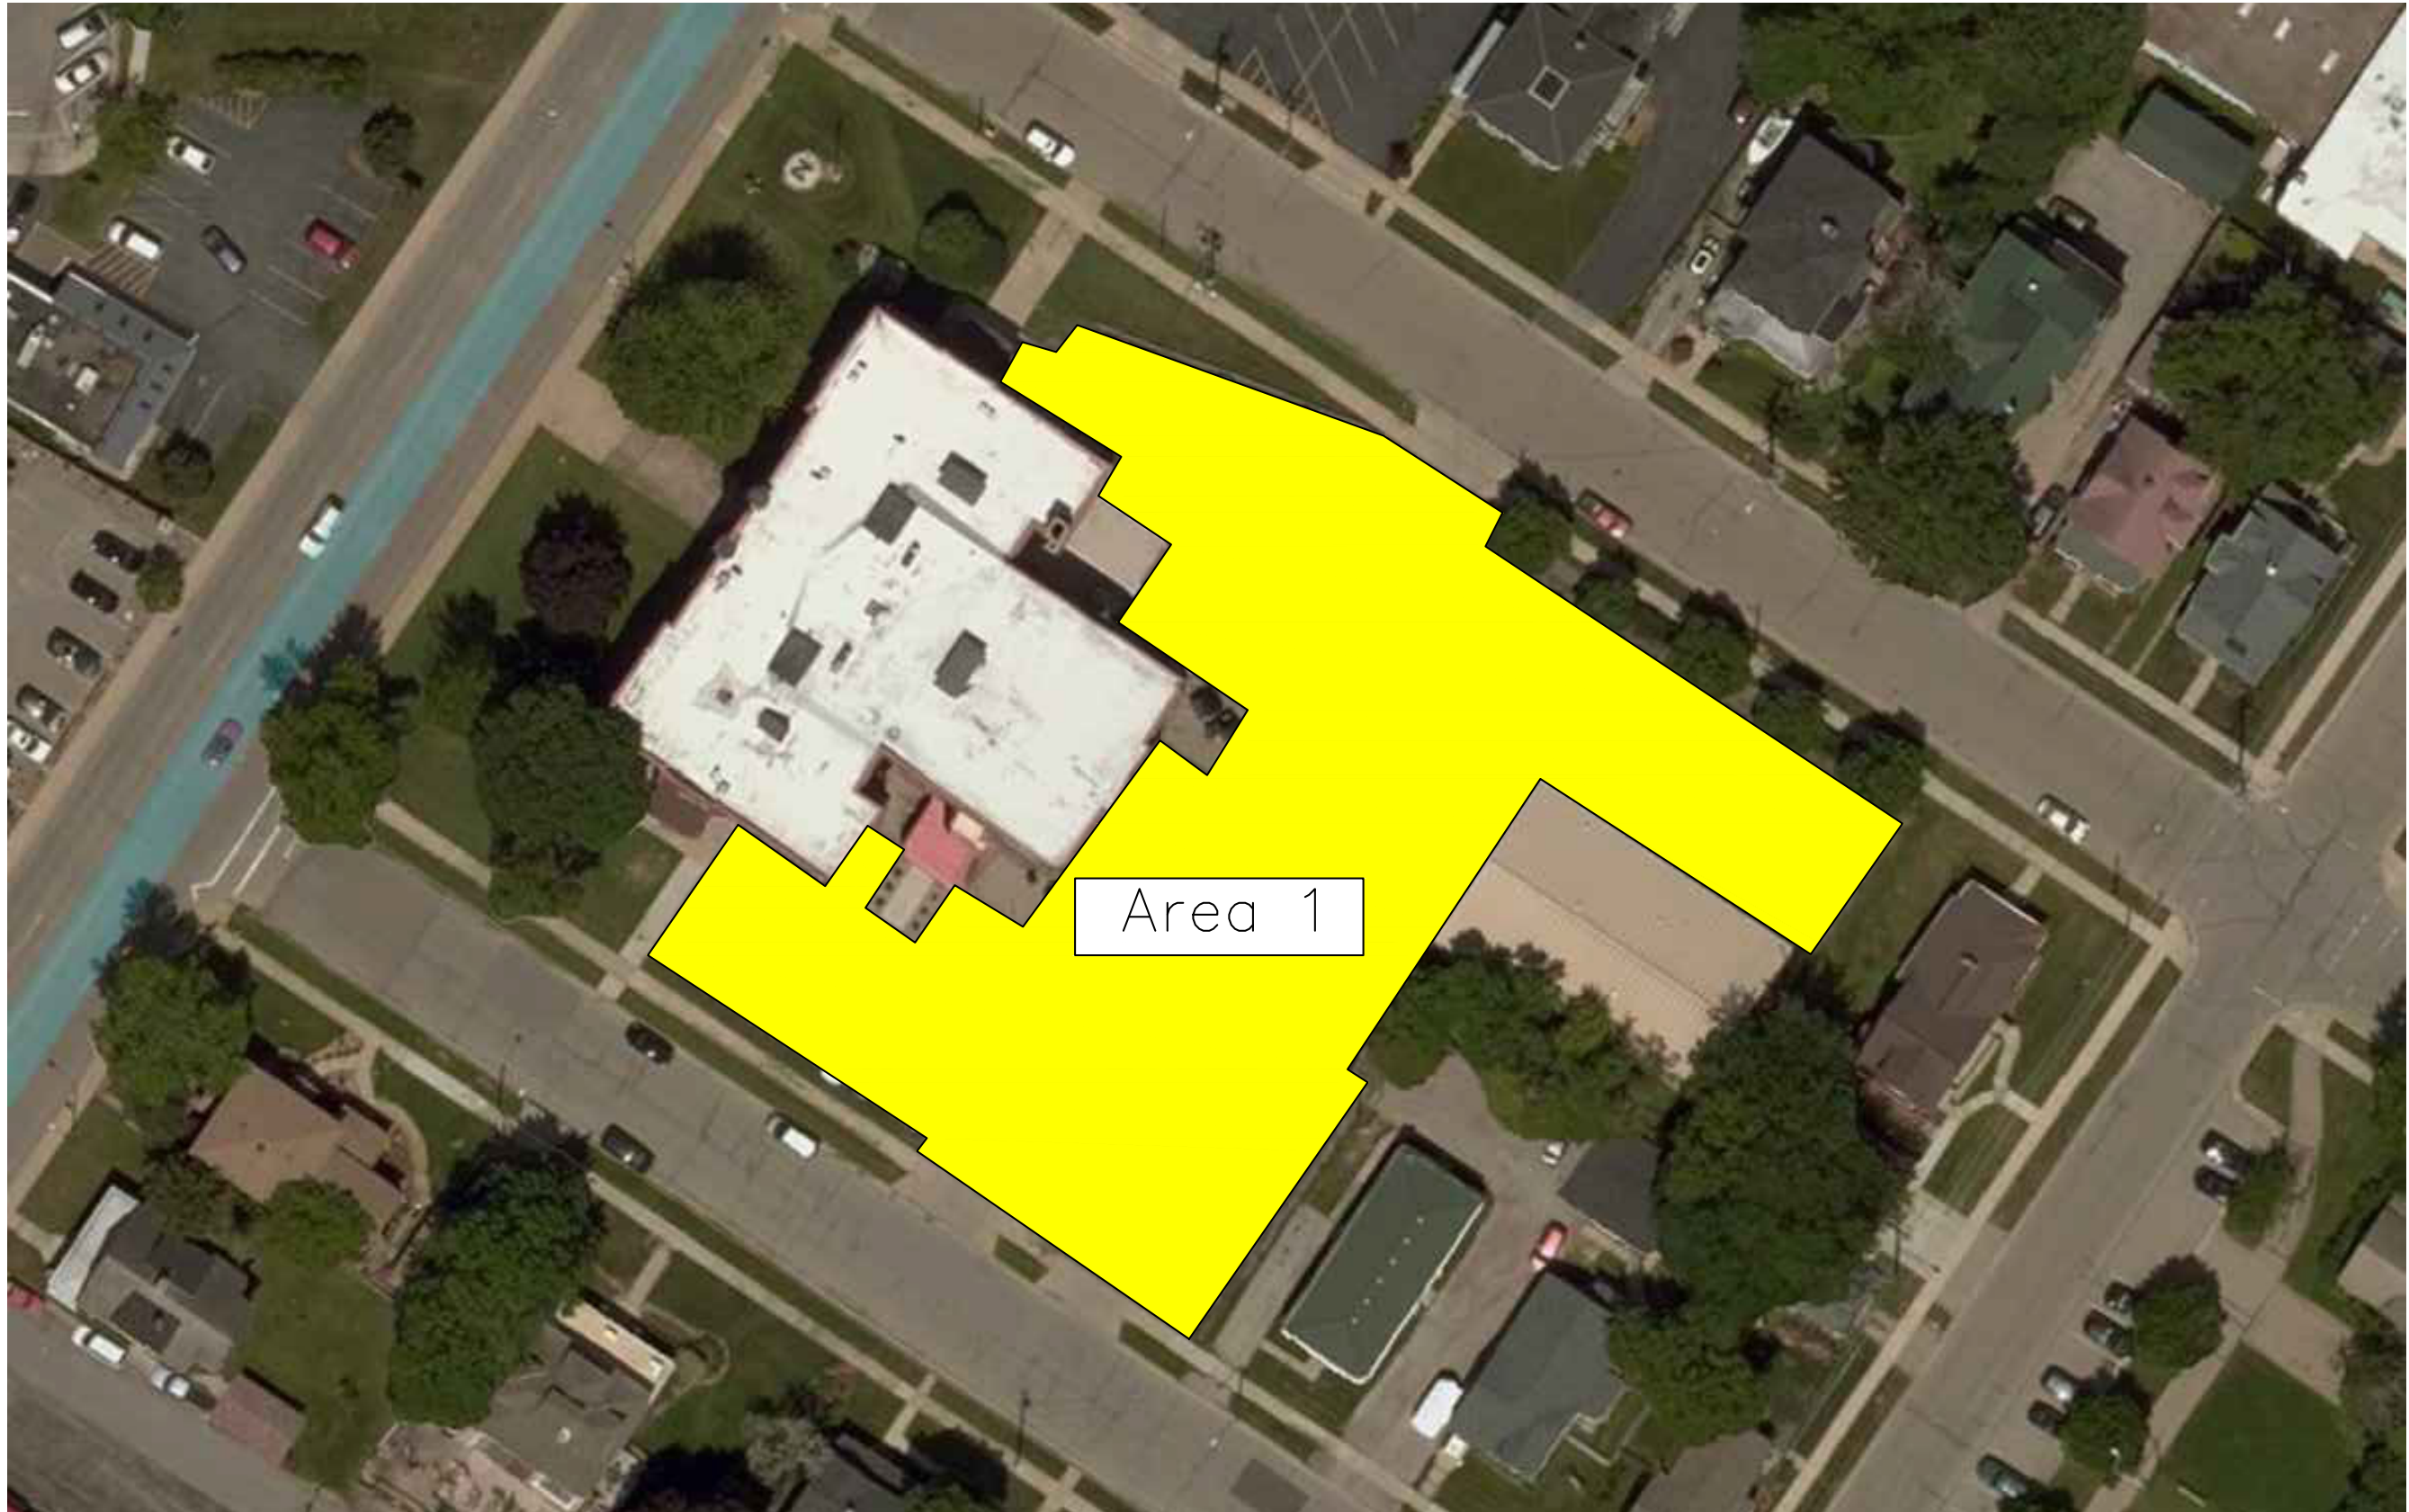
SITE PLAN
not to scale

Area 1

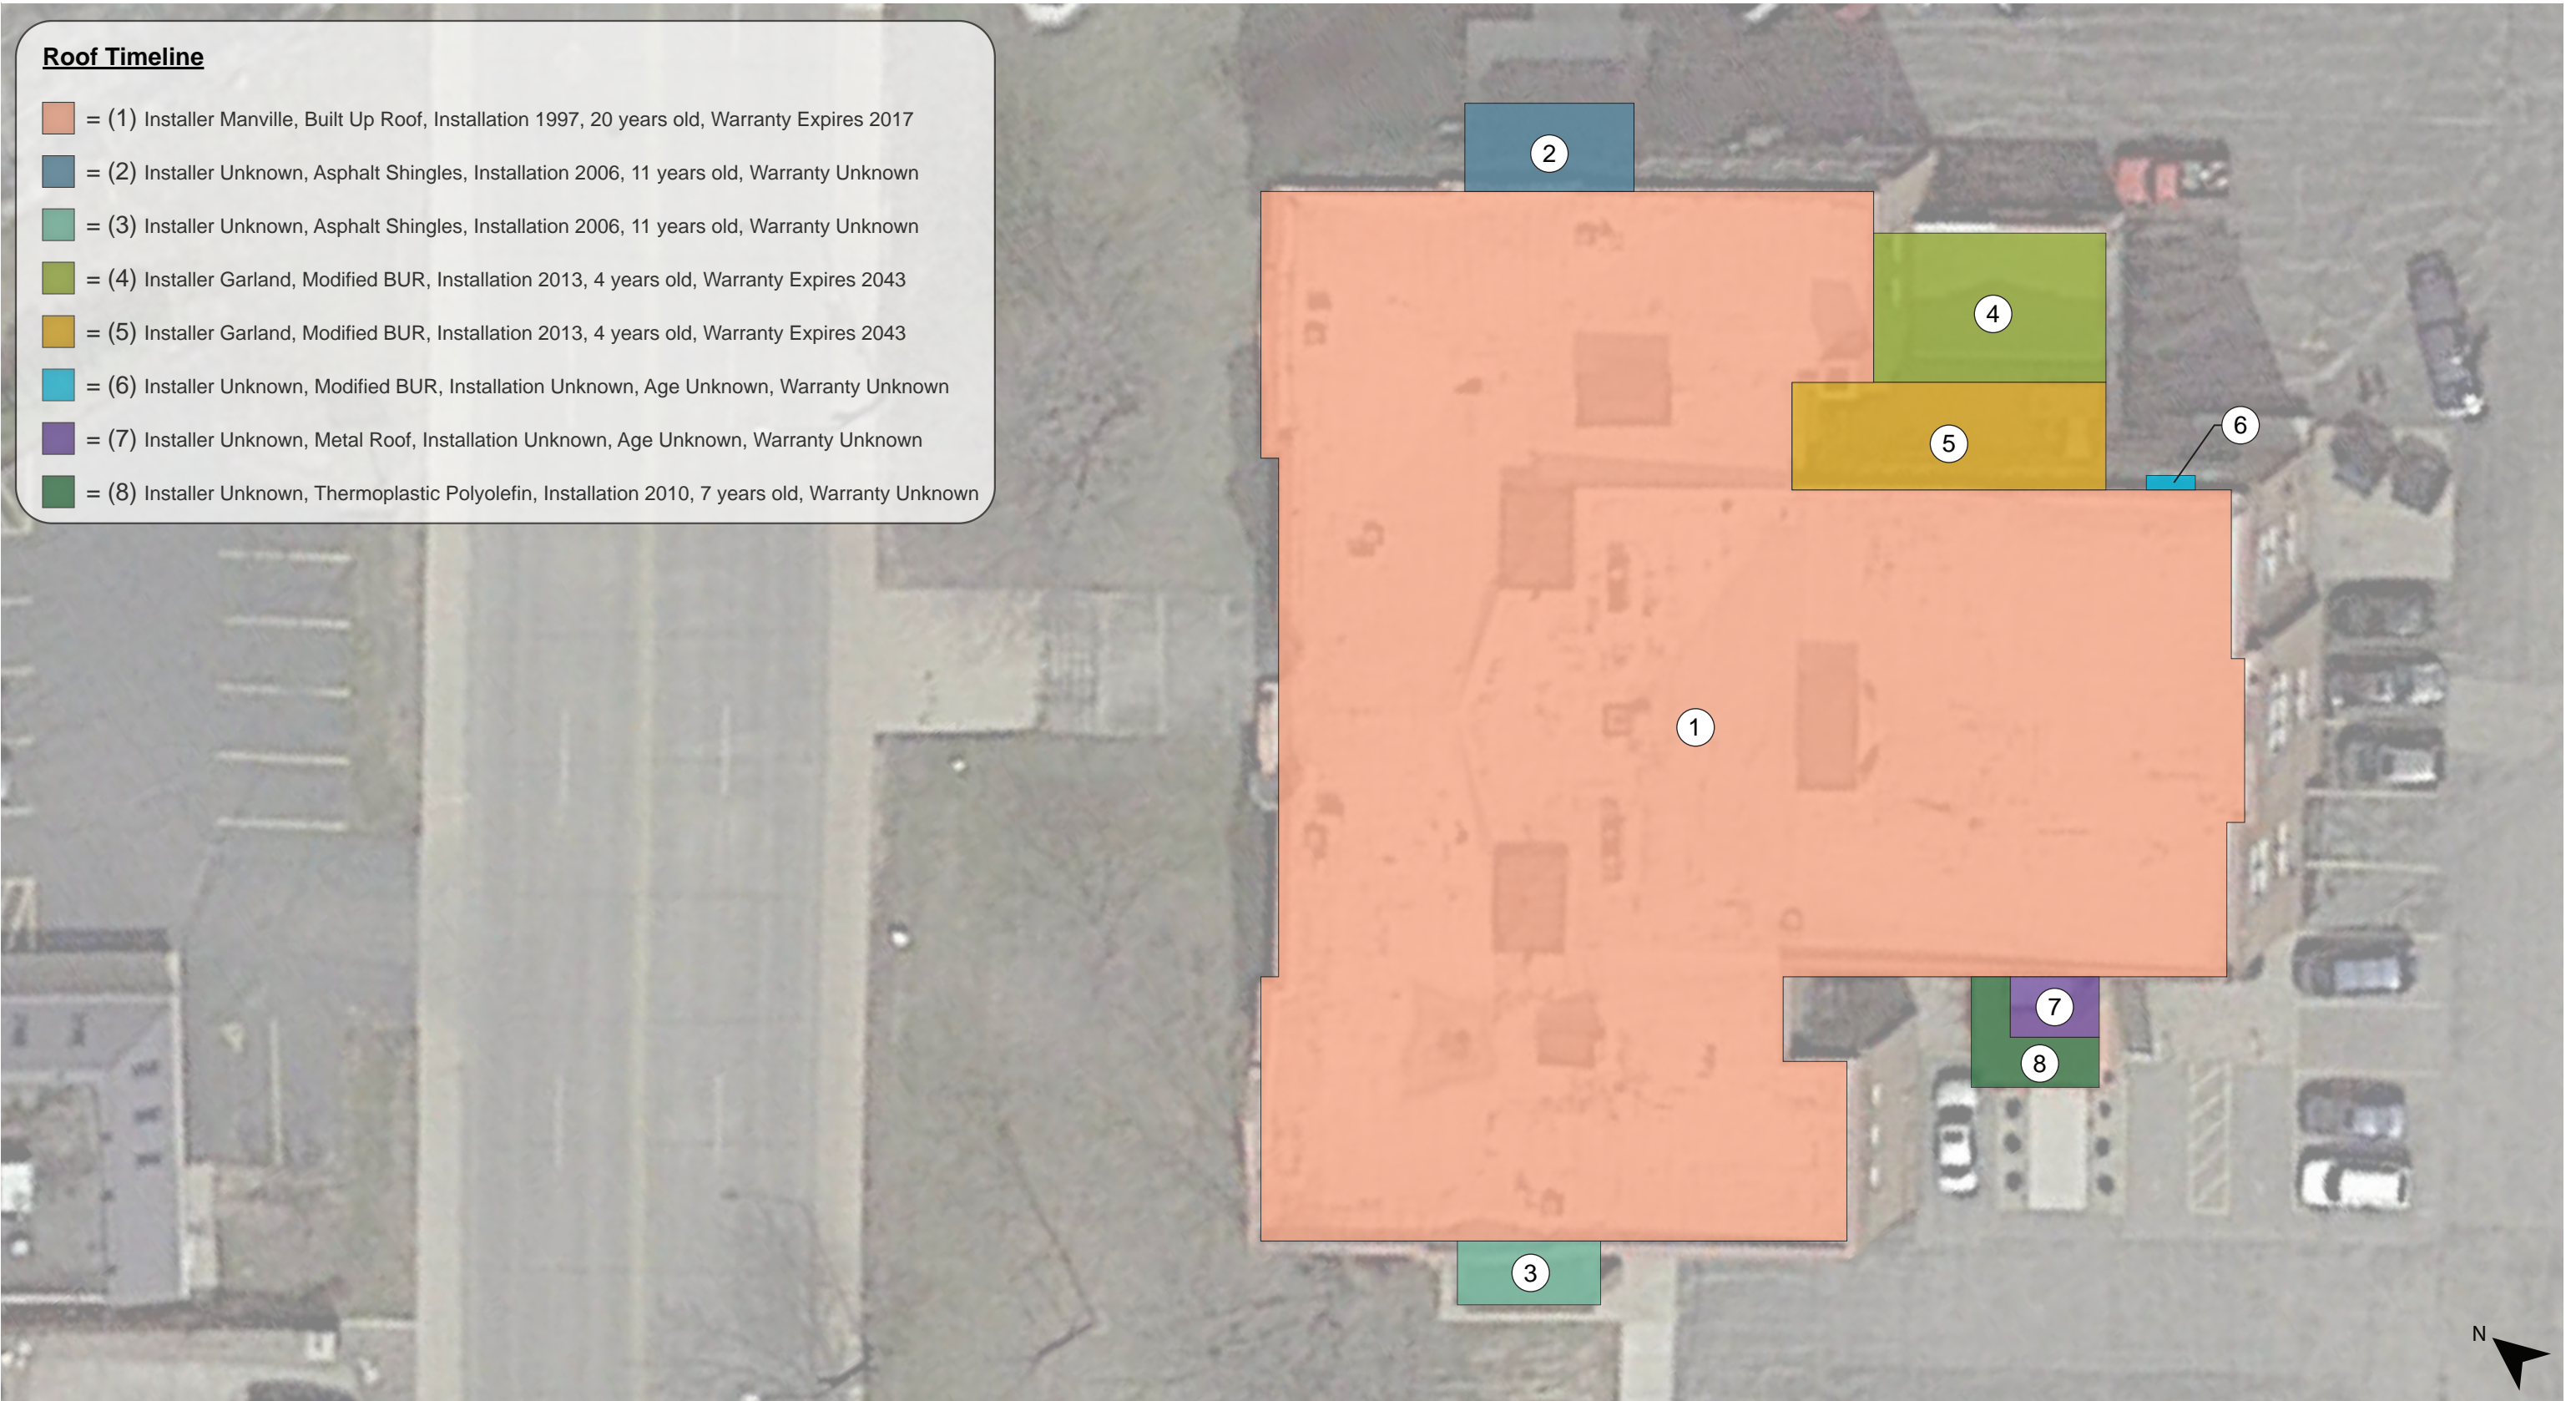
ROOF PLAN
not to scale

ADMINISTRATION BUILDING: ROOF PLAN

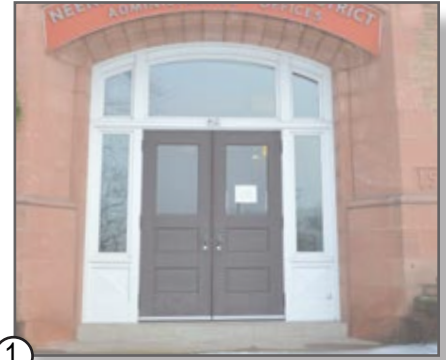
① WOOD DOORS & WOOD FRAME

- h. Original wood doors are damaged, stained and peeling, while their hollow metal frames appear newer and match the recently replaced windows; there is rust present, especially near the base of the door and hinge locations. Interior frames for these doors are wood, are worn, peeling, and were reported by staff to not close properly
