14 ADMINISTRATION BUILDING

The Administration building resides in the old Kimberly High School building and houses District Office Staff.

The Administration Building was originally constructed in 1907 as Kimberly High School. A garage addition was completed in 1977 and another addition in 2009, and now serves as the Neenah Joint School District Office.

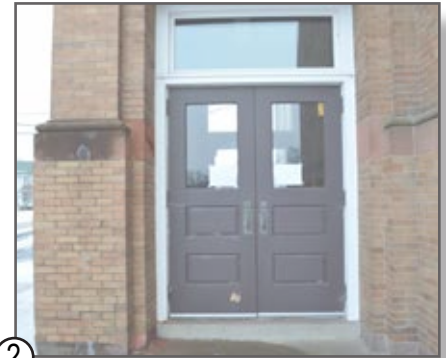
② WOOD DOORS & WOOD FRAME

- h. Original wood doors are damaged, stained and peeling, while their hollow metal frames appear newer and match the recently replaced windows; there is rust present, especially near the base of the door and hinge locations. Interior frames for these doors are wood, are worn, peeling, and were reported by staff to not close properly

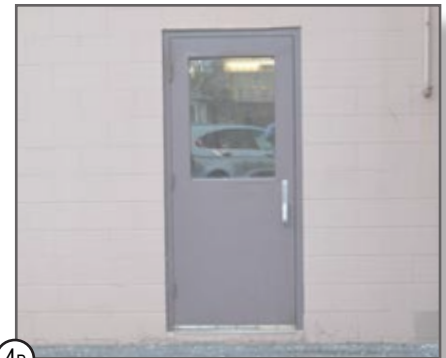
④B HOLLOW METAL DOOR & HOLLOW METAL FRAME

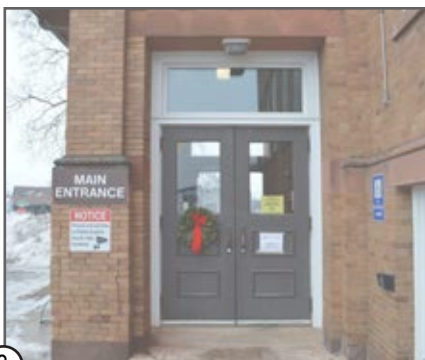
⑧ WOOD DOORS & WOOD FRAME

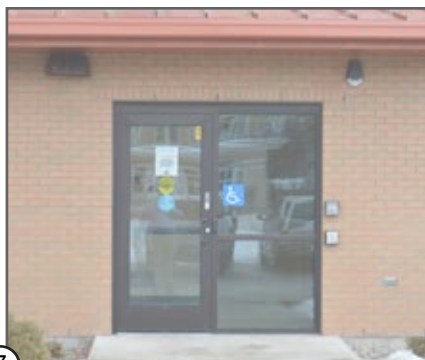
⑦ ALUMINUM DOOR & ALUMINUM STOREFRONT

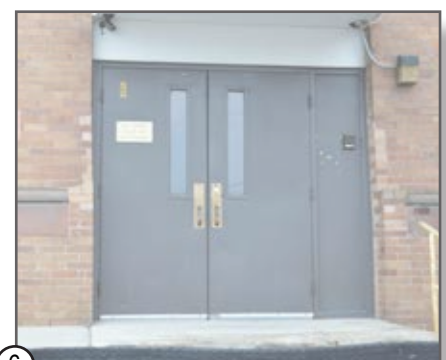
⑥ HOLLOW METAL DOORS & HOLLOW METAL FRAME

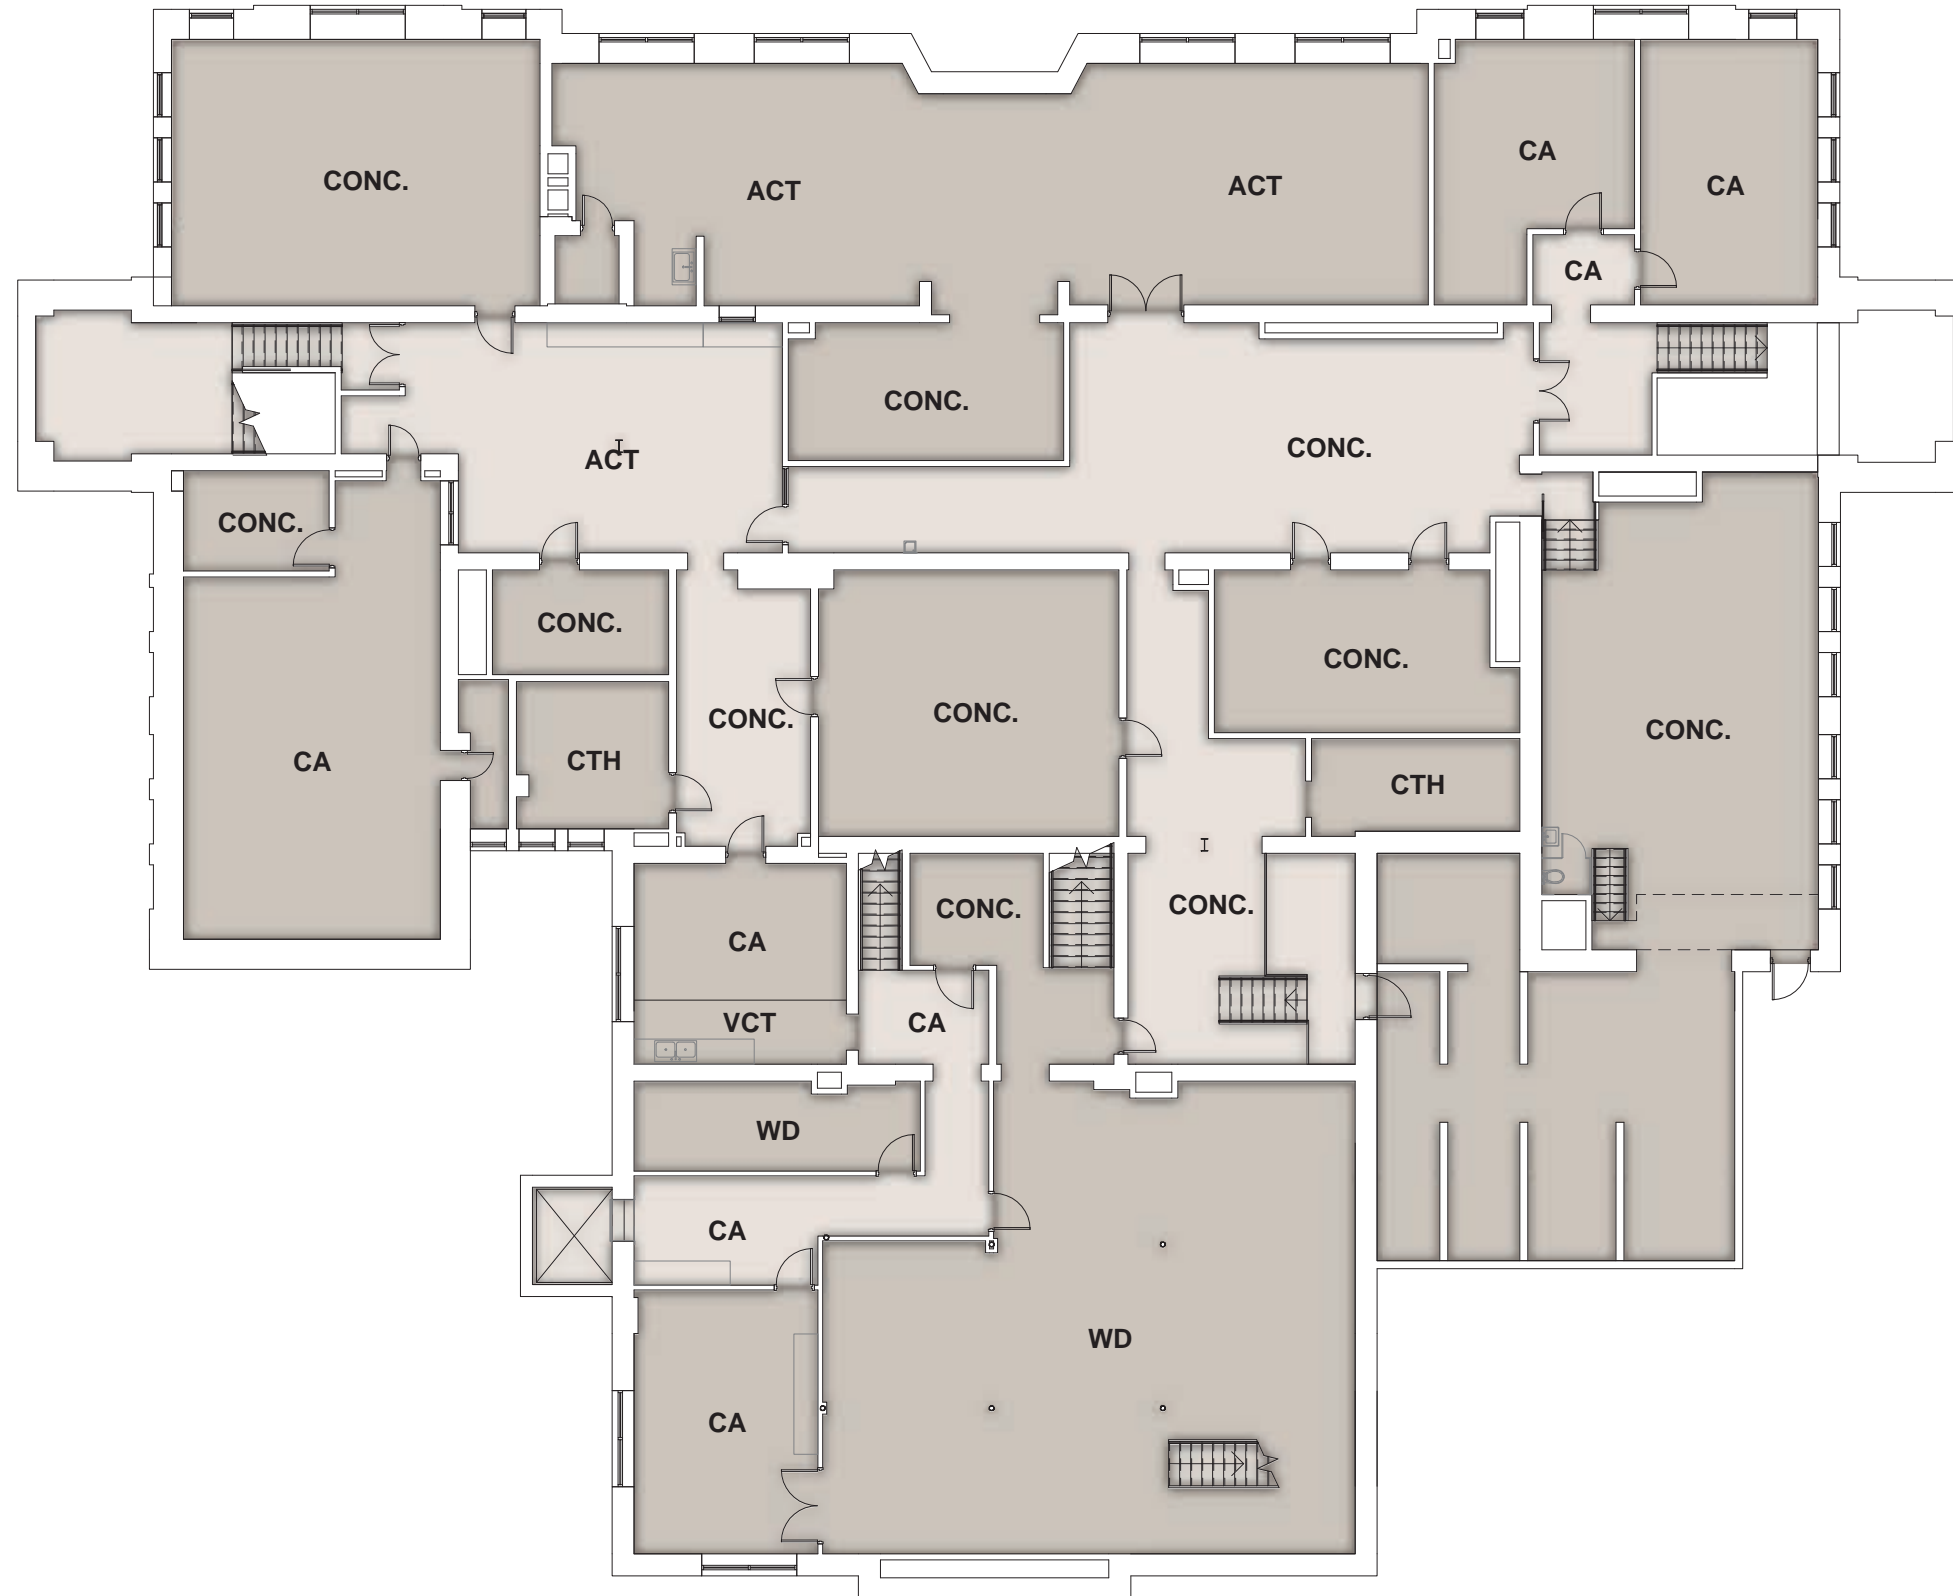
LOWER FLOOR PLAN
not to scale

ADMINISTRATION BUILDING: FLOORING ANALYSIS

- ACT** - 9x9 (Asbestos)
- ACT1** - 12x12 (Asbestos)
- ACT2** - 6x6 (Asbestos)
- CA** - Carpet Broadloom
- CAT** - Carpet Tile
- CT1** - 1x1 Ceramic Tile
- CT2** - 2x2 Ceramic Tile
- CT12** - 1x2 Ceramic Tile
- CTH** - Hex Ceramic Tile
- CONC.** - Concrete
- PT** - 8x8 Paver Tile
- PT1** - 6x6 Paver Tile
- PT2** - 3x3 Paver Tile
- PT3** - 3x6 Paver Tile
- RT** - Rubber Tile
- RTT** - Rubber Tile Tread
- SS** - Seamless Synthetic
- SV** - Sheet Vinyl
- TER** - Terrazzo Tile
- TER1** - 12x12 Terrazzo Tile
- VCT** - 12x12
- WD** - Wood
- WDP** - 4x4 Wood Parquet
- WM** - Walk-off Mat

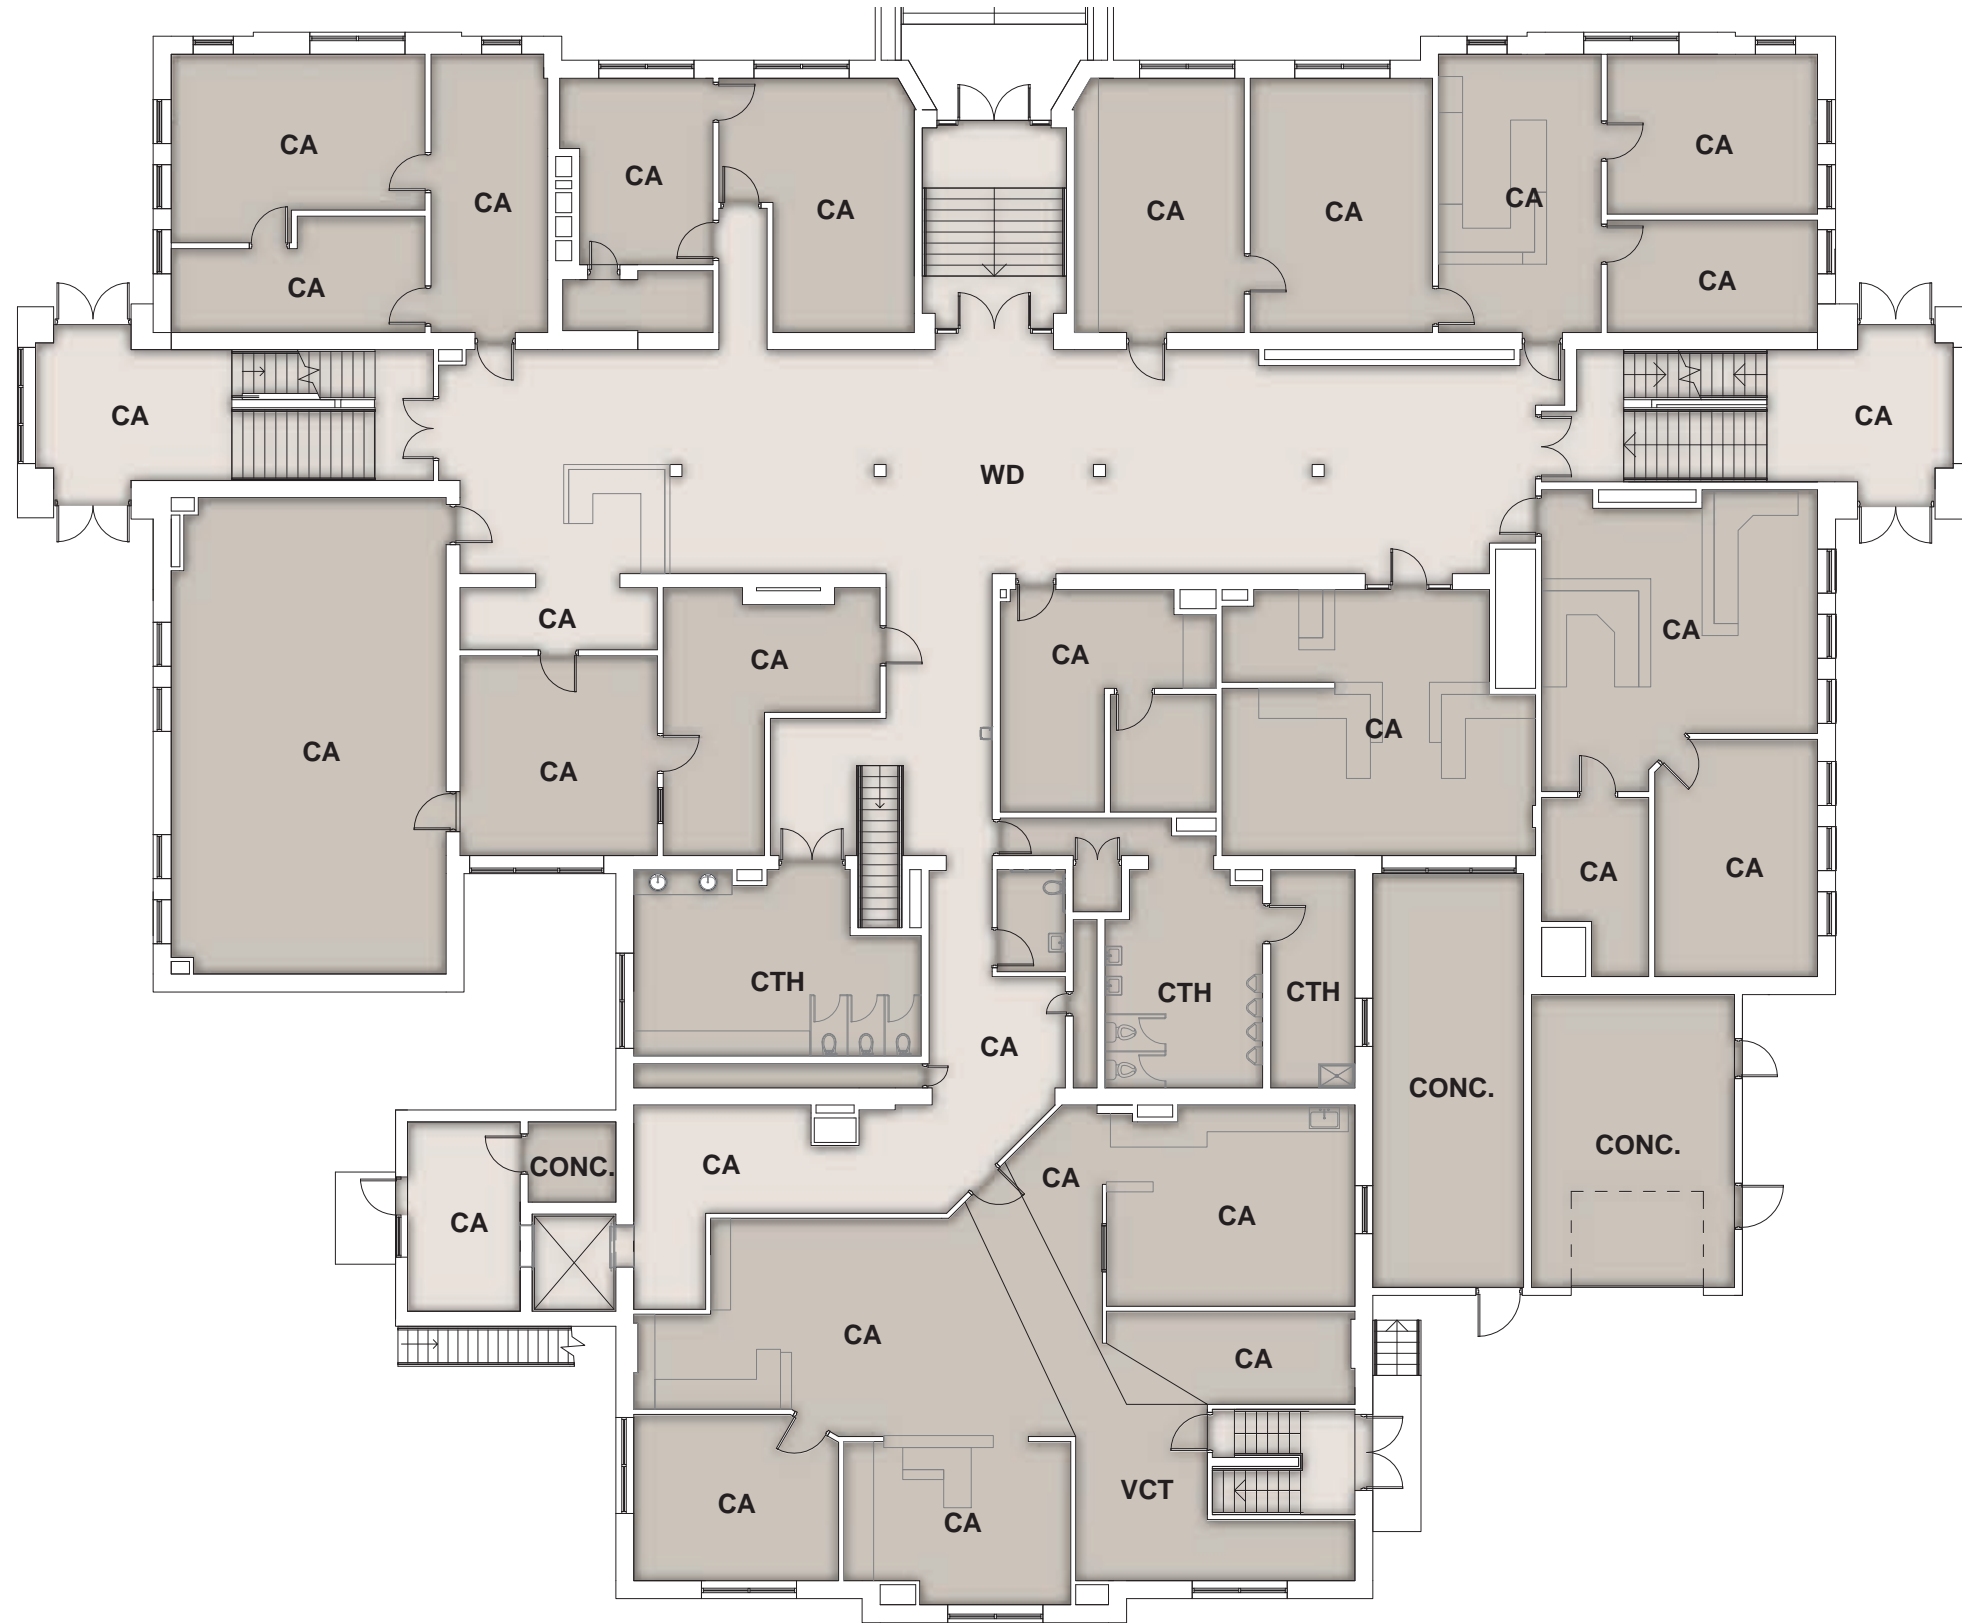
FIRST FLOOR PLAN
not to scale

- ACT - 9x9 (Asbestos)
- ACT1 - 12x12 (Asbestos)
- ACT2 - 6x6 (Asbestos)
- CA - Carpet Broadloom
- CAT - Carpet Tile
- CT1 - 1x1 Ceramic Tile
- CT2 - 2x2 Ceramic Tile
- CT12 - 1x2 Ceramic Tile
- CTH - Hex Ceramic Tile
- CONC. - Concrete
- PT - 8x8 Paver Tile
- PT1 - 6x6 Paver Tile
- PT2 - 3x3 Paver Tile
- PT3 - 3x6 Paver Tile
- RT - Rubber Tile
- RTT - Rubber Tile Tread
- SS - Seamless Synthetic
- SV - Sheet Vinyl
- TER - Terrazzo Tile
- TER1 - 12x12 Terrazzo Tile
- VCT - 12x12
- WD - Wood
- WDP - 4x4 Wood Parquet
- WM - Walk-off Mat

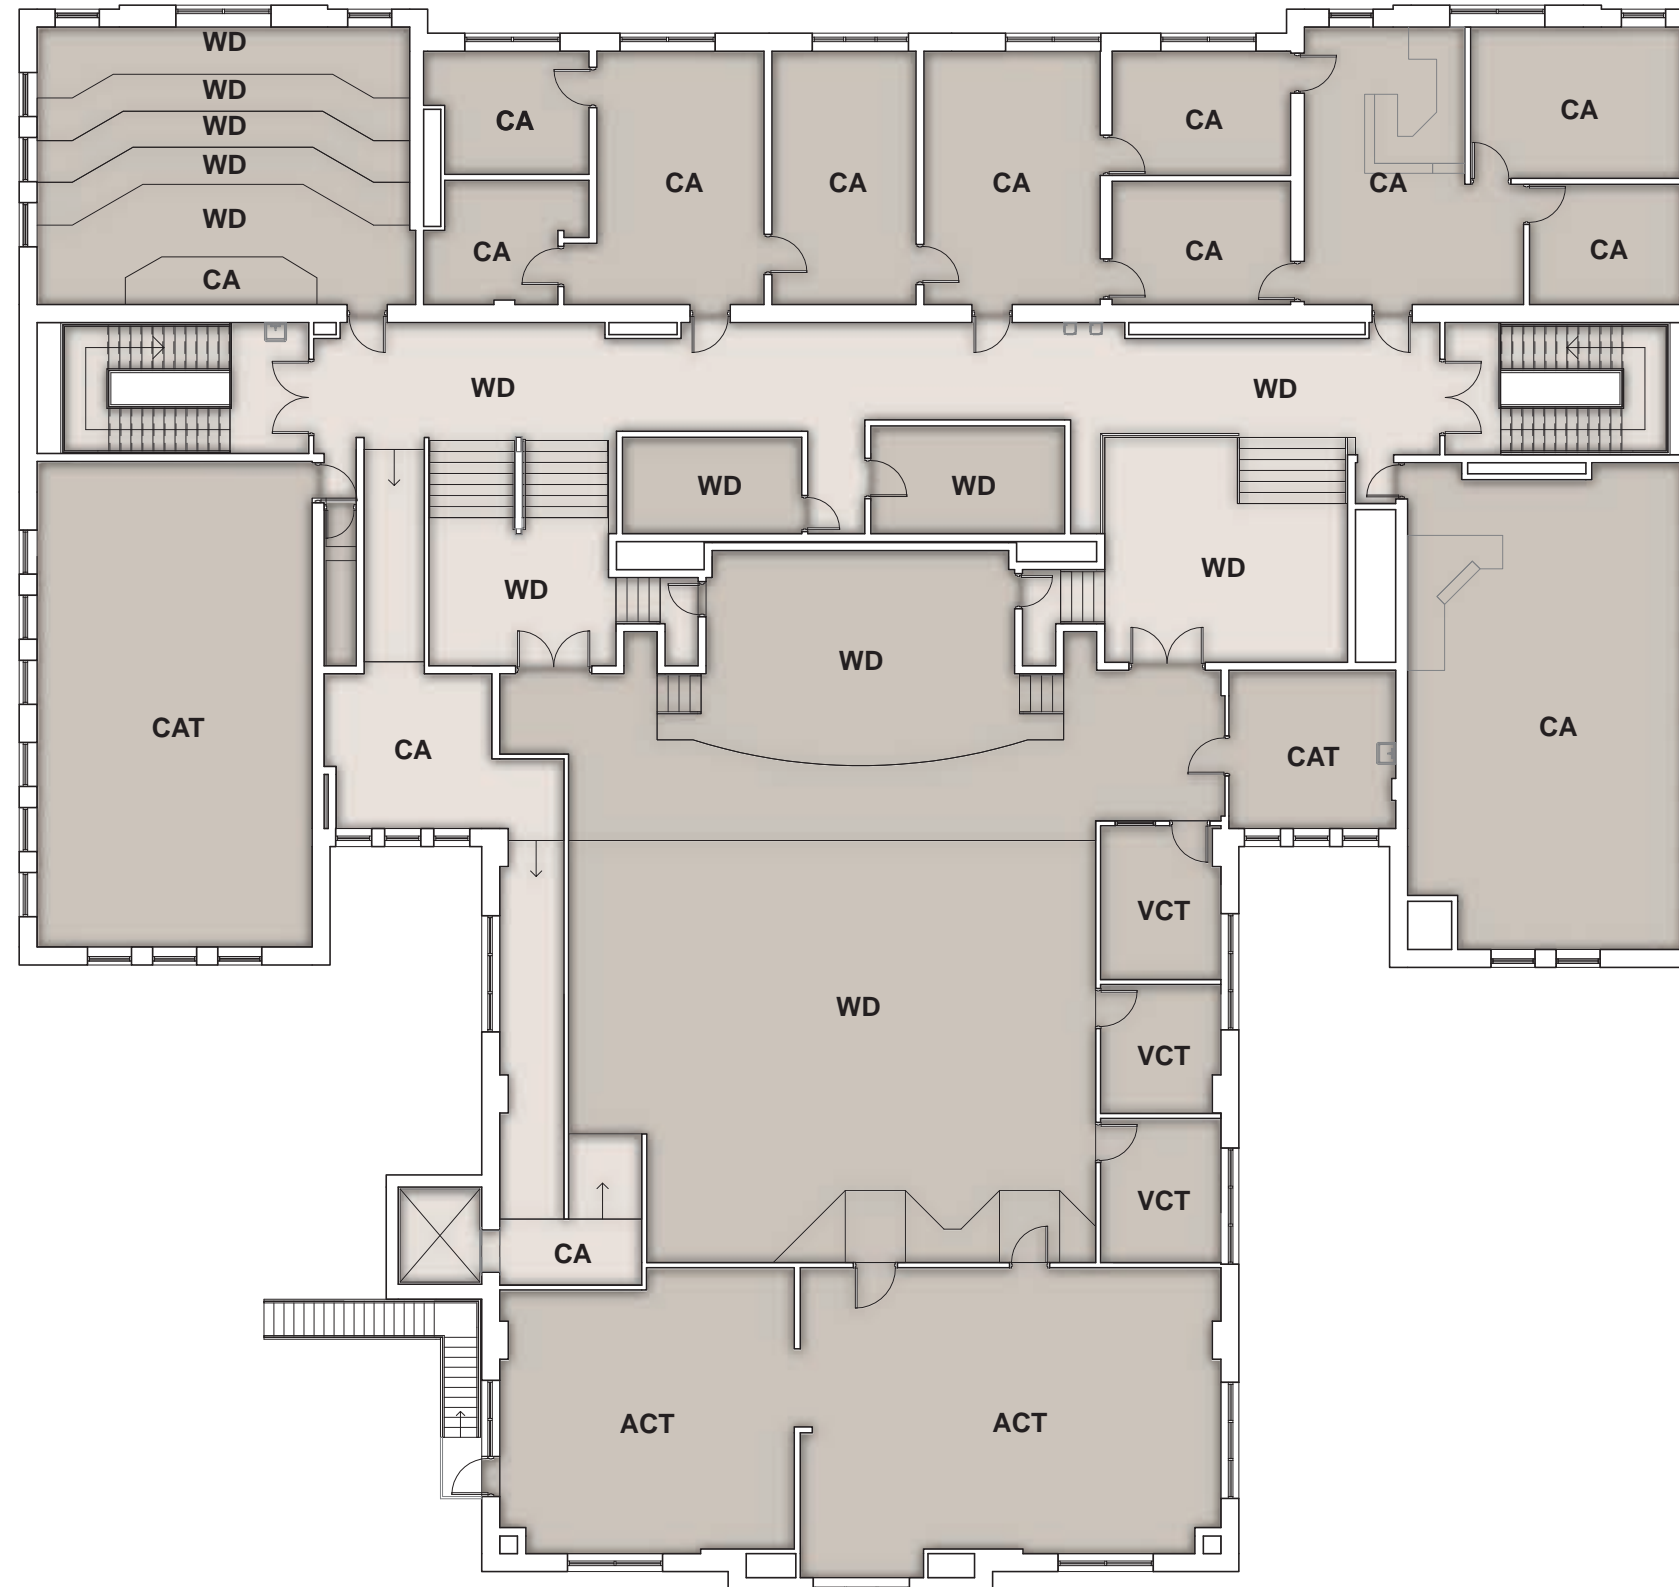
SECOND FLOOR PLAN
not to scale

- ACT** - 9x9 (Asbestos)
- ACT1** - 12x12 (Asbestos)
- ACT2** - 6x6 (Asbestos)
- CA** - Carpet Broadloom
- CAT** - Carpet Tile
- CT1** - 1x1 Ceramic Tile
- CT2** - 2x2 Ceramic Tile
- CT12** - 1x2 Ceramic Tile
- CTH** - Hex Ceramic Tile
- CONC.** - Concrete
- PT** - 8x8 Paver Tile
- PT1** - 6x6 Paver Tile
- PT2** - 3x3 Paver Tile
- PT3** - 3x6 Paver Tile
- RT** - Rubber Tile
- RTT** - Rubber Tile Tread
- SS** - Seamless Synthetic
- SV** - Sheet Vinyl
- TER** - Terrazzo Tile
- TER1** - 12x12 Terrazzo Tile
- VCT** - 12x12
- WD** - Wood
- WDP** - 4x4 Wood Parquet
- WM** - Walk-off Mat
